**WEST EASTON BOROUGH
NORTHAMPTON COUNTY**

**IN-DEPTH BRIDGE INSPECTION AND
ALTERNATIVES DISCUSSION REPORT**

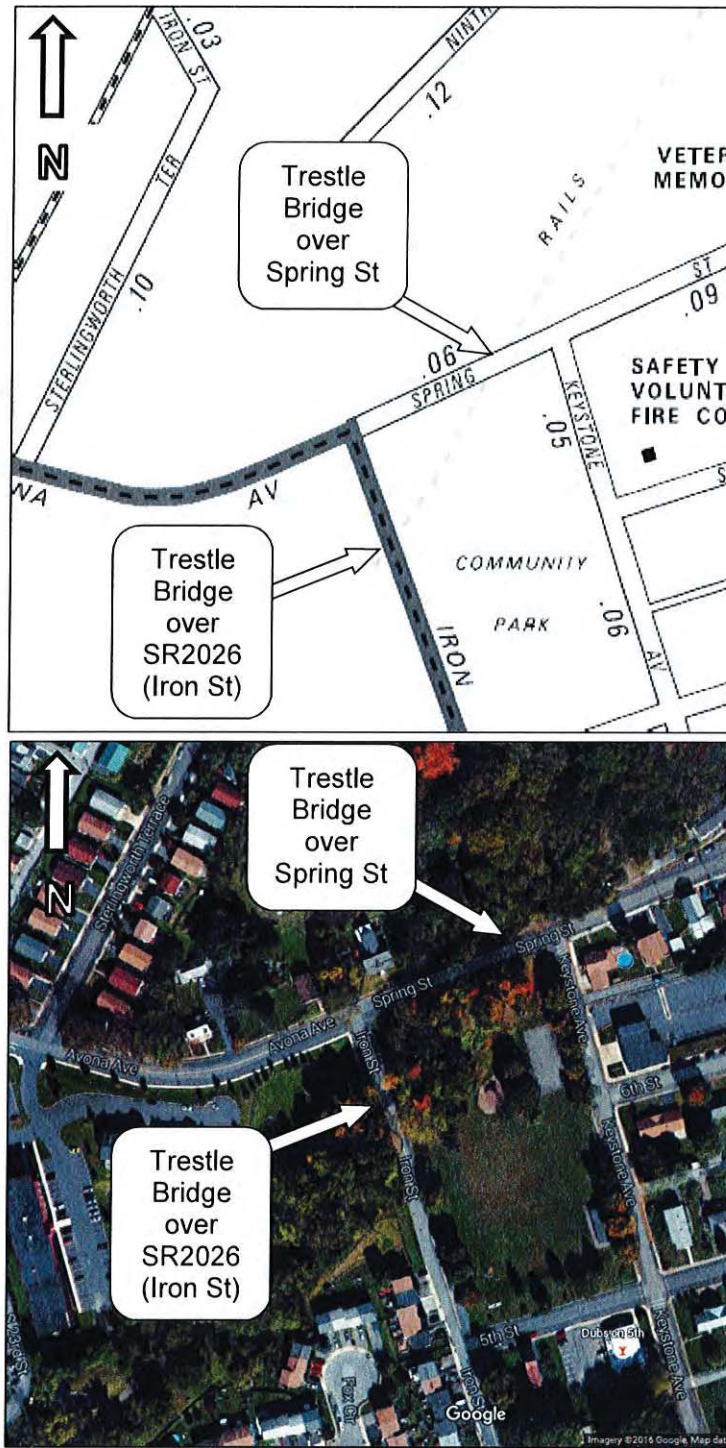
Figure 1: Location Map, West Easton Borough (PennDOT Type 5 and Google Maps)

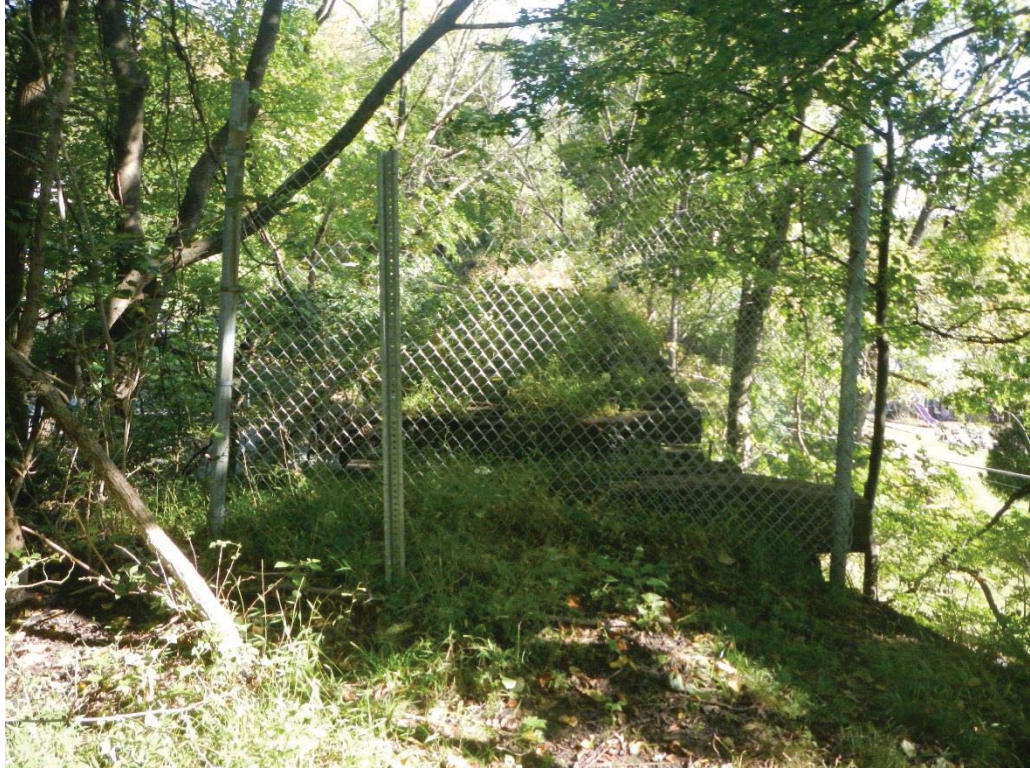
1. View Over Structure From Near (West) End

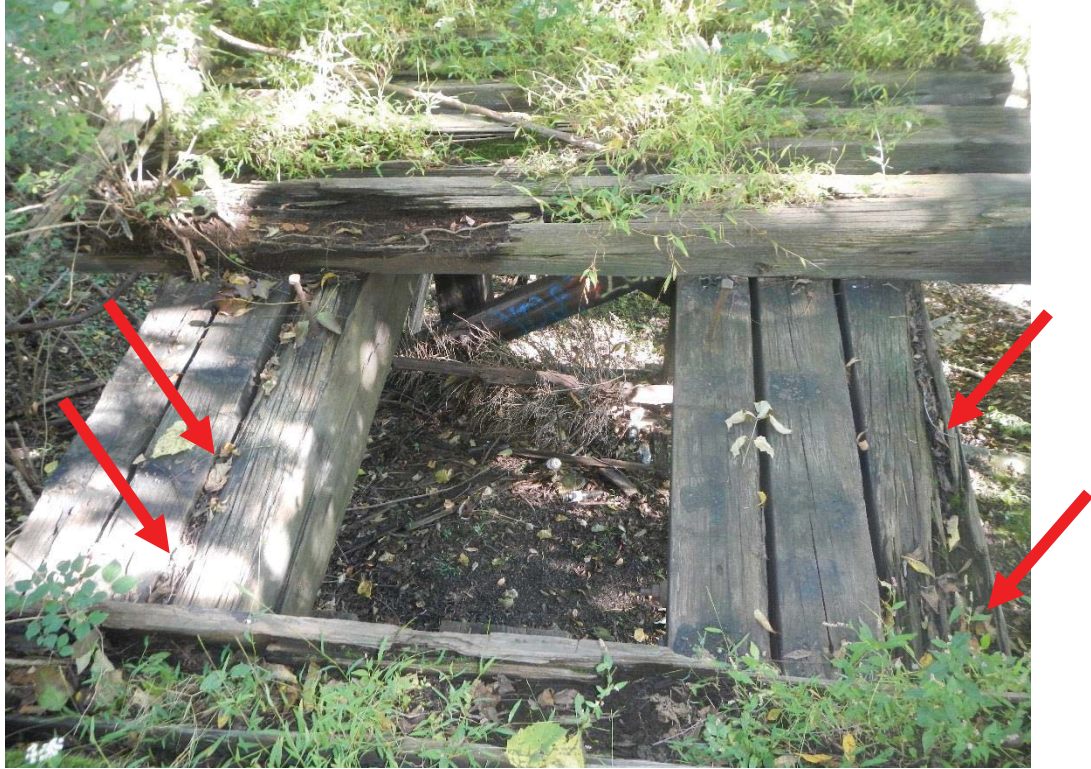
13. Span 1 Stringers Decay to Top of Stringers Adjacent to Near (West) Abutment

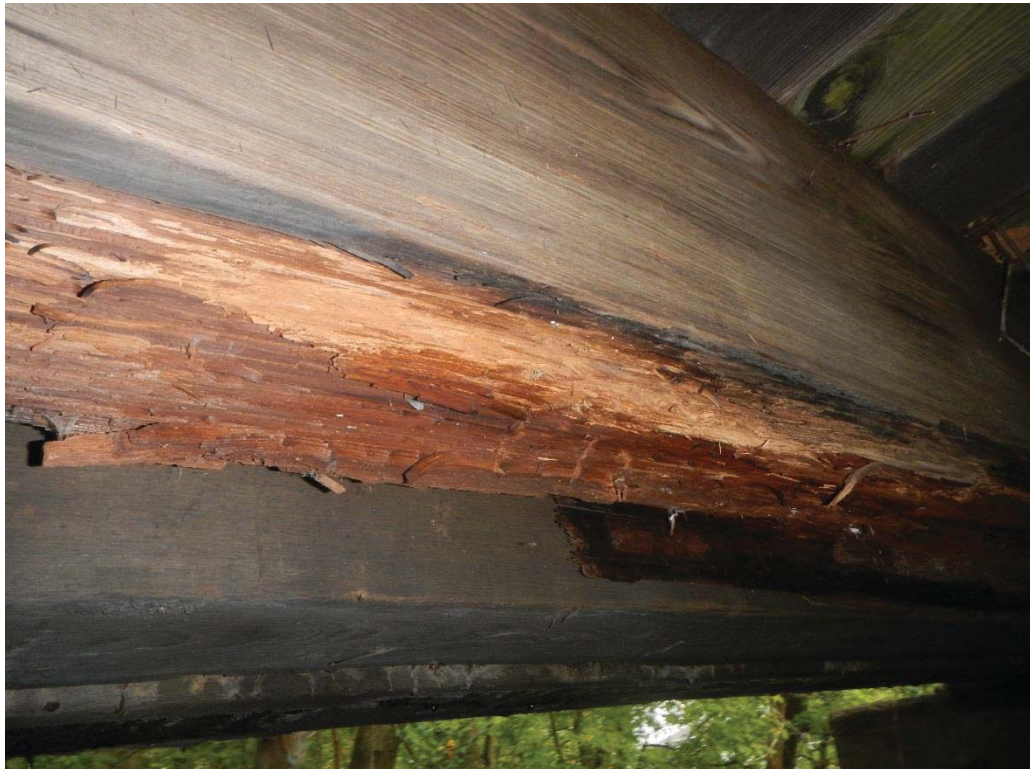
14. Span 2 Stringer 3 Decay Along Bottom of Stringer

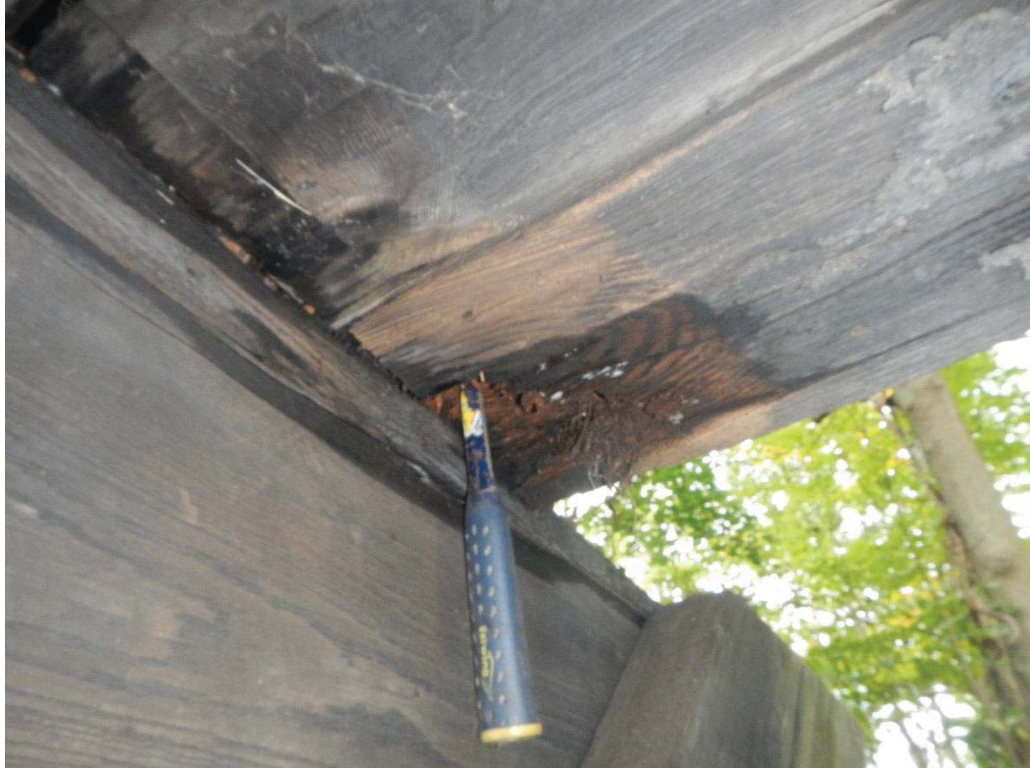
15. Span 3 Stringer 1 Decay at Bot of Stringer Adj to Pier 2 (Hammer Penetration up to 6") (Decay Extends Full Height)

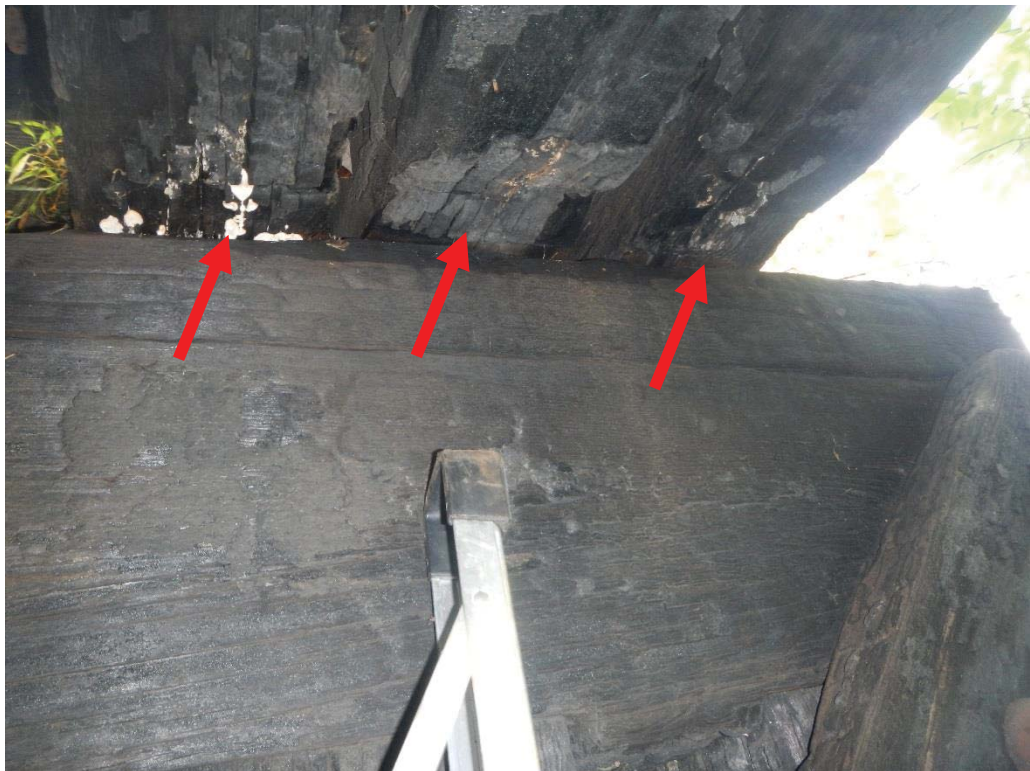
16. Span 3 Stringers 4 Thru 6 Fire/Fungus Damage Along Bottom of Stringers Adjacent to Pier 3

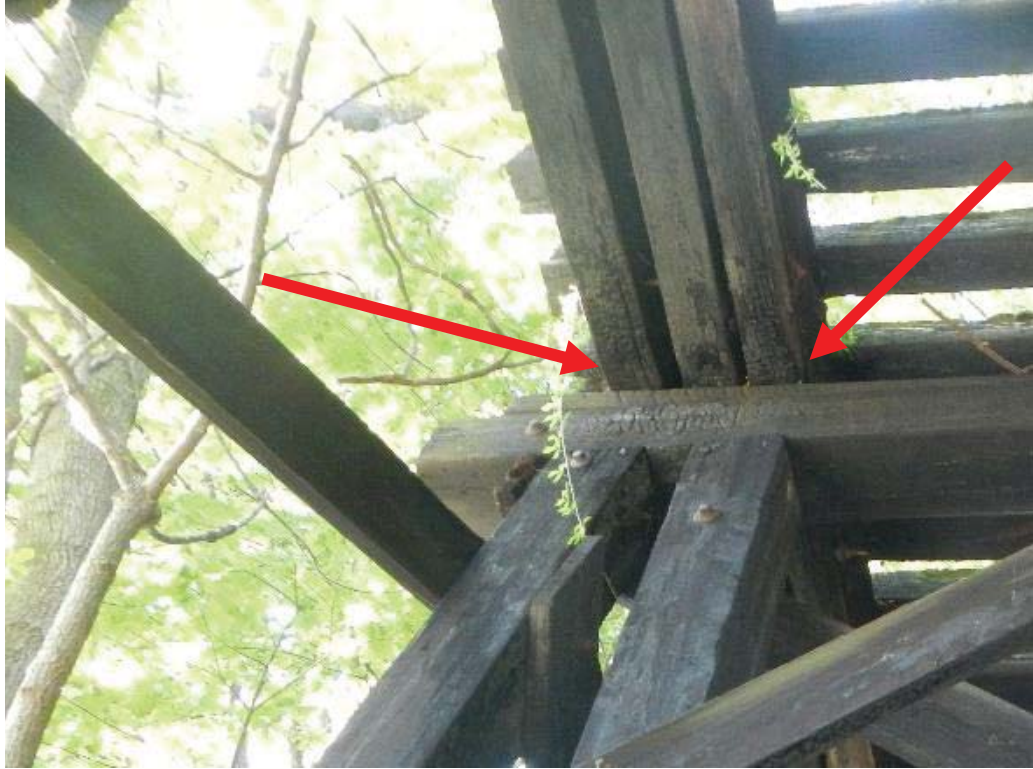
17. Span 4 Stringers 4 Thru 6 Fire/Fungus Damage Along Bottom of Stringers Adjacent to Pier 3

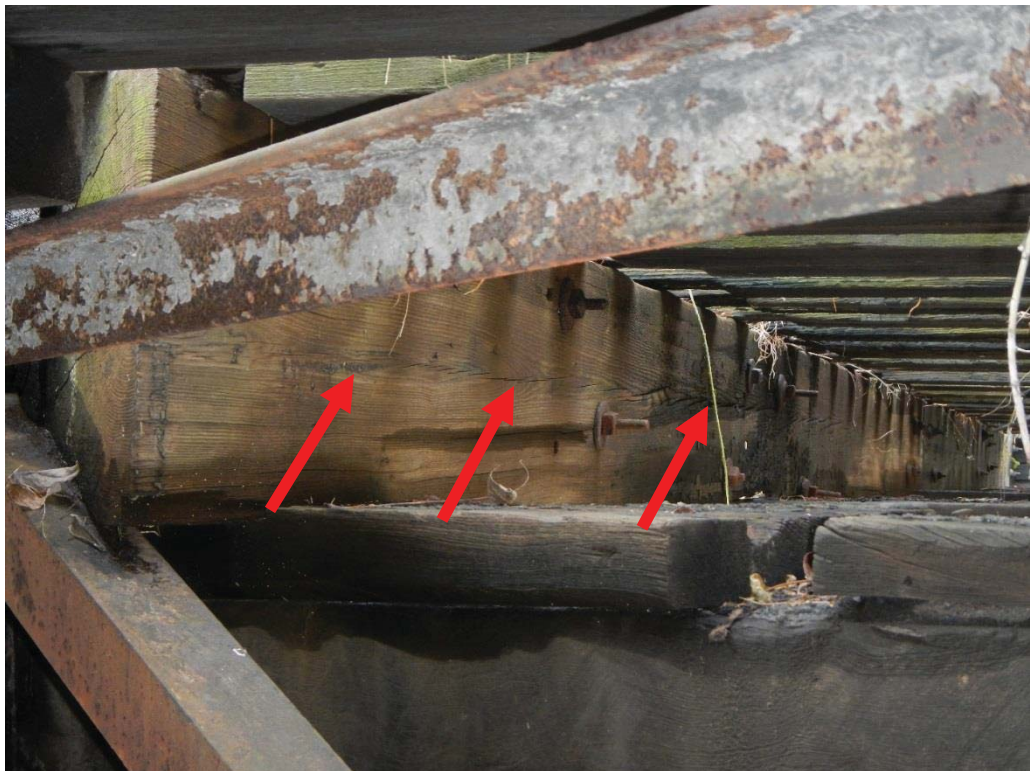
18. Span 4 Stringer 4 Horizontal Split in Stringer Adjacent to Pier 4 (Split is Full Length)

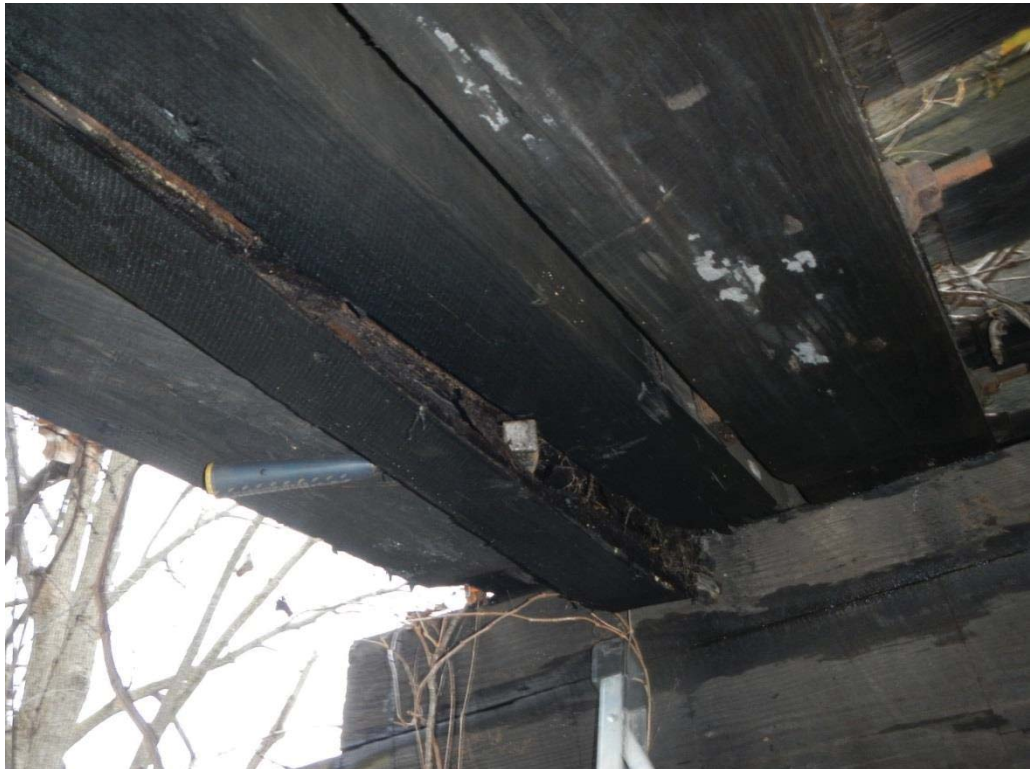
20. Span 8 Stringer 5 Decay to Bottom of Stringer Adjacent to Pier 7

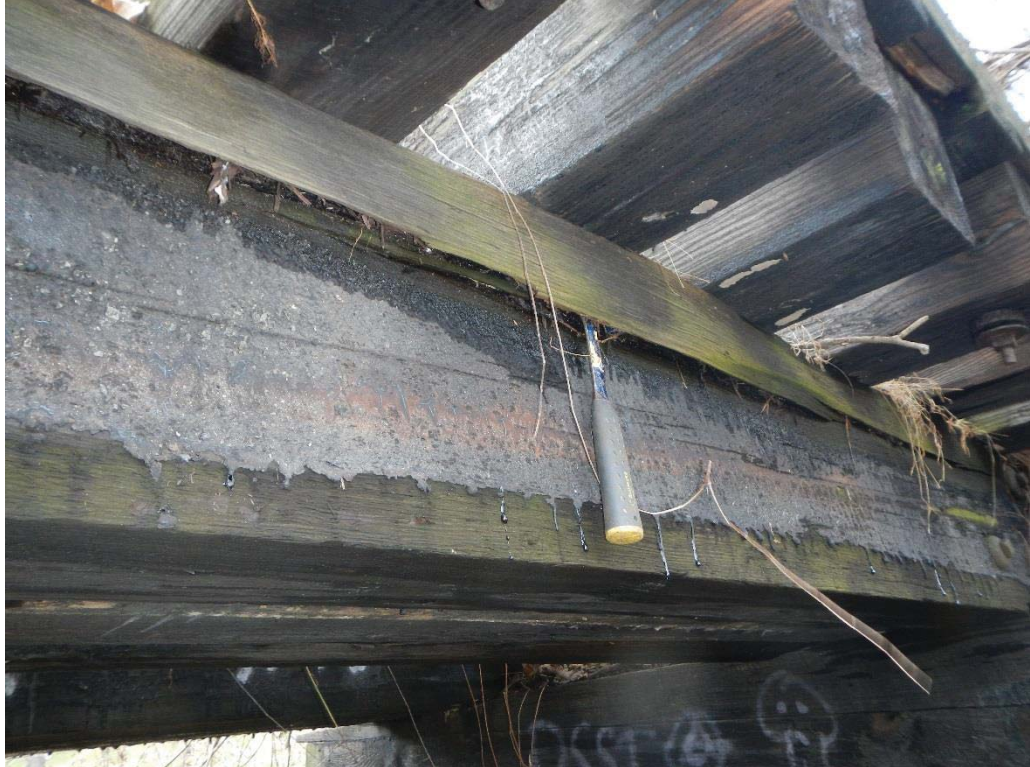
21. Span 9 Stringer 6 Decay to Top Portion of Stringer Along Entire Span

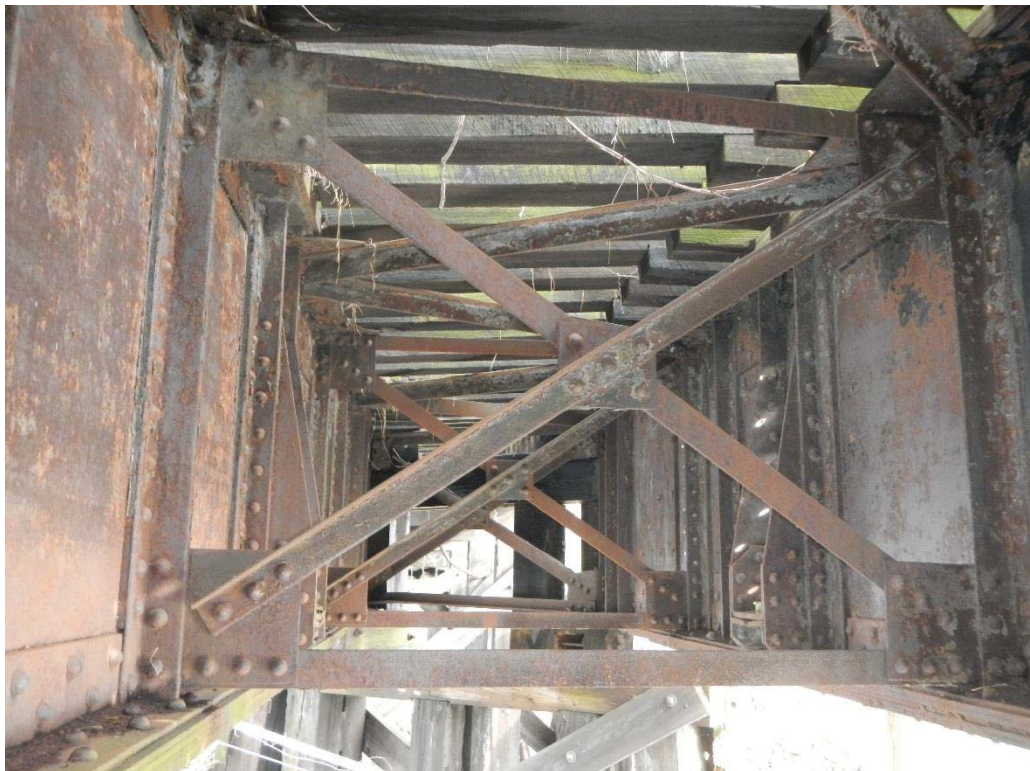
22. General View of Steel Superstructure in Span 5 (Main Span) in Fair Condition

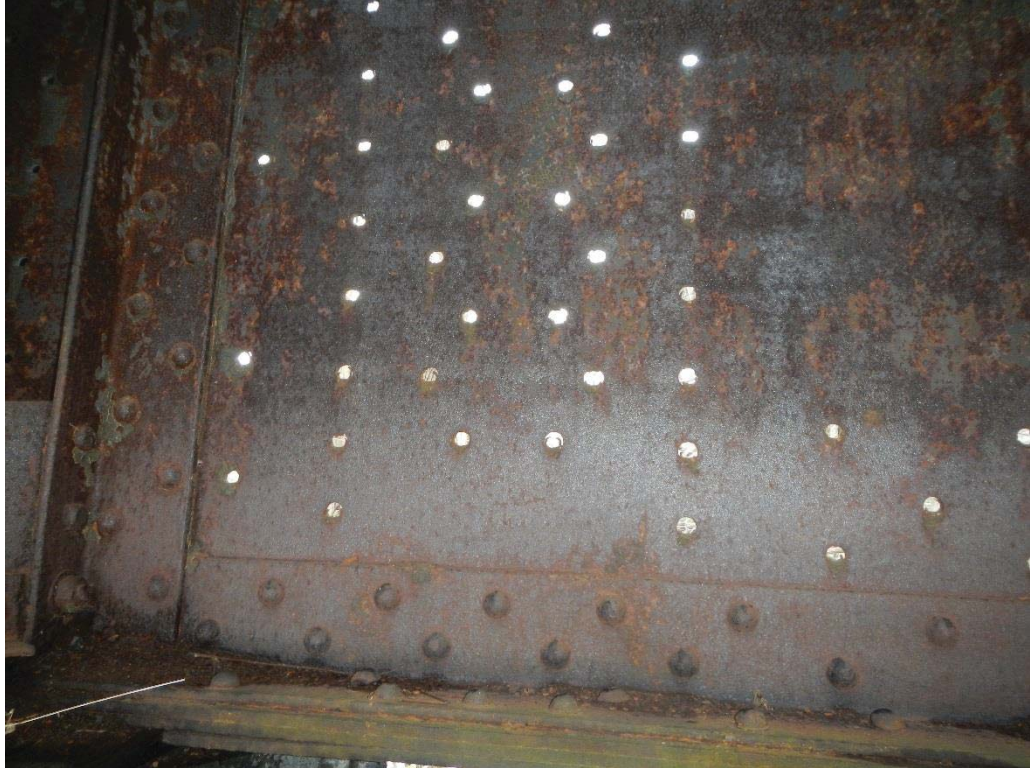
23. Open Bolt Holes in Girder 1 Web Near Pier 4

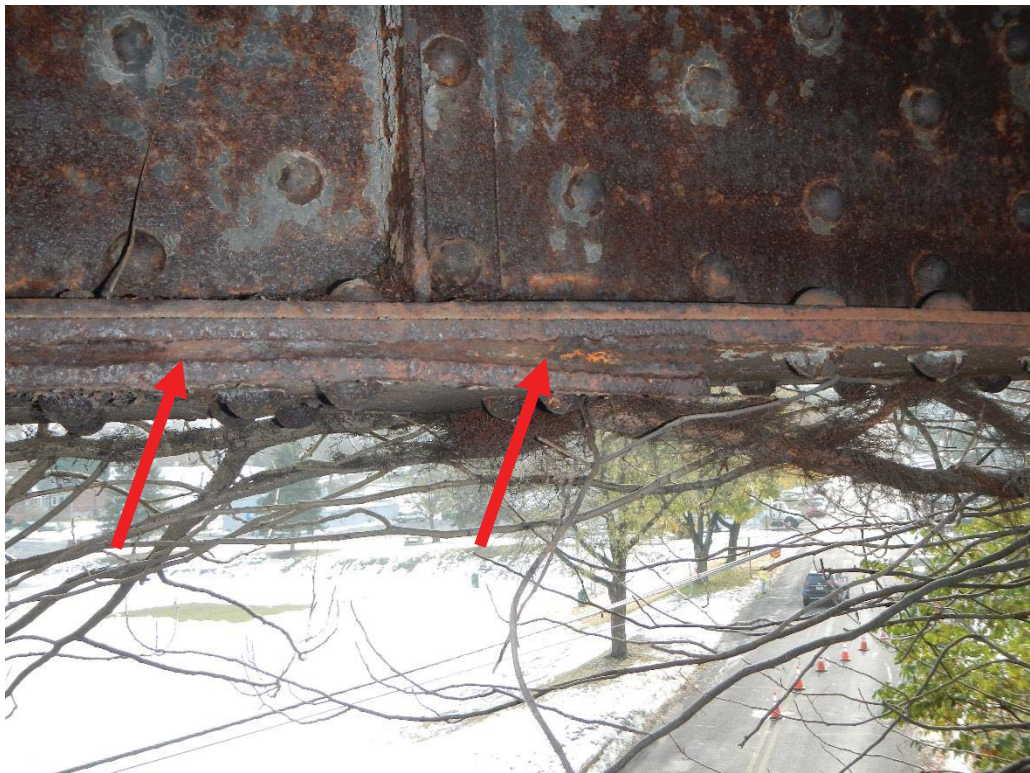
24. Pack Rust Between Girder 2 Cover Plates and Bent Cover Plate Near Pier 4

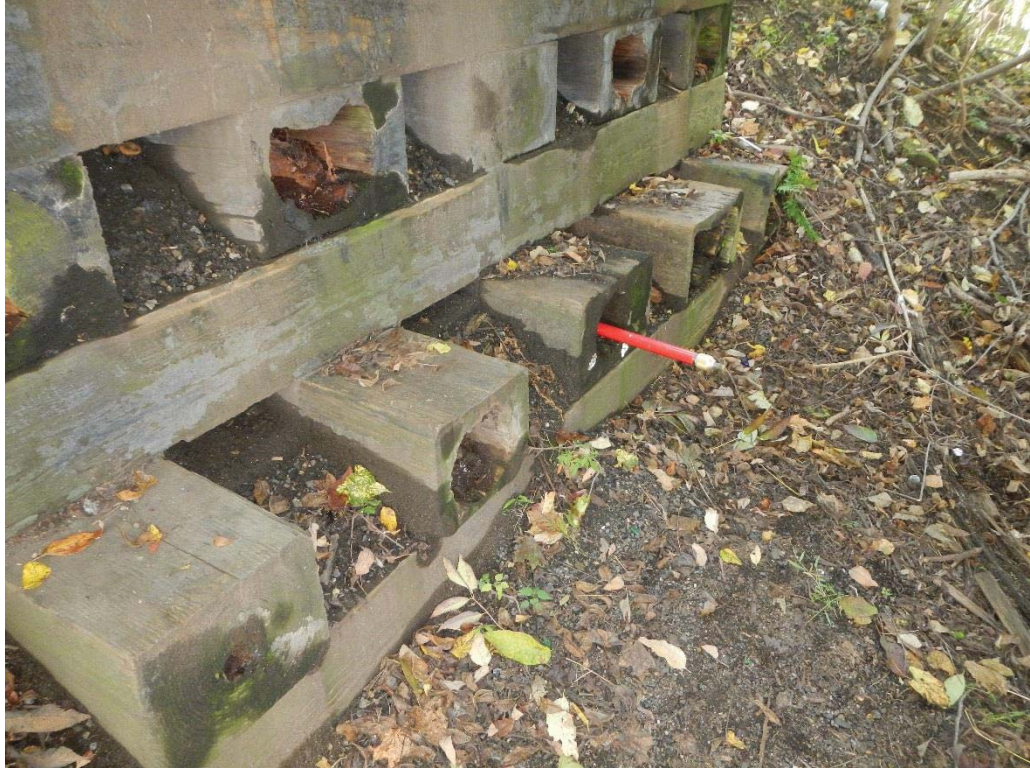
25. Near (West) Abutment Stem Longitudinal Member Decay (3' of Penetration with 4' Rod, Typical Condition)

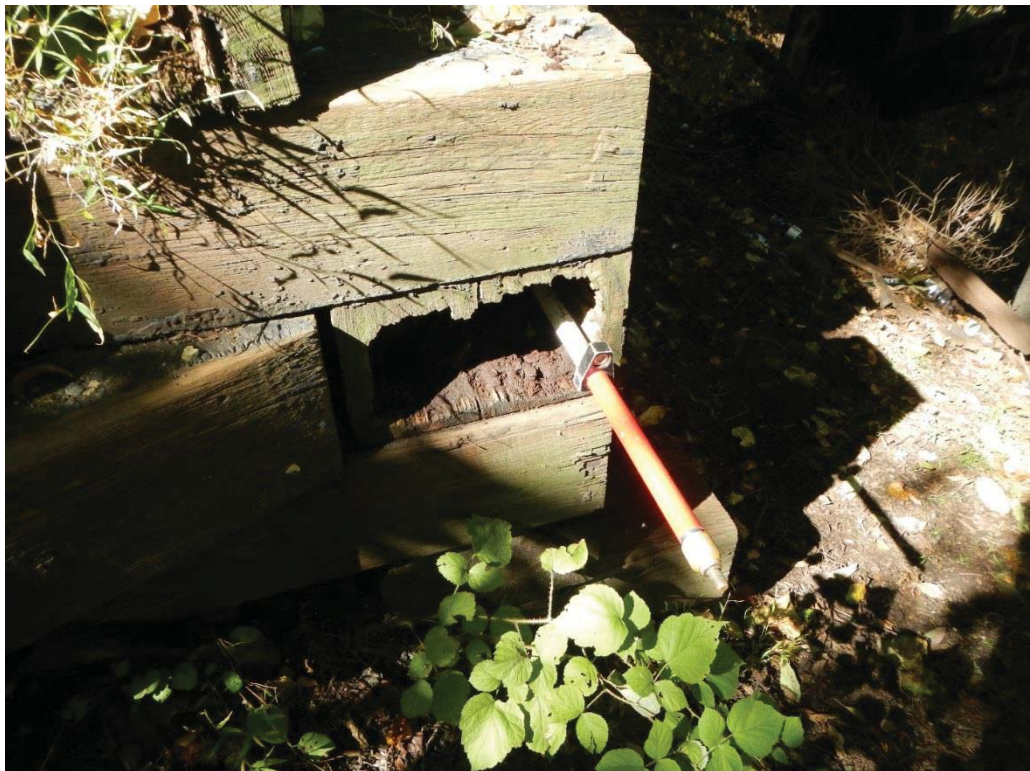
26. Near (West) Abutment Stem Transverse Member Decay (3' of Penetration with 4' Rod)

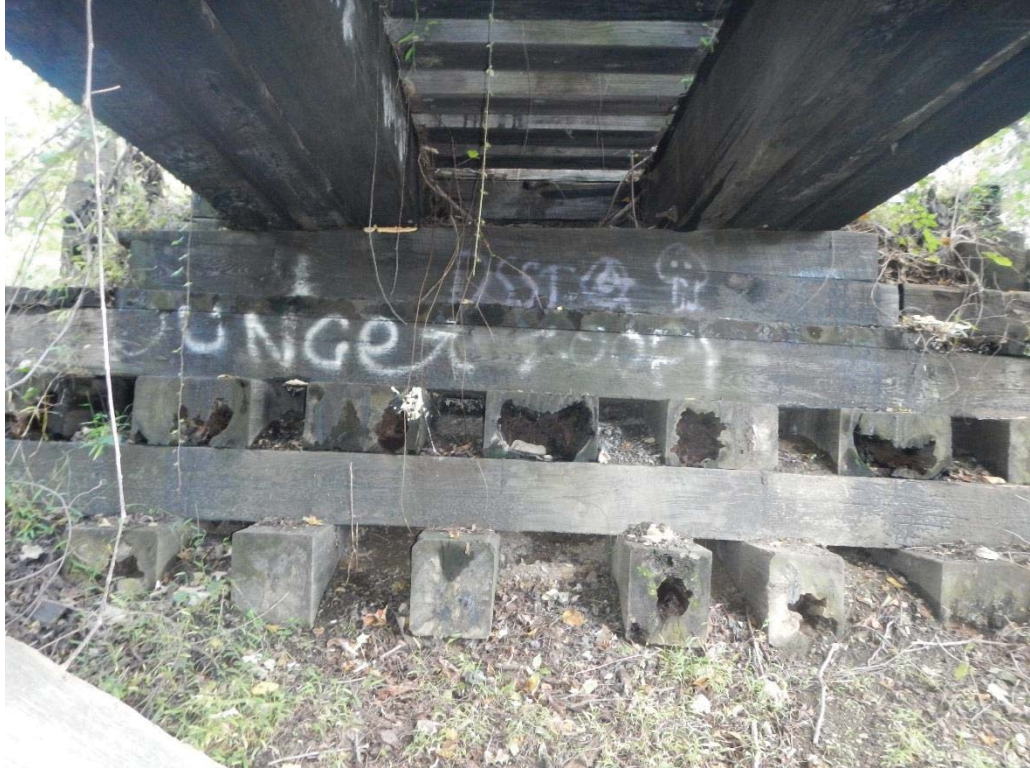
27. General View of Far (East) Abutment Stem Longitudinal Member Decay

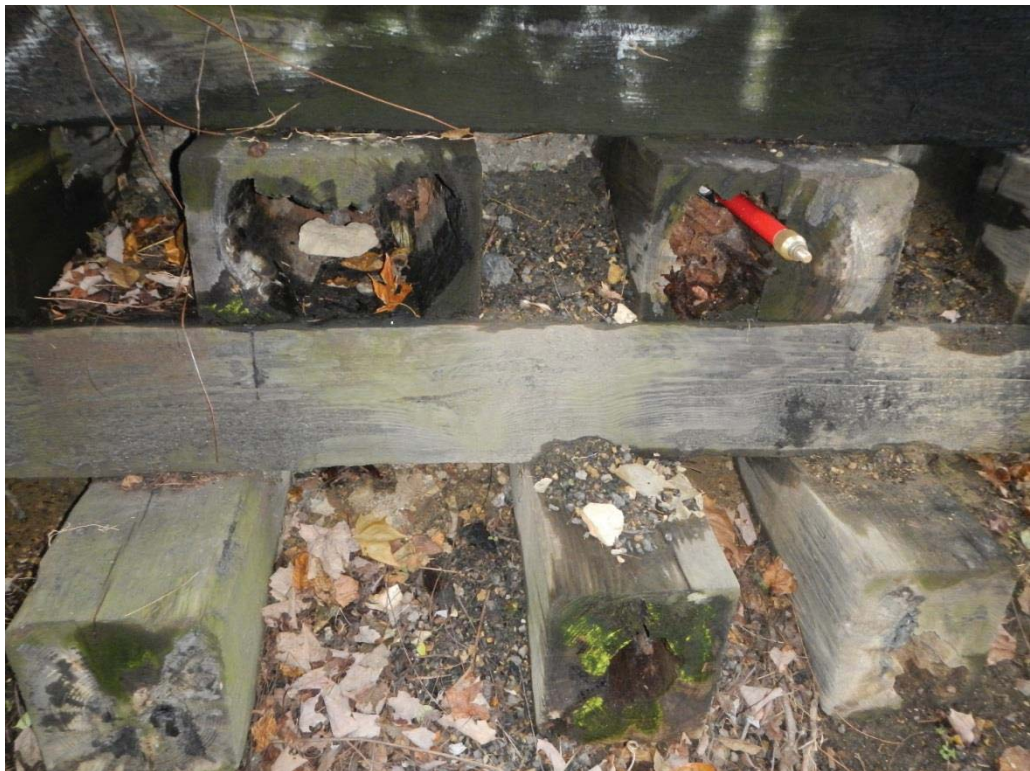
28. Far (East) Abutment Stem Longitudinal Member Decay (3'-6" of Penetration with 4' Rod, Typical Condition)

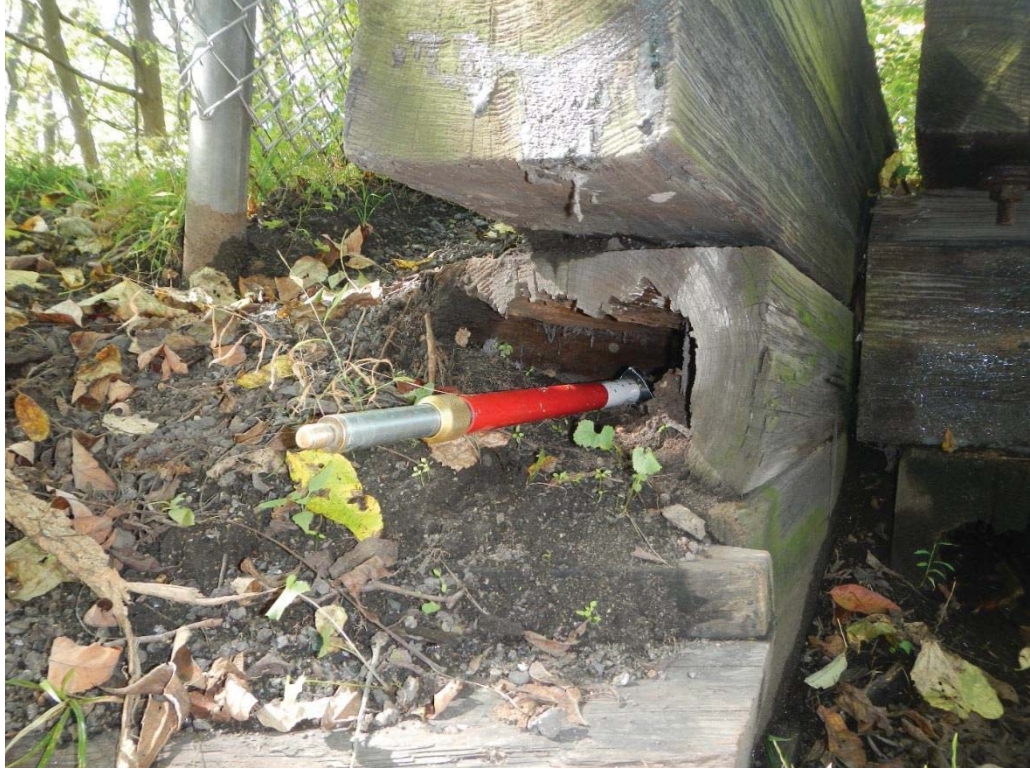
29. Near (West) Abutment Right (South) End Backwall Member Decay (4' of Penetration with 4' Rod)

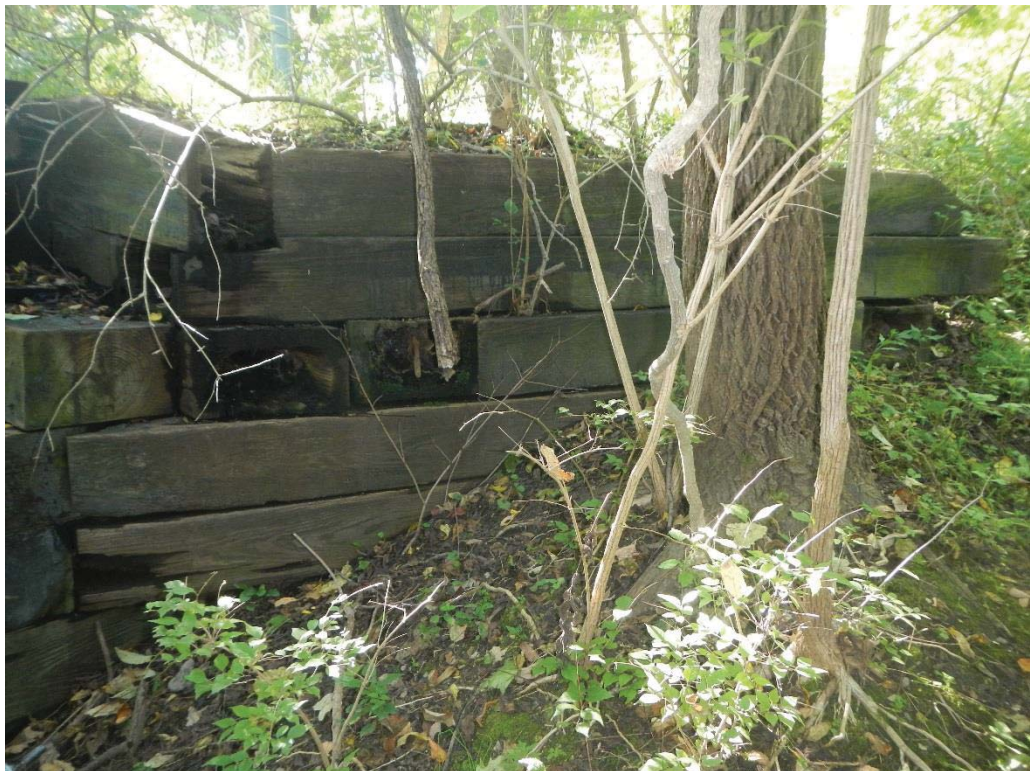
30. Near (West) Abutment Left (North) Wing Decay

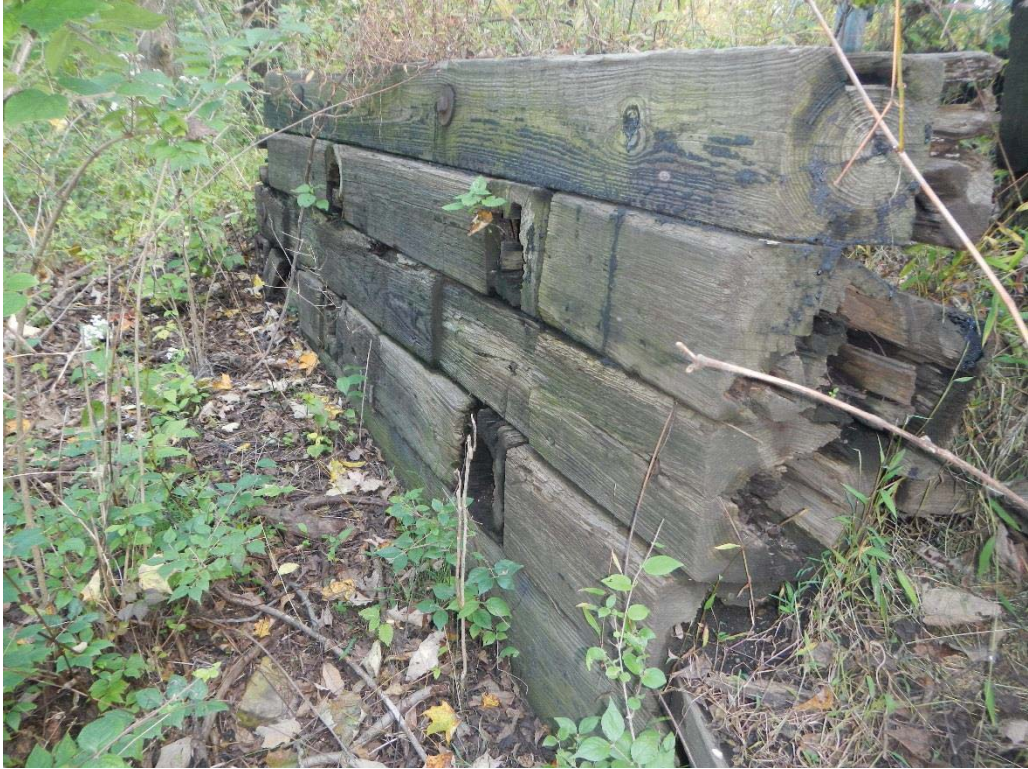
31. Far (East) Abutment Left (North) Wing Decay

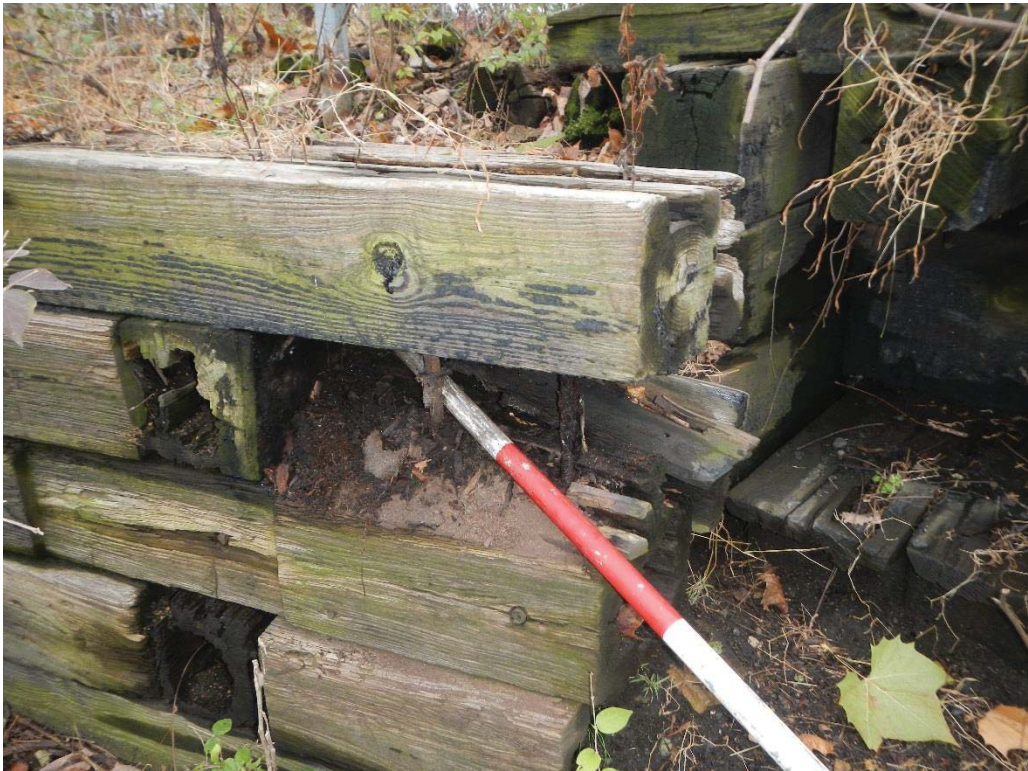
32. Far (East) Abutment Left (North) Wing Decay

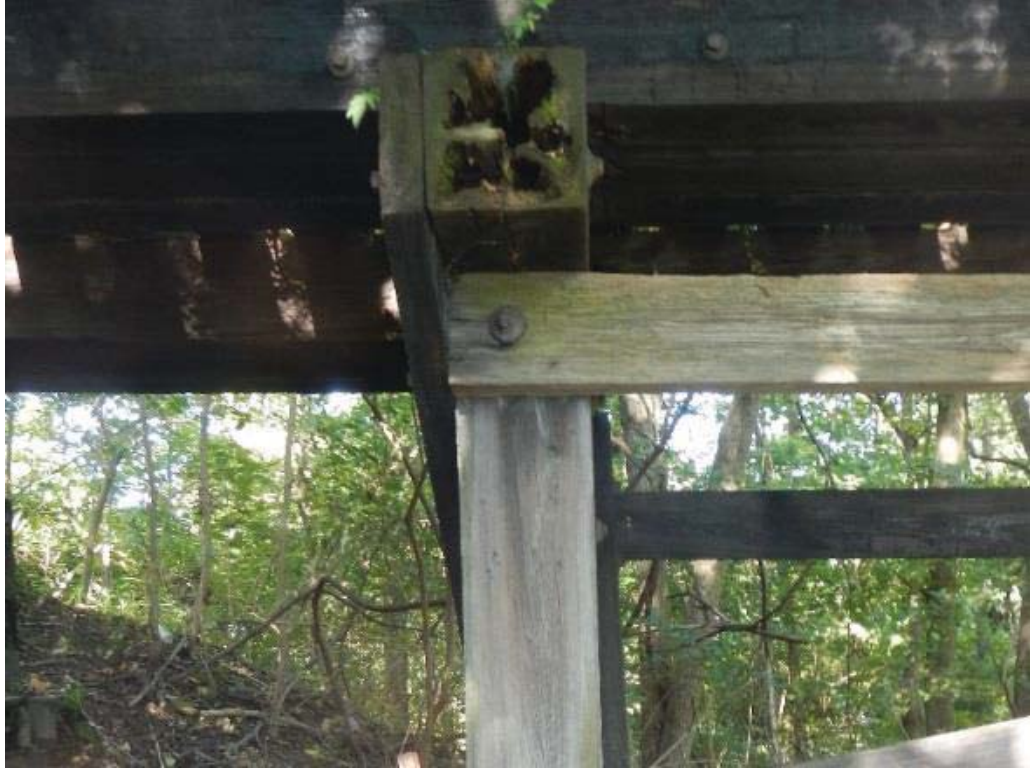
33. Pier 1 Right (South) End Top Strut Decay

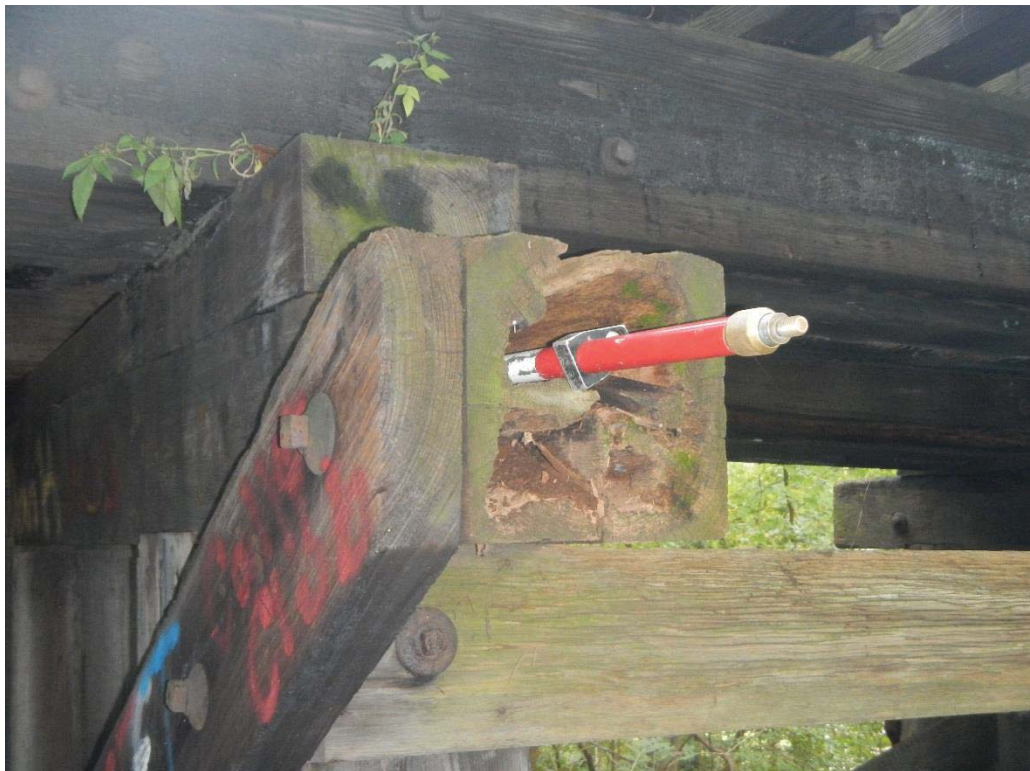
34. Pier 1 Right (South) End Top Strut Decay Close Up (3'-2" of Penetration with 4' Rod)

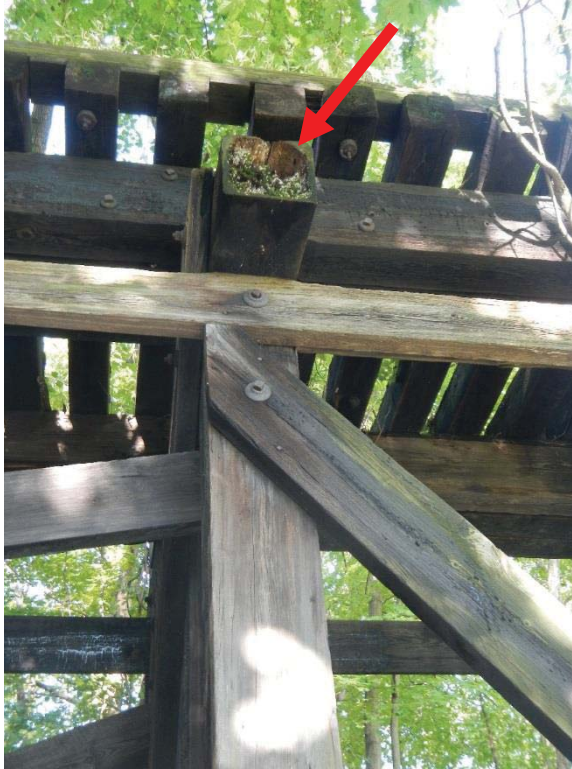
35. Pier 2 Right (South) End Top Strut Decay and Algae/Fungus Growth

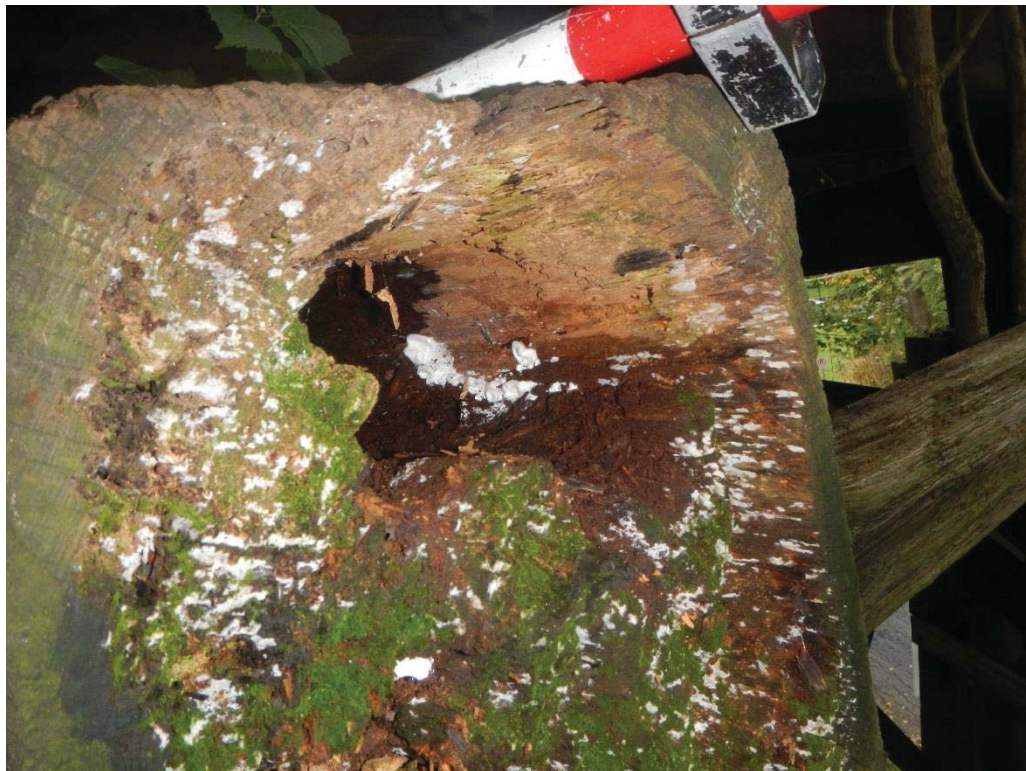
36. Pier 2 Right (South) End Top Strut Decay and Algae/Fungus Growth Close Up

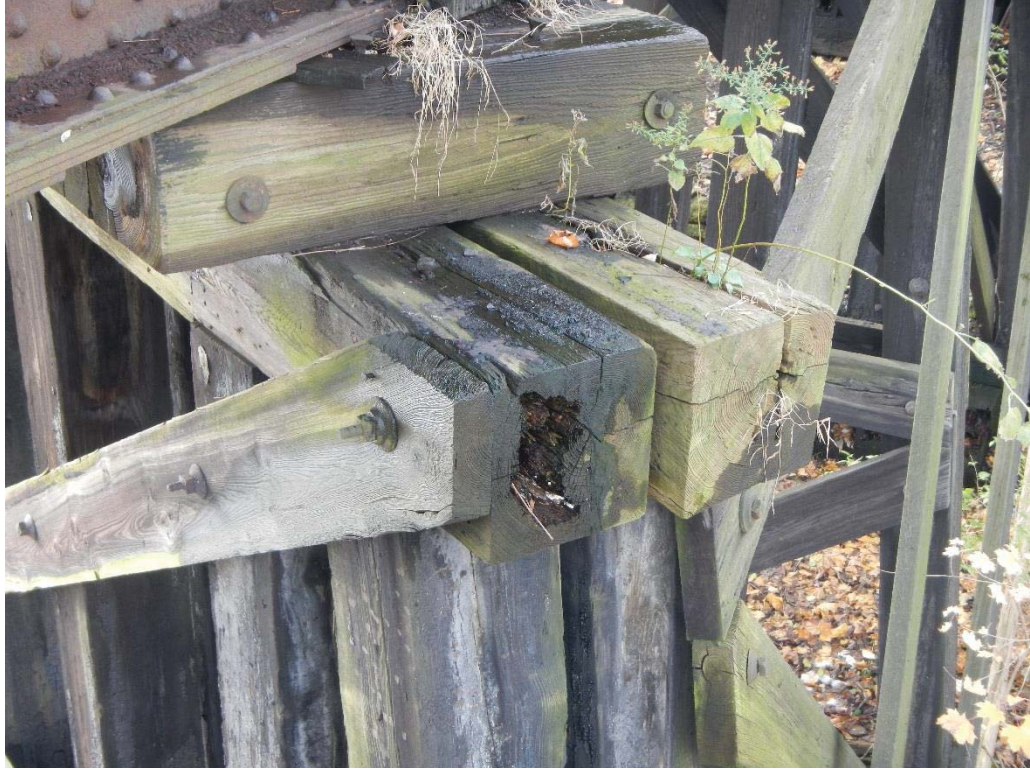
37. Pier 4 Left (North) End Top Strut Decay and Splits

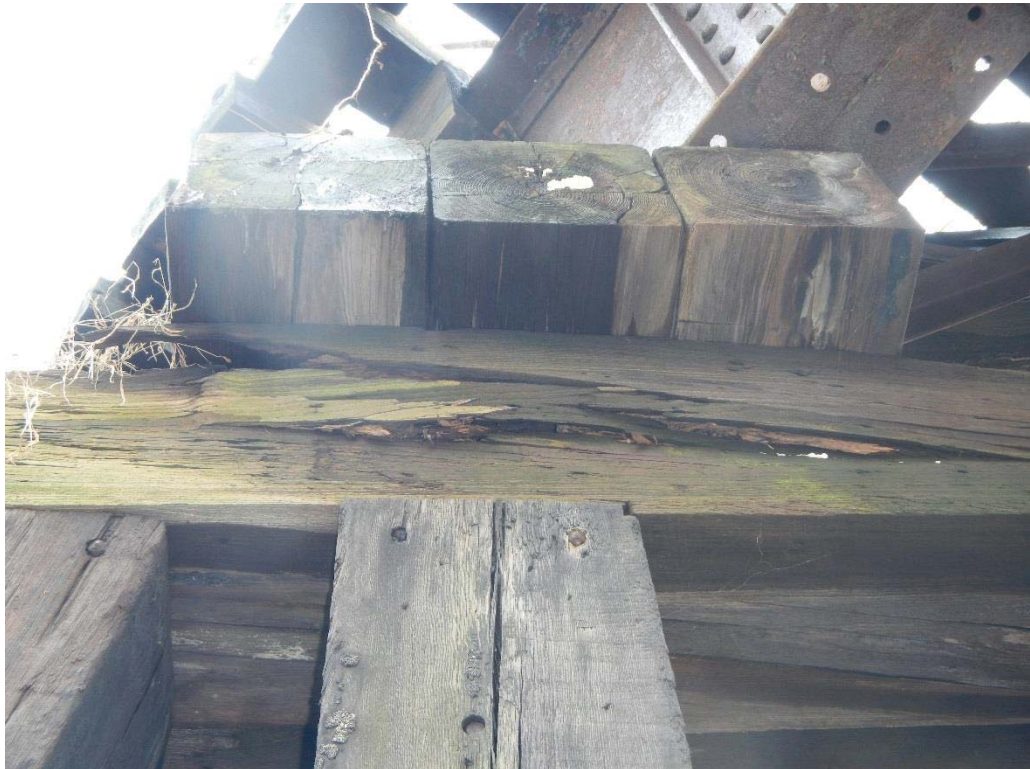
38. Pier 5 Near (West) Side Top Strut Decay Over Column 2 (Decay Extends to Left (North) End)

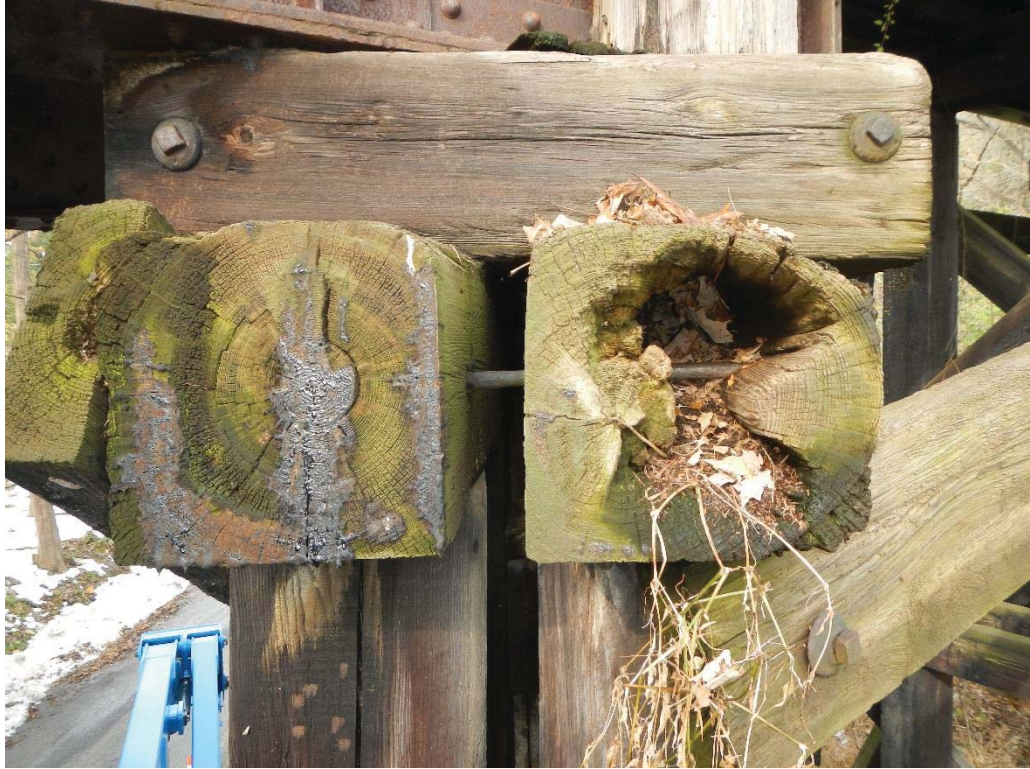
39. Pier 5 Right (South) End Top Strut Decay
