**WEST EASTON BOROUGH
NORTHAMPTON COUNTY**

**IN-DEPTH BRIDGE INSPECTION AND
ALTERNATIVES DISCUSSION REPORT**

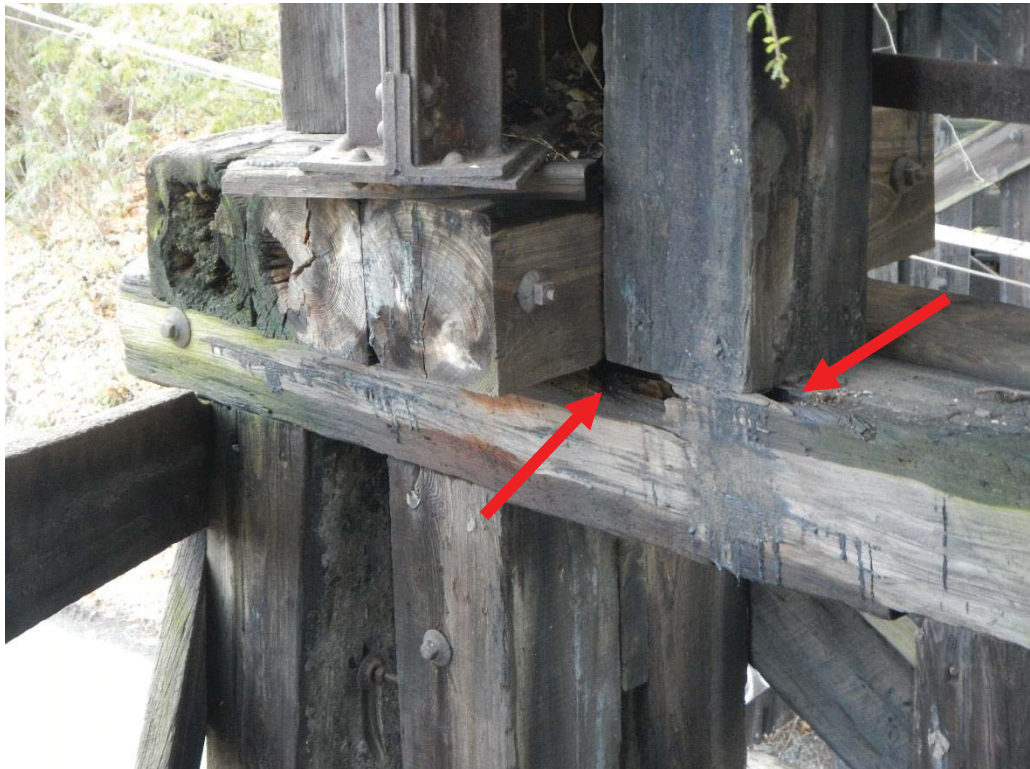
40. Pier 5 Far (West) Side Top Strut Decay Over Column 4 (Decay Extends to Right (South) End)

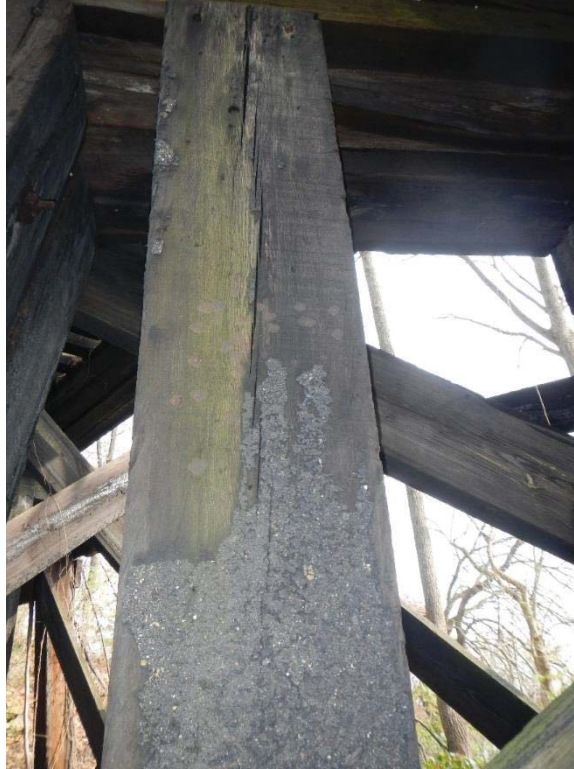
41. Pier 5 Column 2 Split Near (West) Face

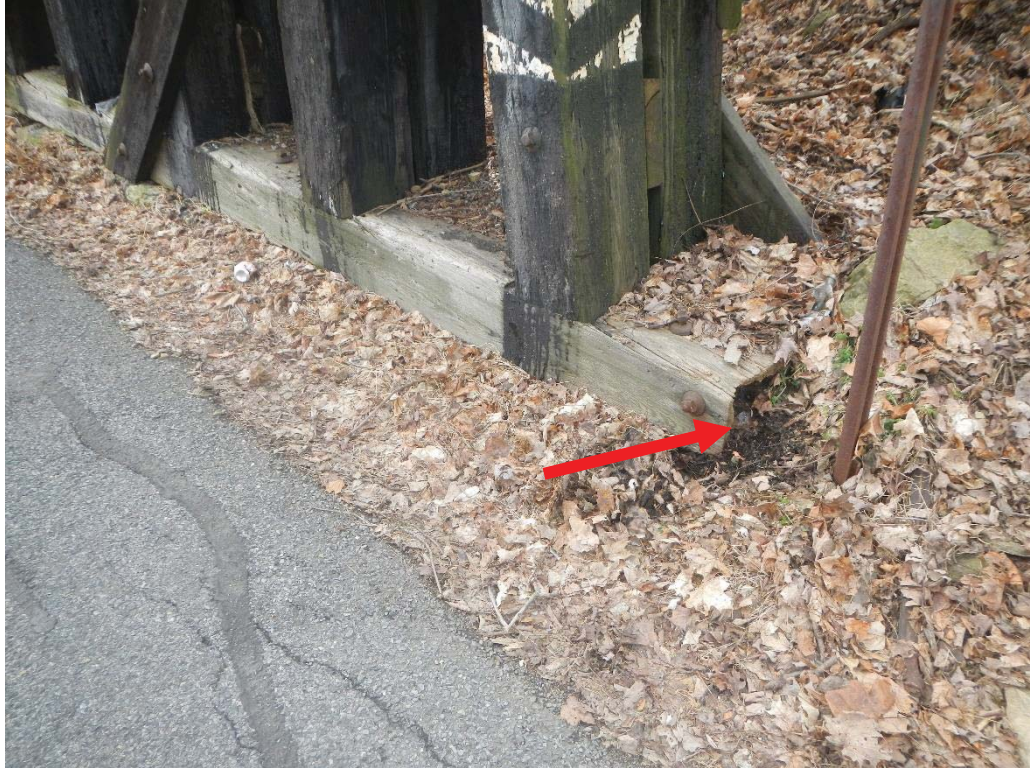
43. Pier 4 Left (North) End Bottom Strut Decay

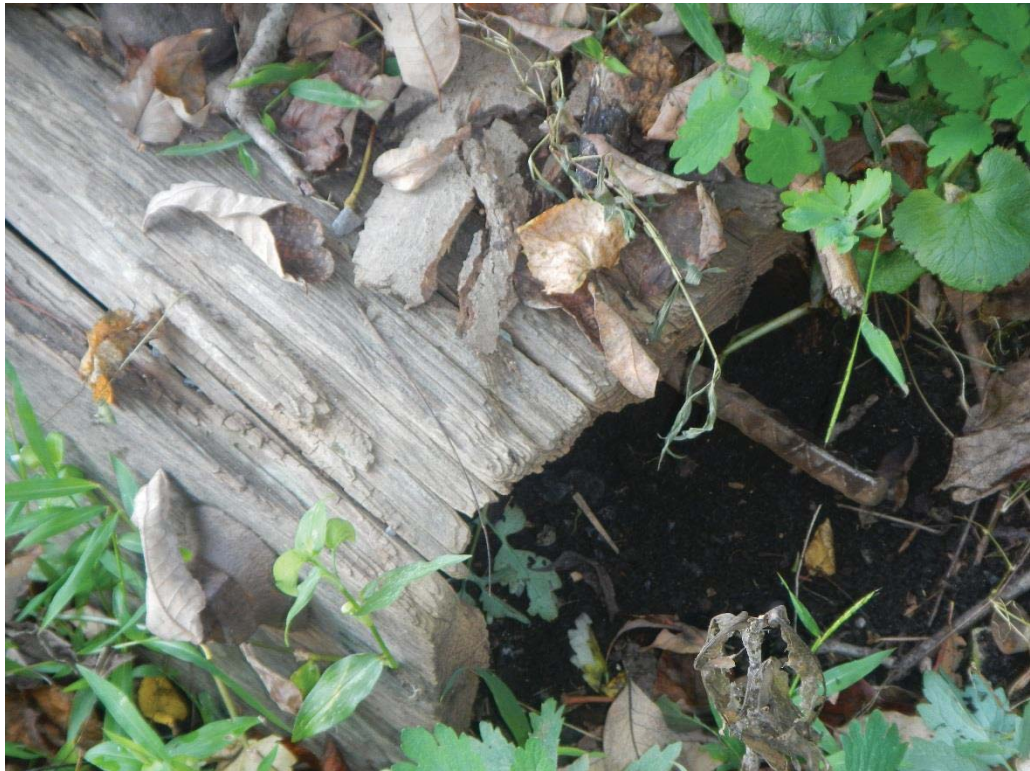
44. Pier 4 Left (North) End Bottom Strut Decay Close Up (5' of Penetration with 6' Rod)

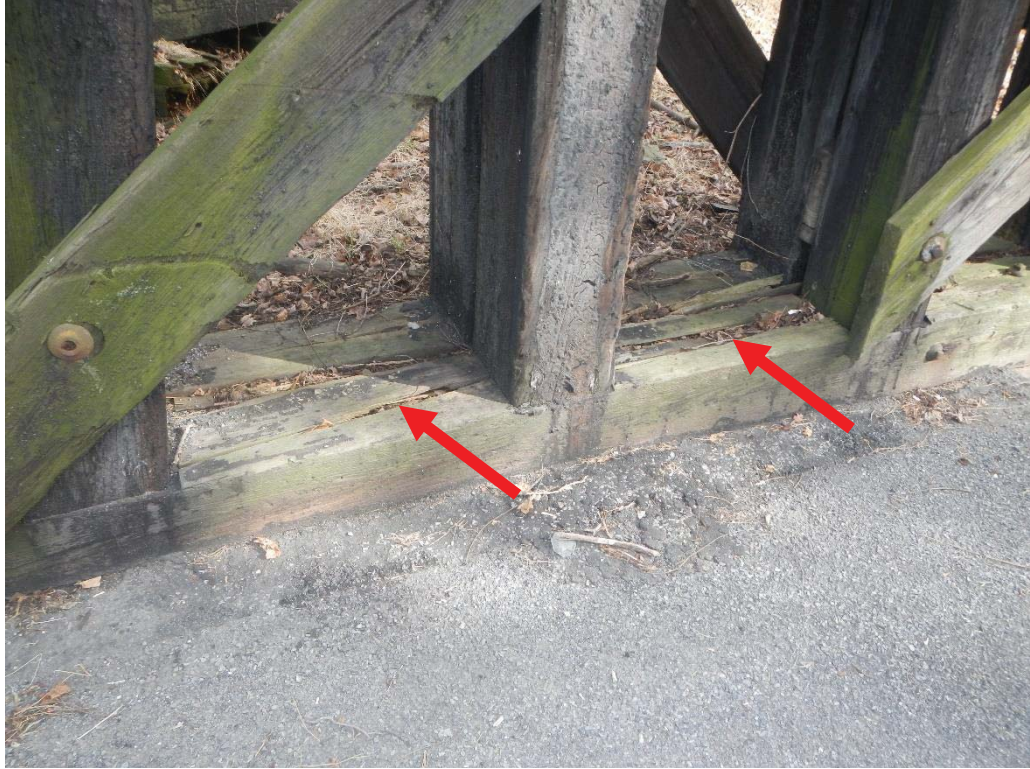
45. Pier 5 Bottom Strut Split/Decay Between Columns (Typical Condition)

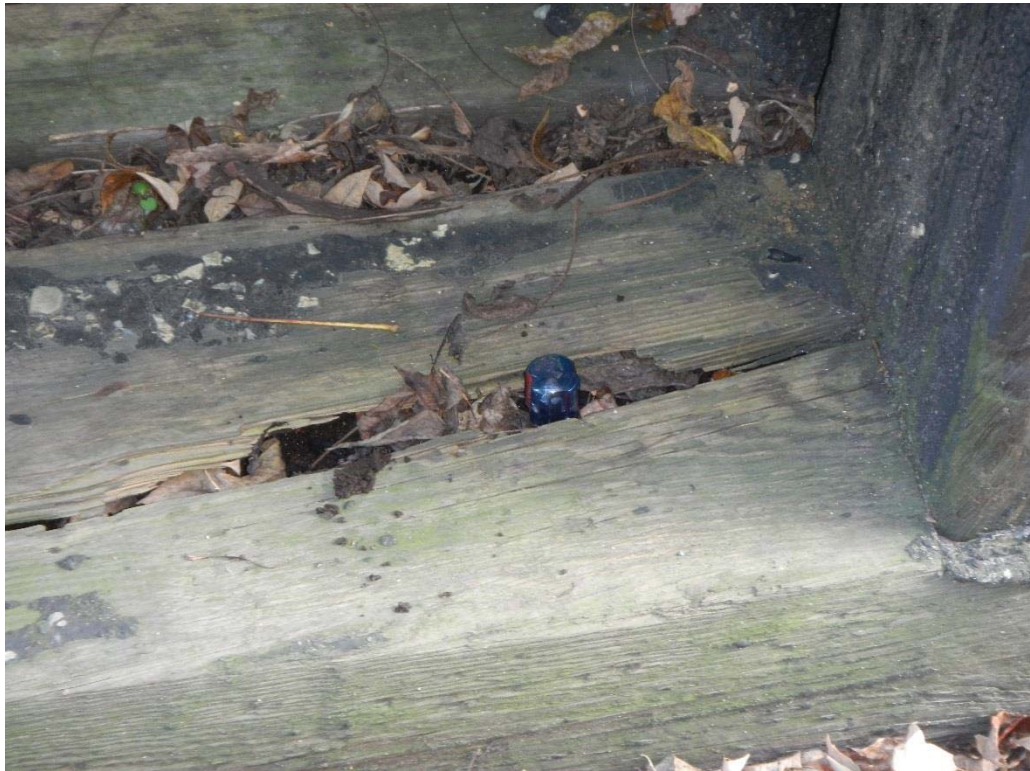
46. Pier 5 Bottom Strut Split/Decay Between Columns 1 and 2 Close Up

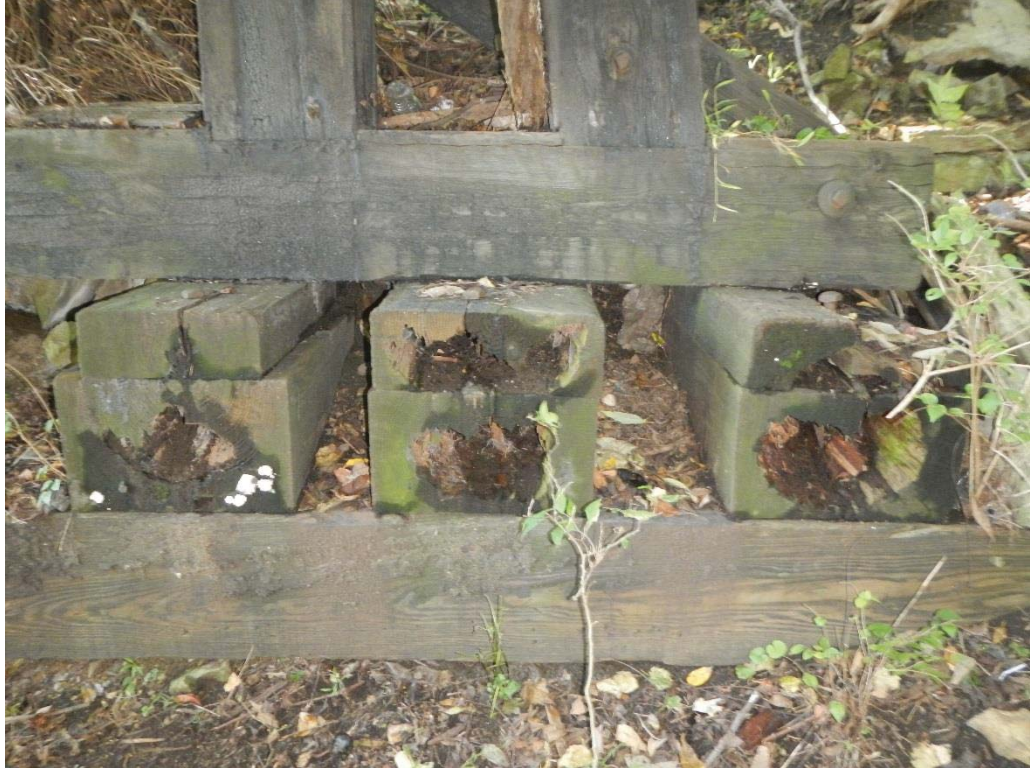
47. Pier 1 Mudsills 1 thru 3 Decay (Typical Condition)

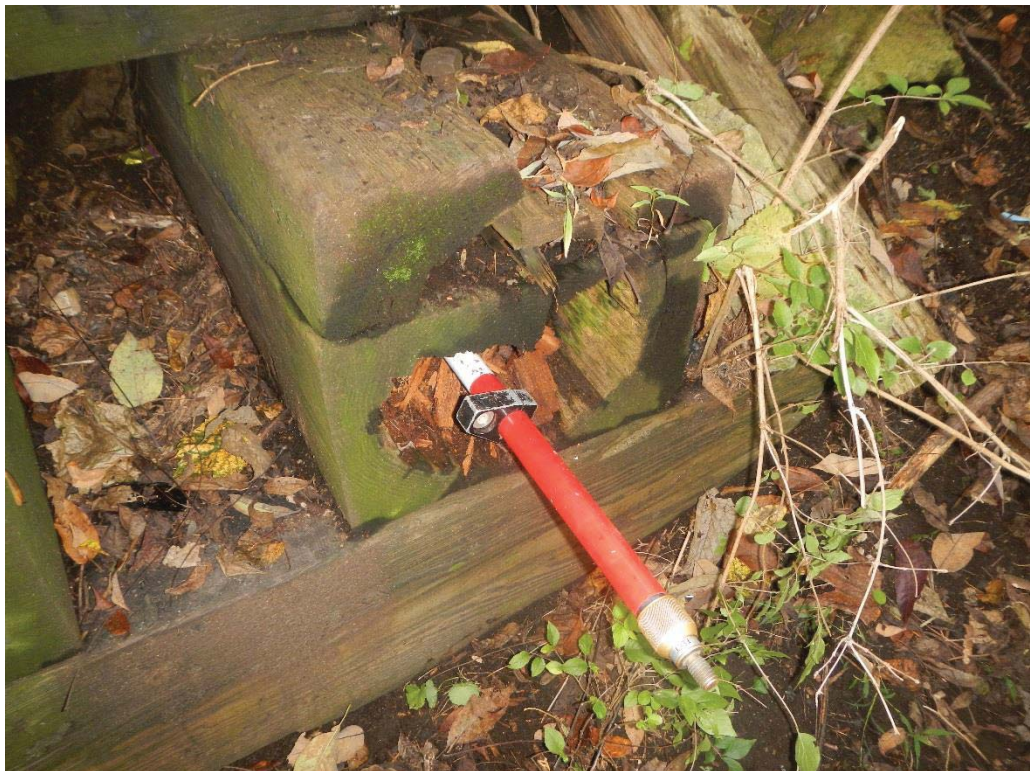
48. Pier 1 Mudsill 1 Decay Close Up (3' of Penetration with 4' Rod, Typical Condition)

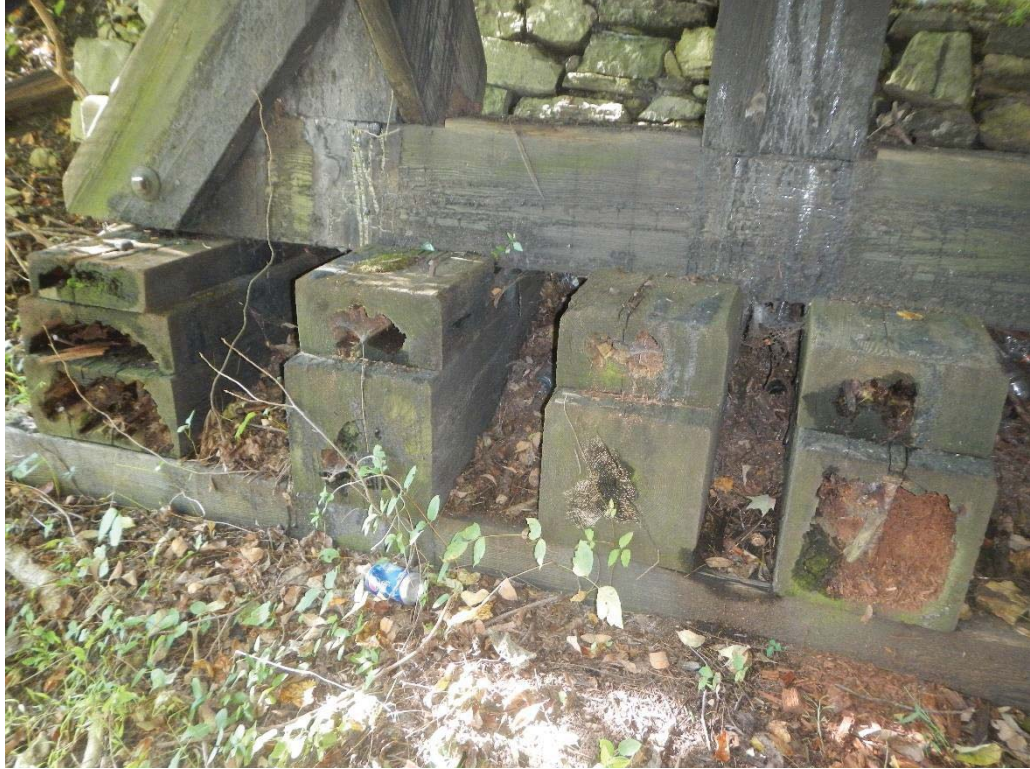
49. Pier 2 Mudsills 5 thru 8 Decay (Typical Condition)

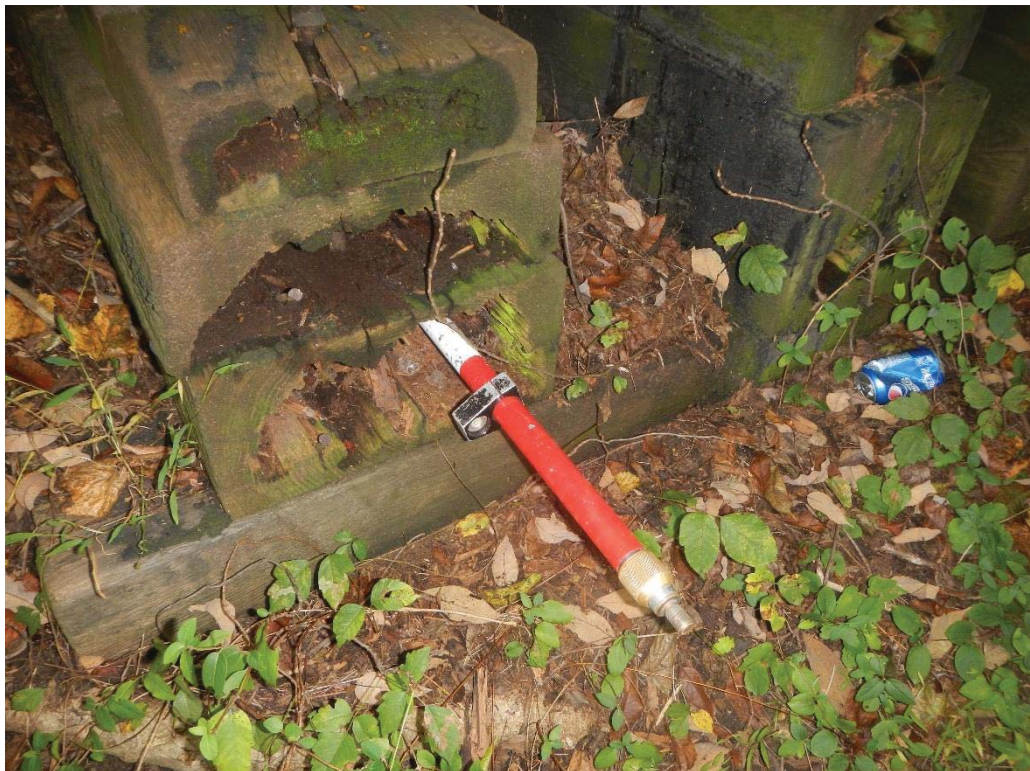
50. Pier 2 Mudsill 8 Decay Close Up (3' of Penetration with 4' Rod, Typical Condition)

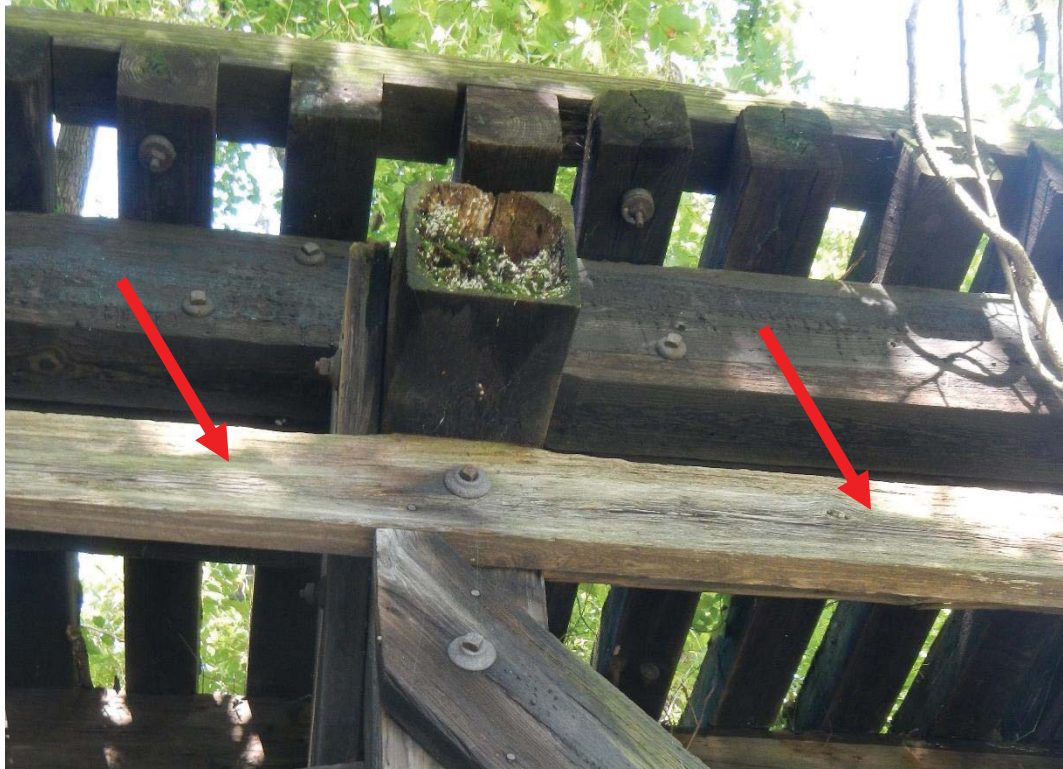
51. Spans 2 & 3 Top Right (South) Longitudinal Bracing Weathering/Decay

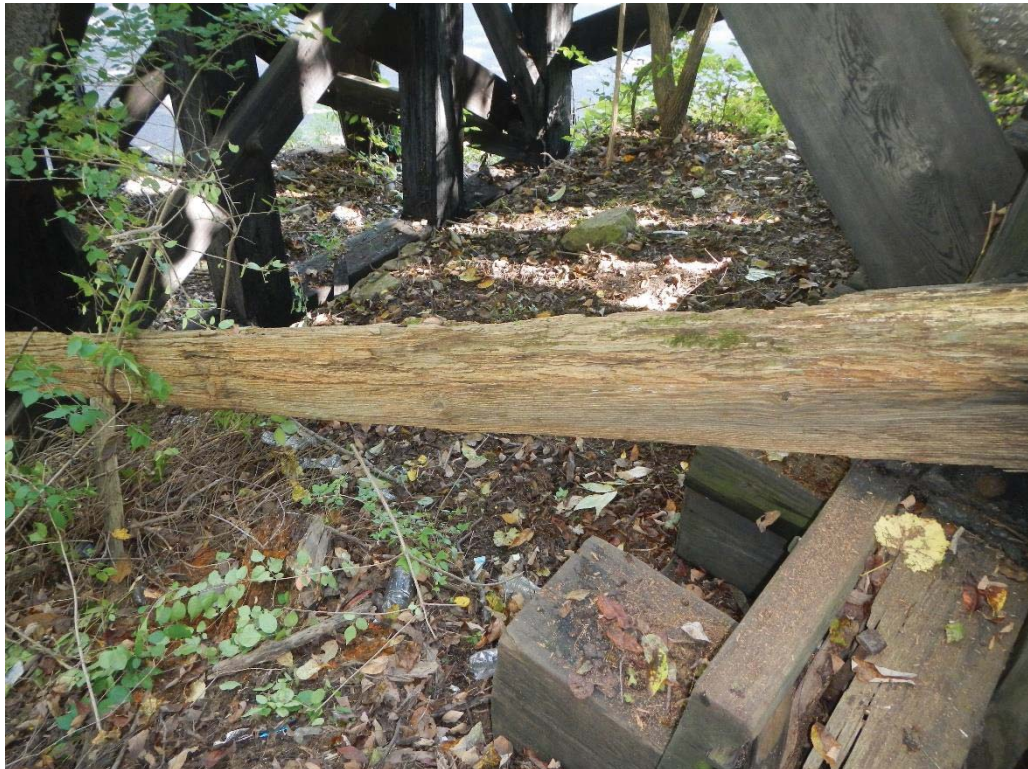
52. Span 3 Bottom Left (North) Longitudinal Bracing Weathering/Decay

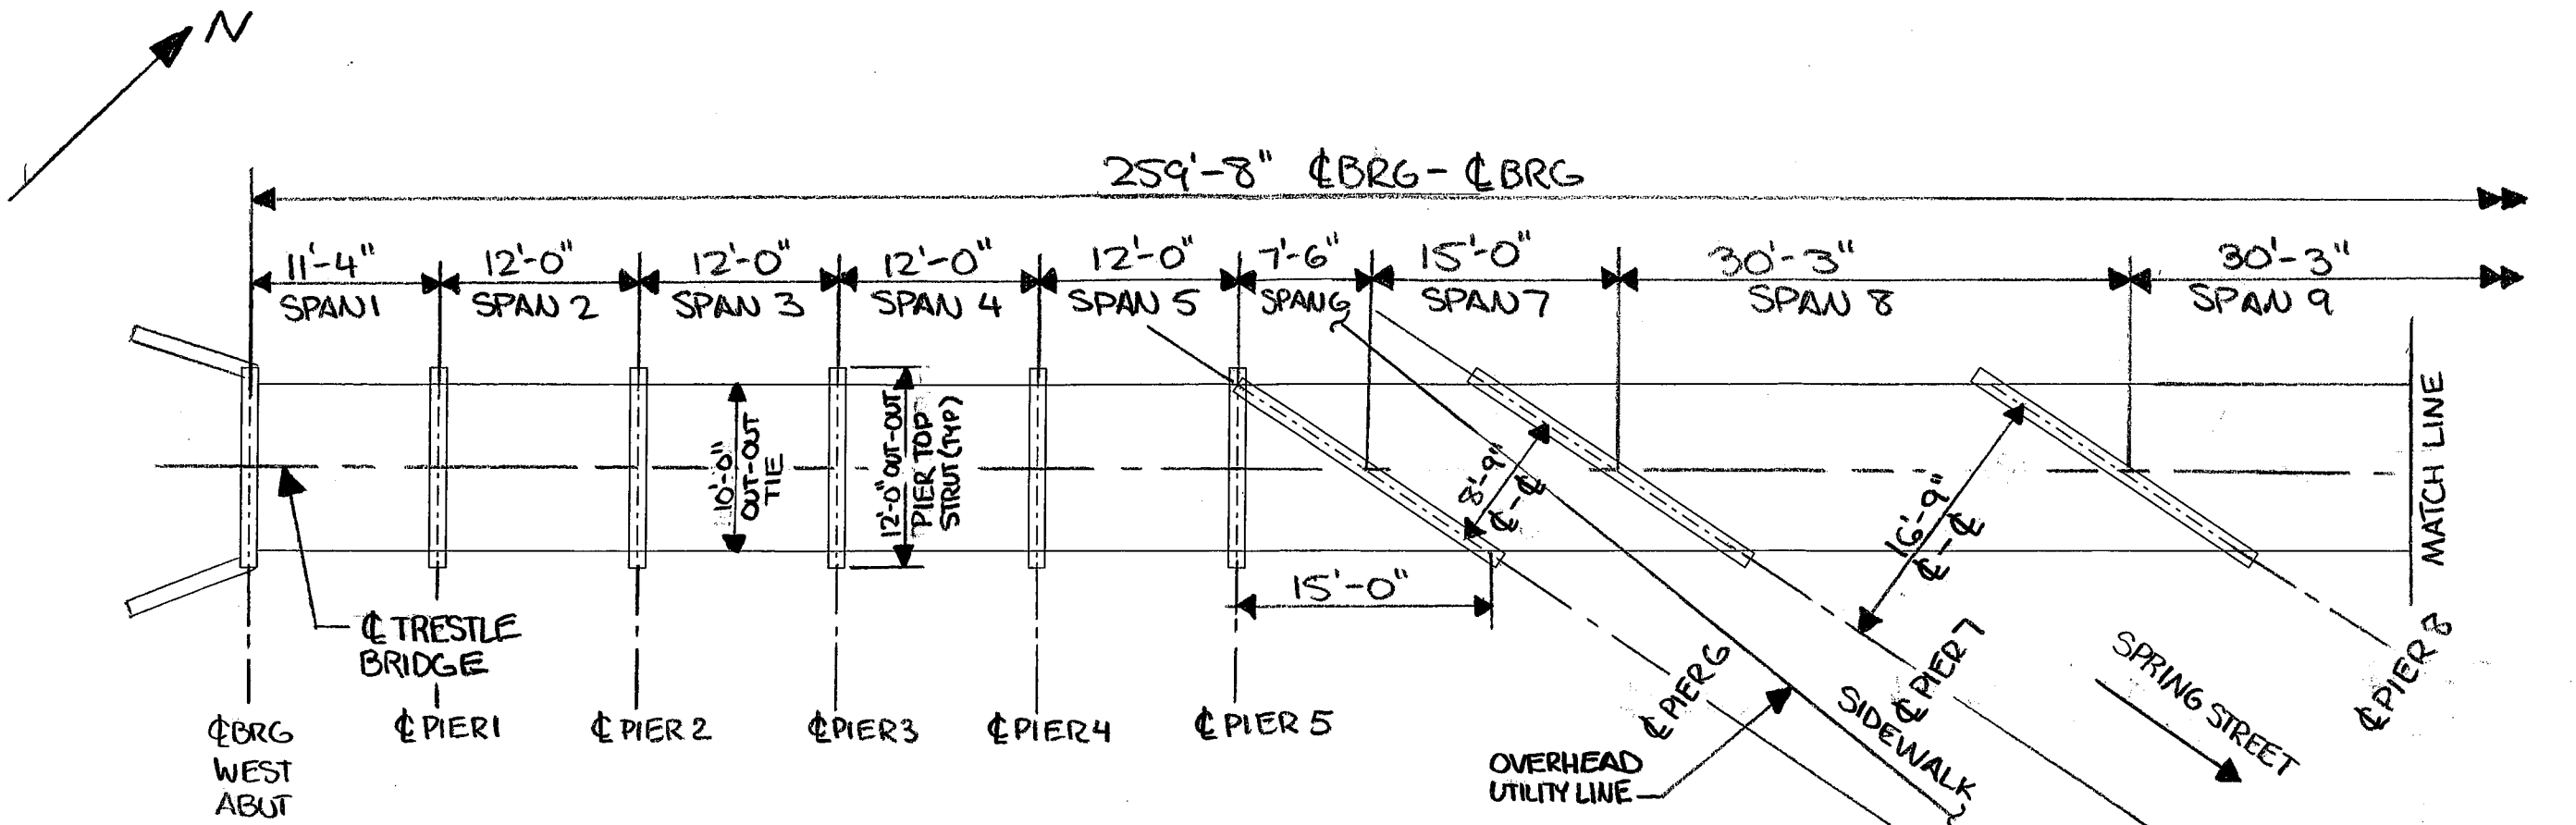
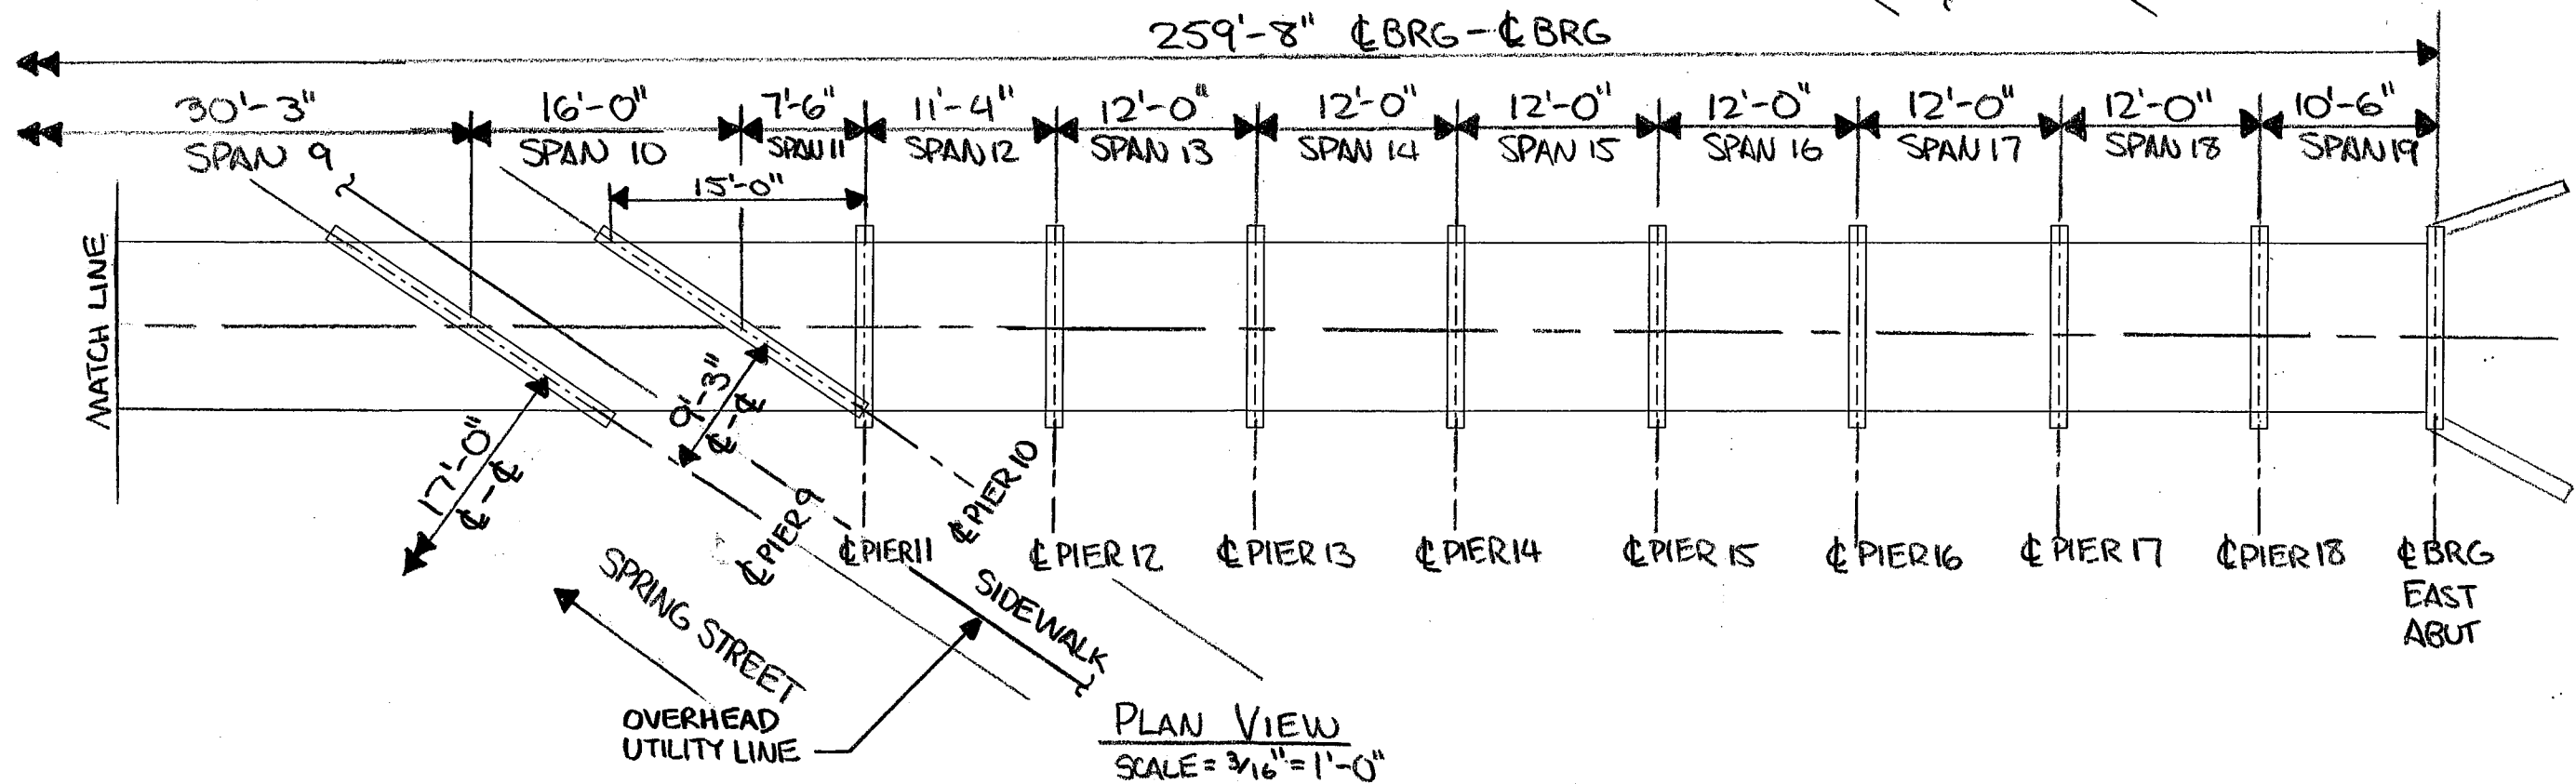
PLAN VIEW
SCALE = 3/16" = 1'-0"

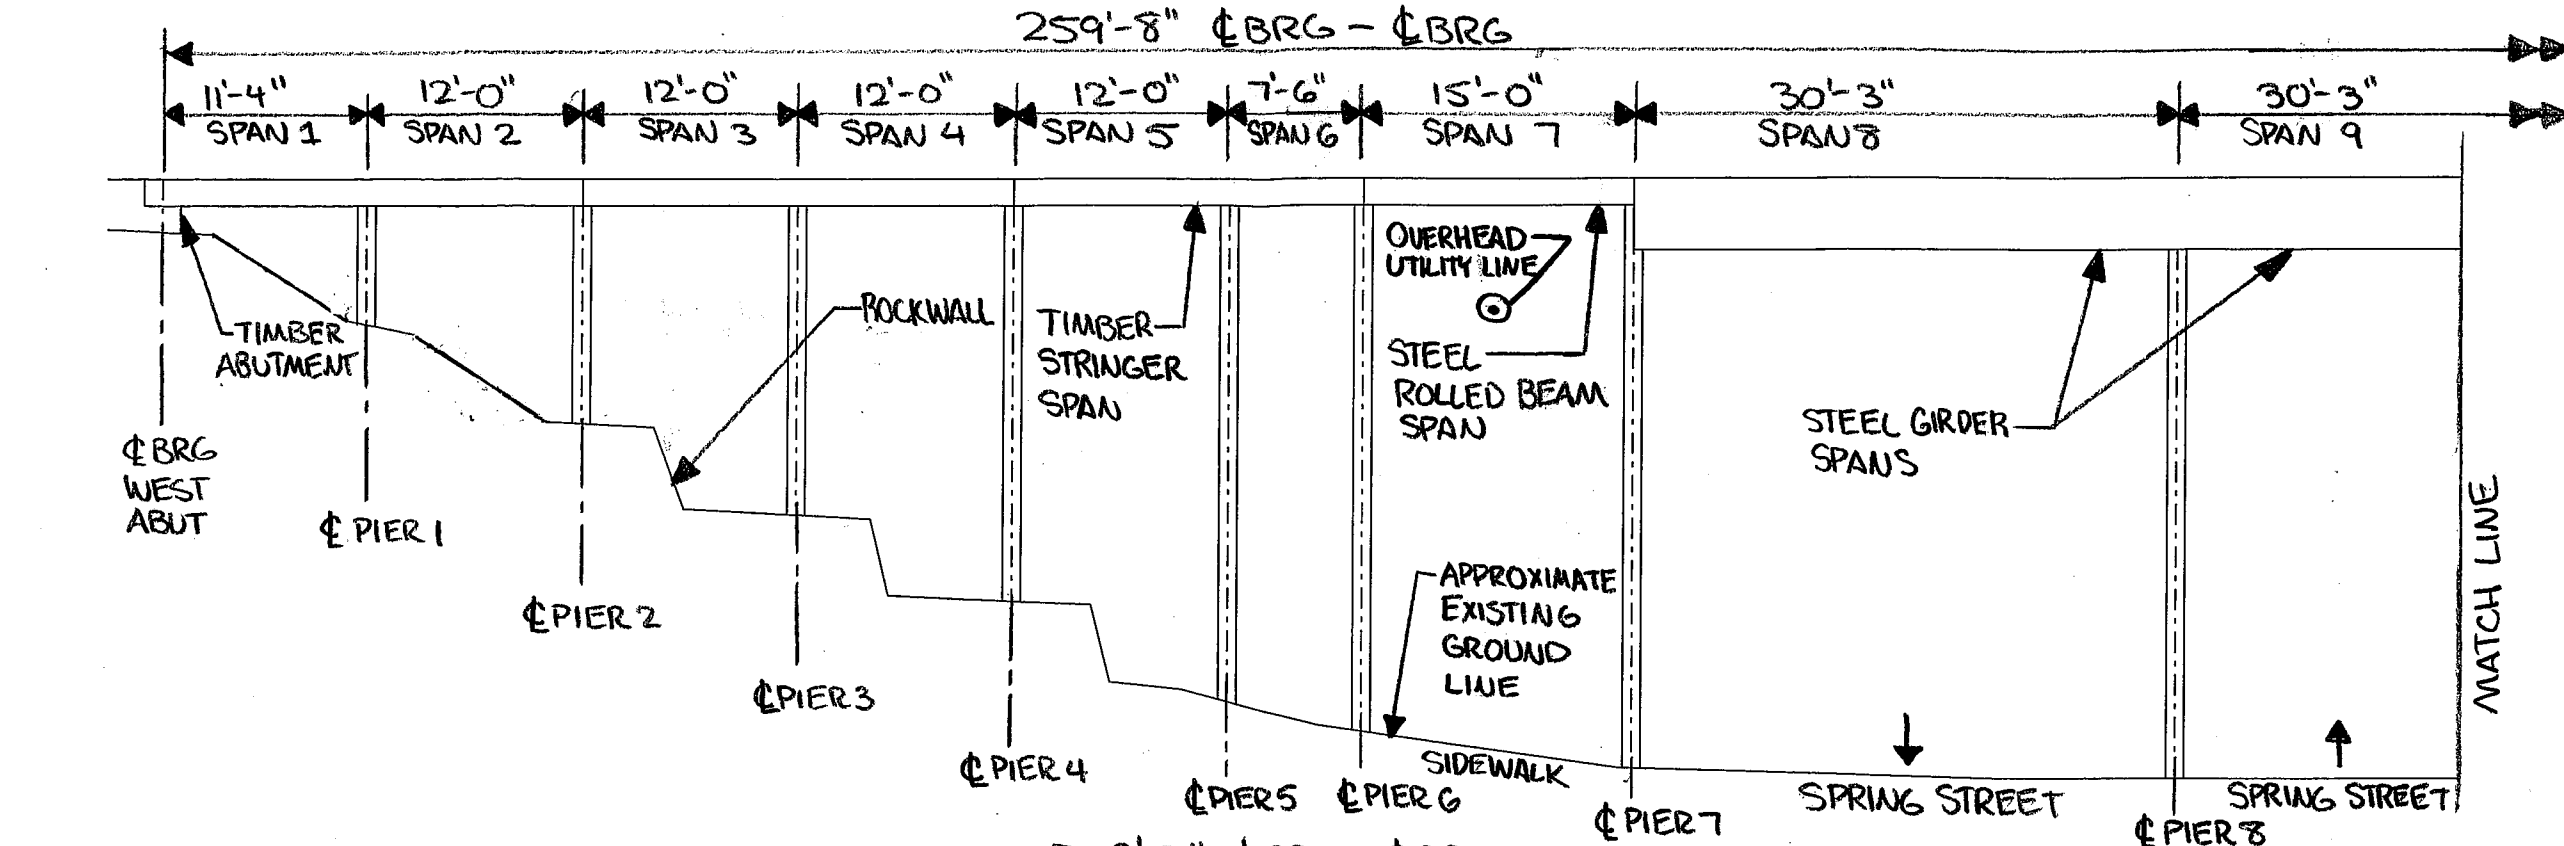
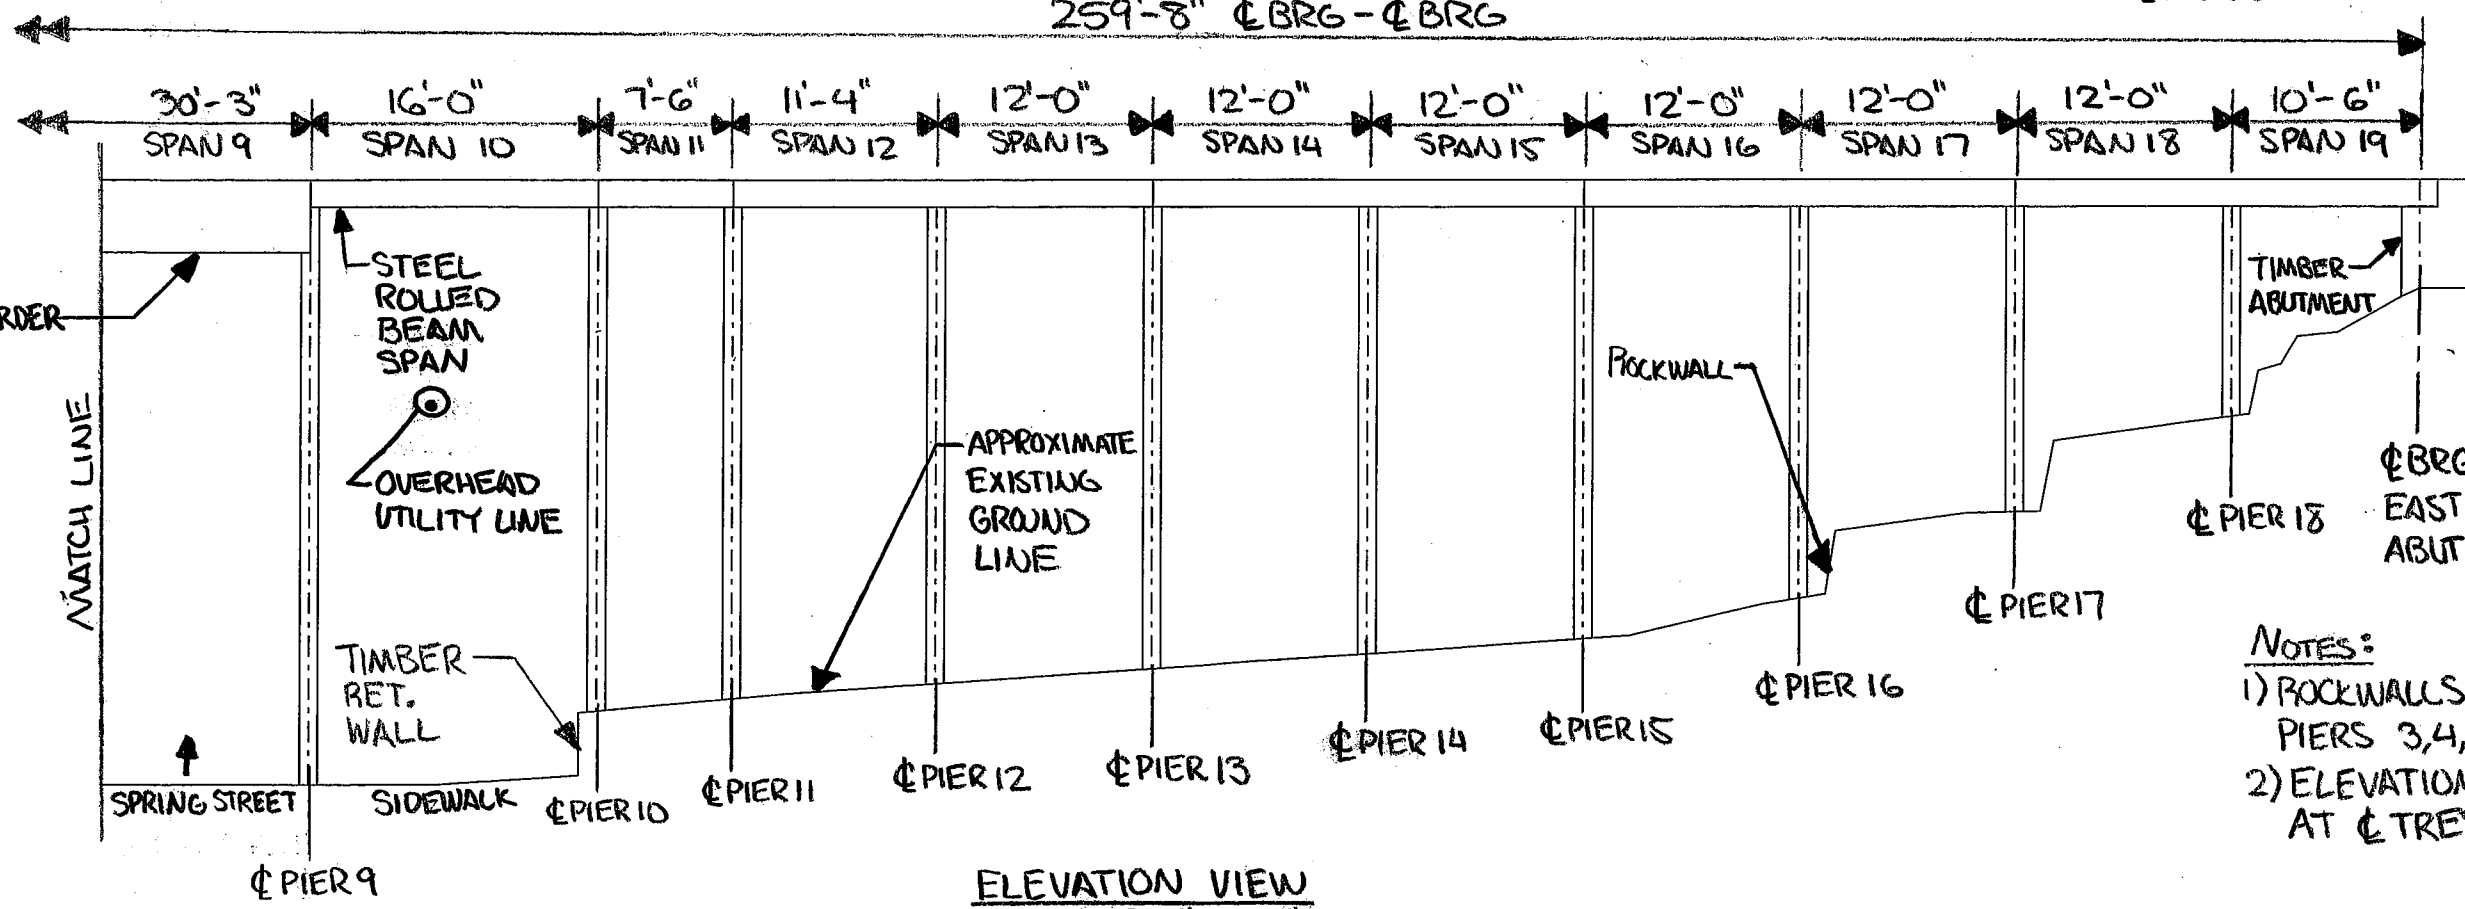
ELEVATION VIEW
 SCALE = 3/16" = 1'-0"
 (LOOKING NORTH)

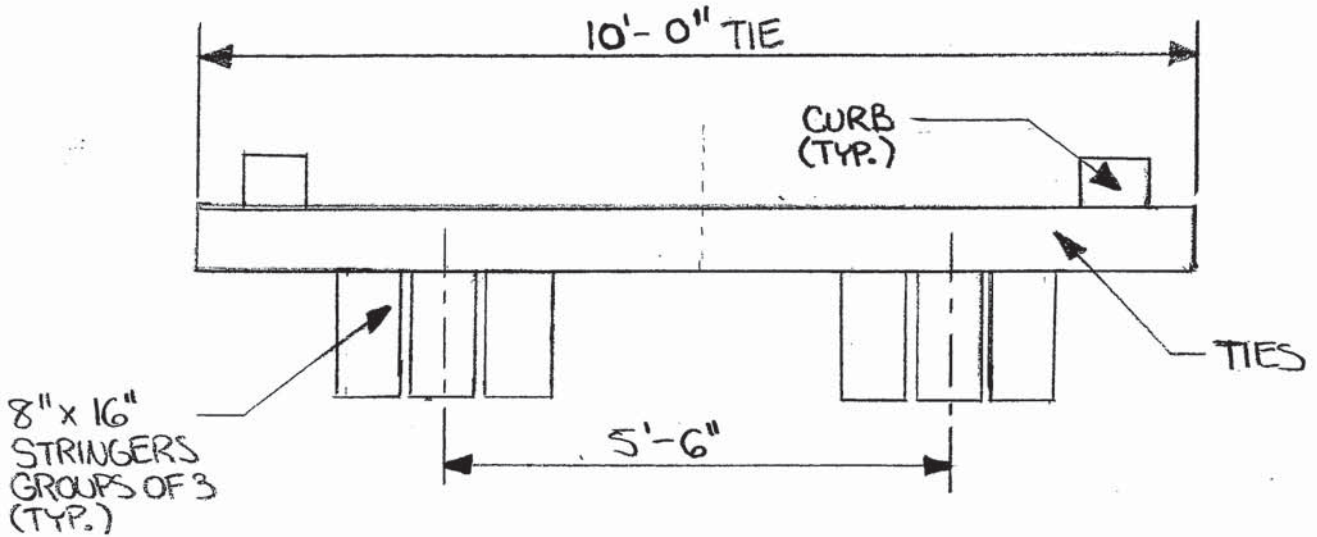
TYPICAL TIMBER STRINGER SPAN SECTION

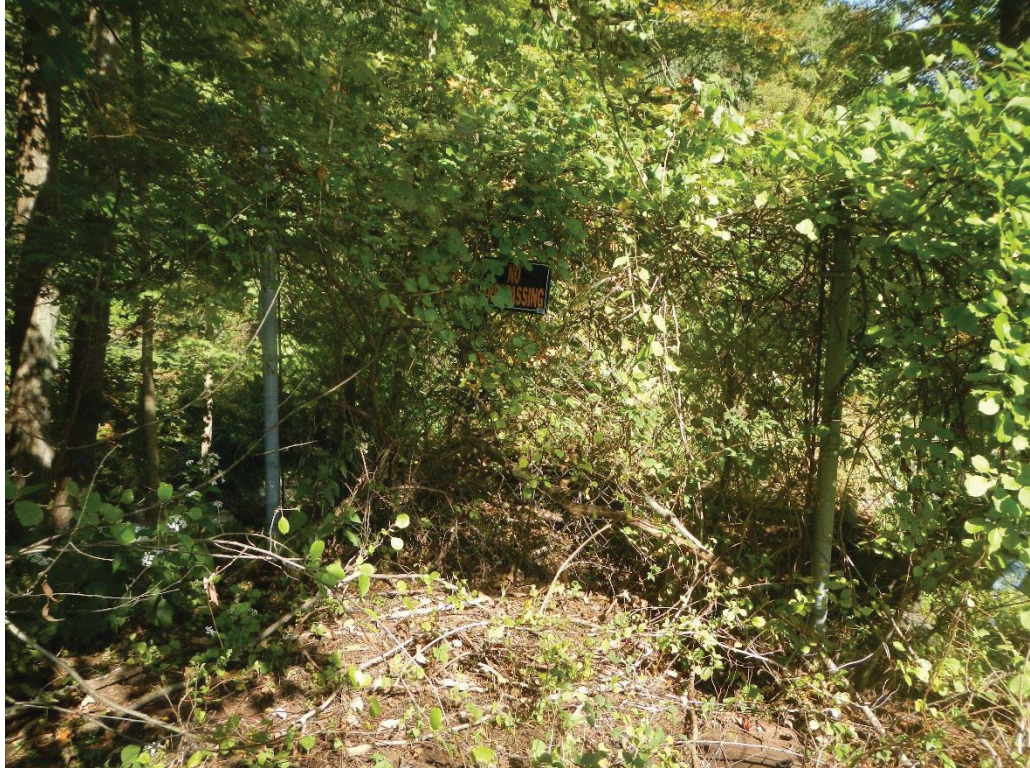
1. View Over Structure From Near (West) End

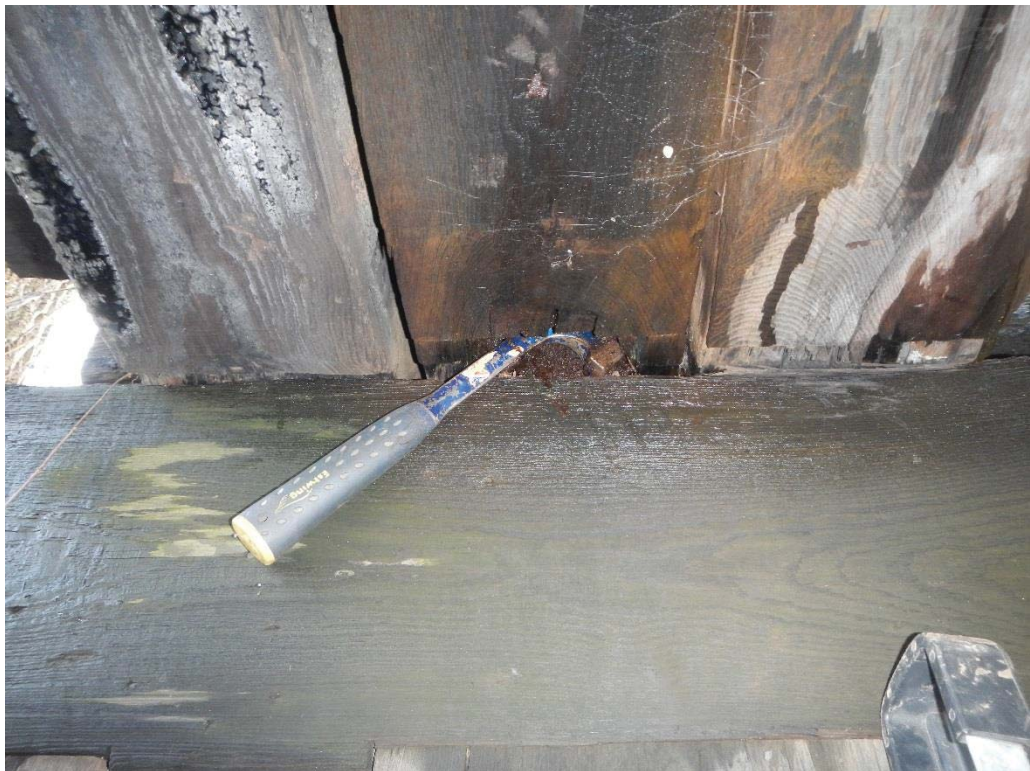
16. Span 3 Stringer 5 Decay at Bottom of Stringer Adj to Pier 2 (Hammer Penetration up to 4") (Decay Extends Full Height)

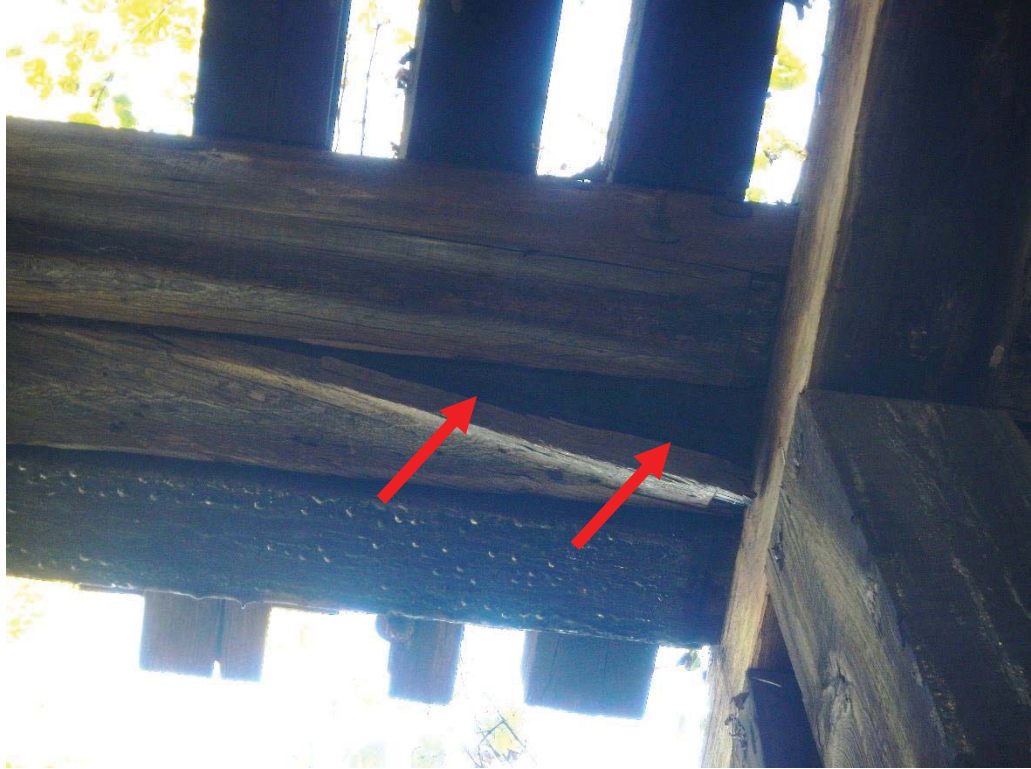
17. Span 4 Stringer 5 Decay Along Bottom of Stringer Adjacent to Pier 3 (Decay Extends Full Length)

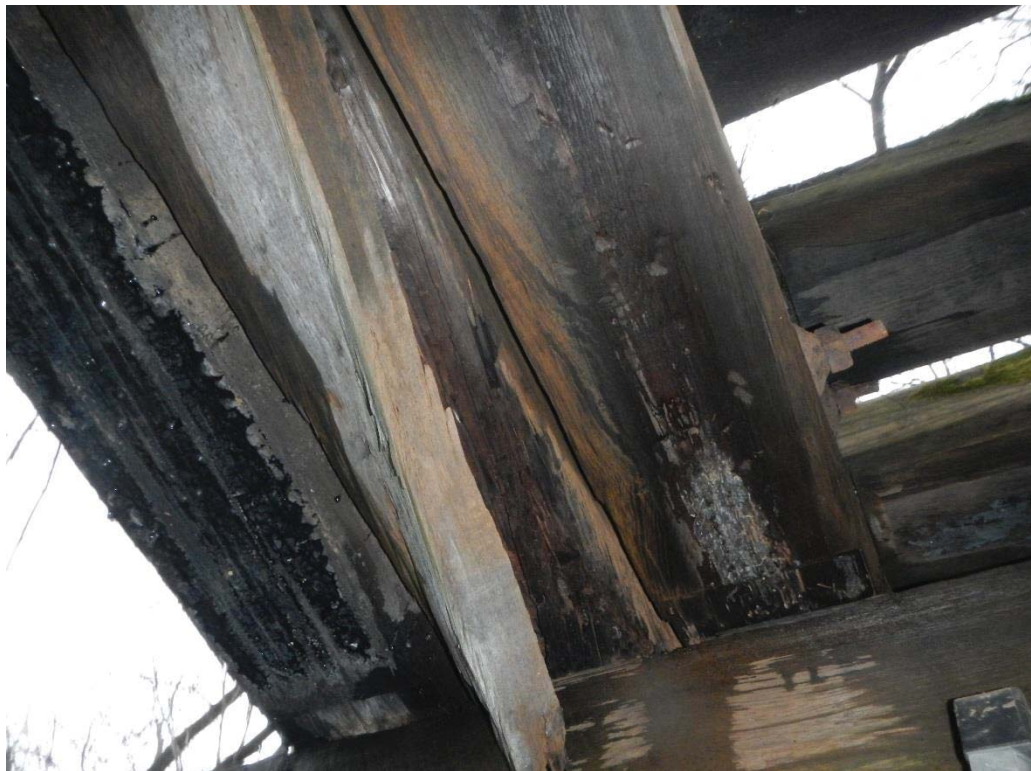
18. Span 4 Stringer 5 Decay Along Bottom of Stringer Adjacent to Pier 3 (Decay Extends Full Length) Close Up

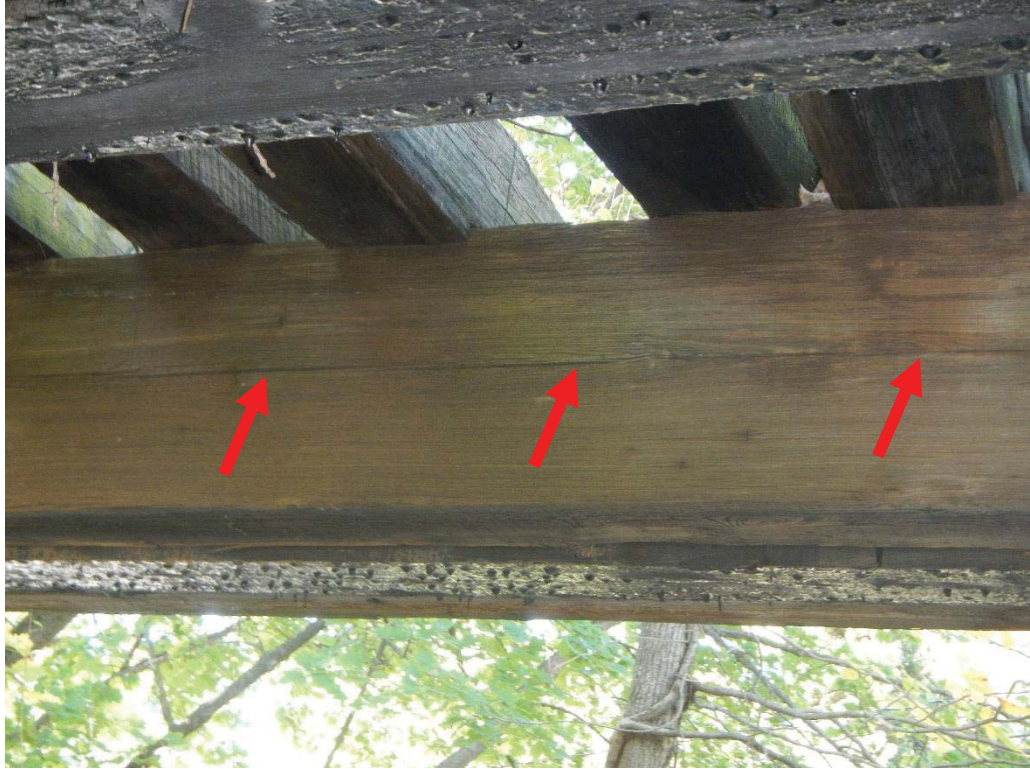
19. Span 5 Stringer 3 Horizontal Split in Stringer
