**WEST EASTON BOROUGH
NORTHAMPTON COUNTY**

**IN-DEPTH BRIDGE INSPECTION AND
ALTERNATIVES DISCUSSION REPORT**

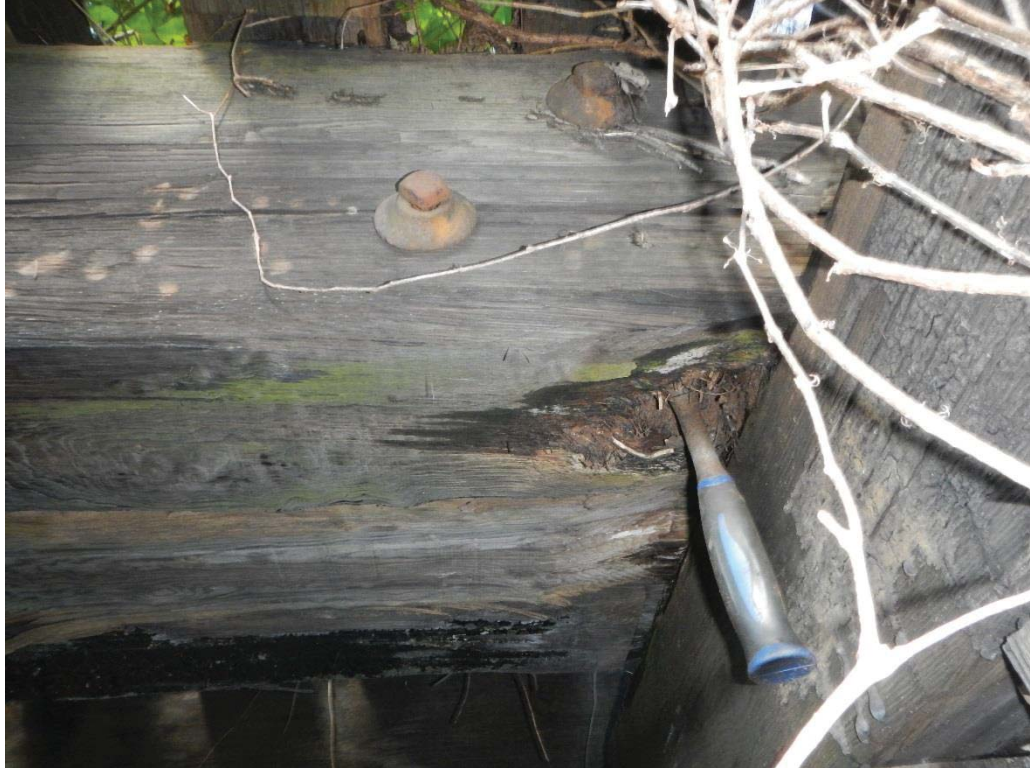
21. Span 14 Stringer 6 Decay to Bottom of Stringer Adj to Pier 14 (Hammer Penetration up to 6") (Decay Extends Full Height)

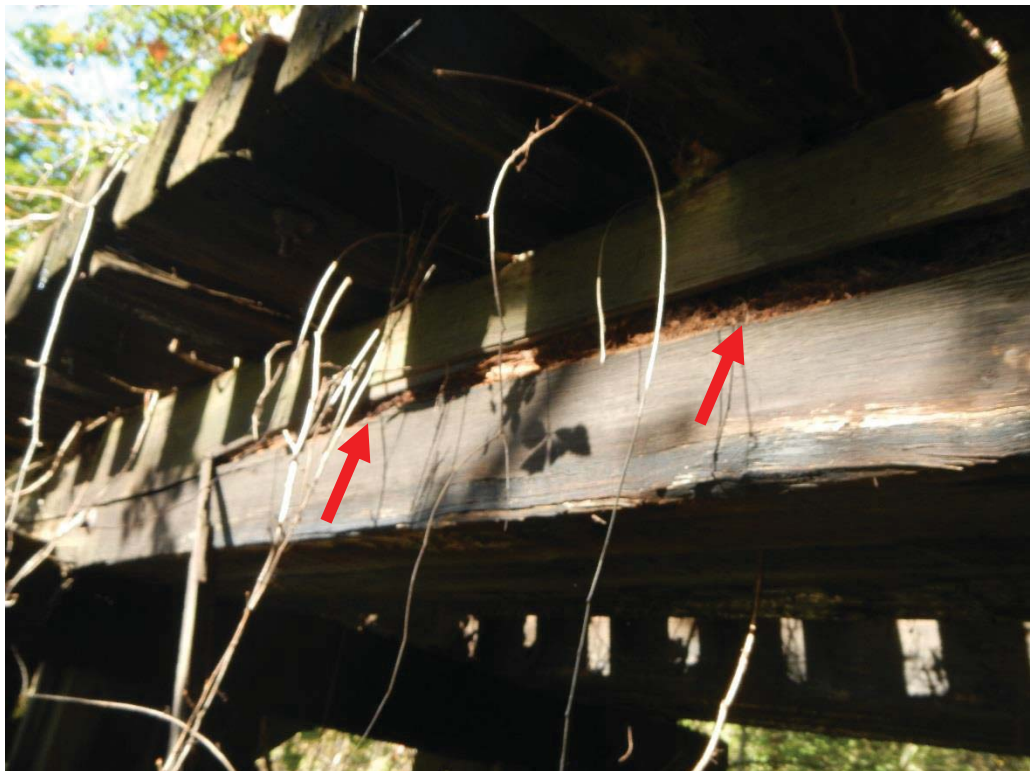
22. Span 15 Stringer 6 Decay to Stringer Along Entire Span

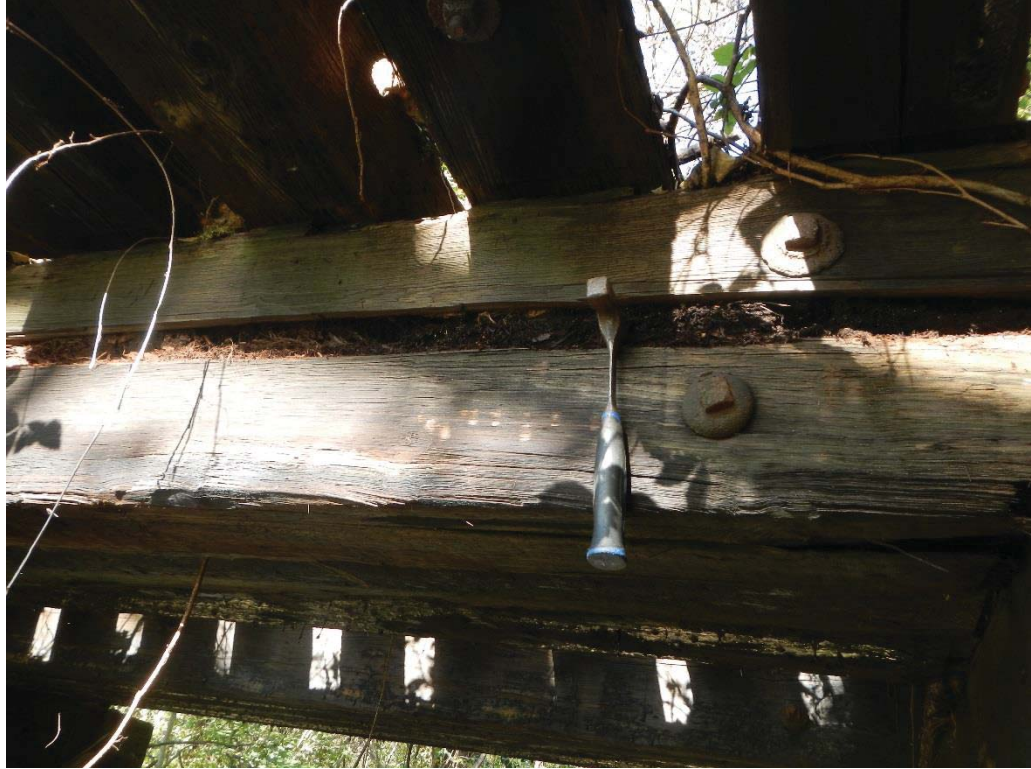
23. Span 15 Stringer 6 Decay to Stringer Along Entire Span Close Up

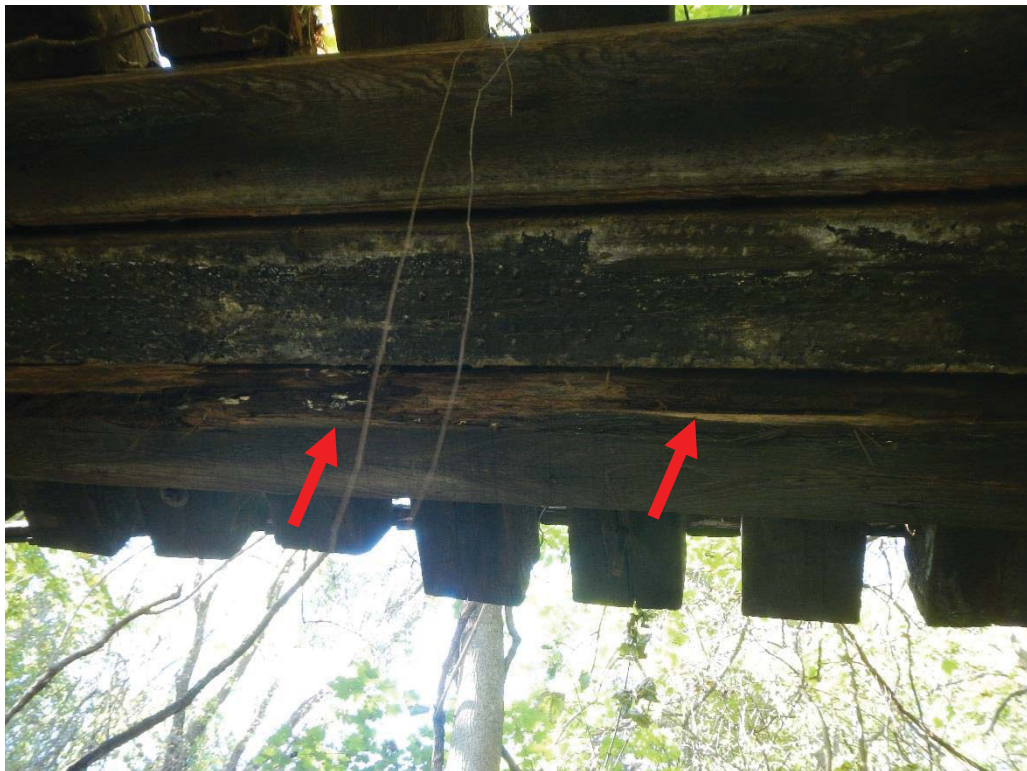
24. Span 16 Stringer 1 Decay to Bottom of Stringer

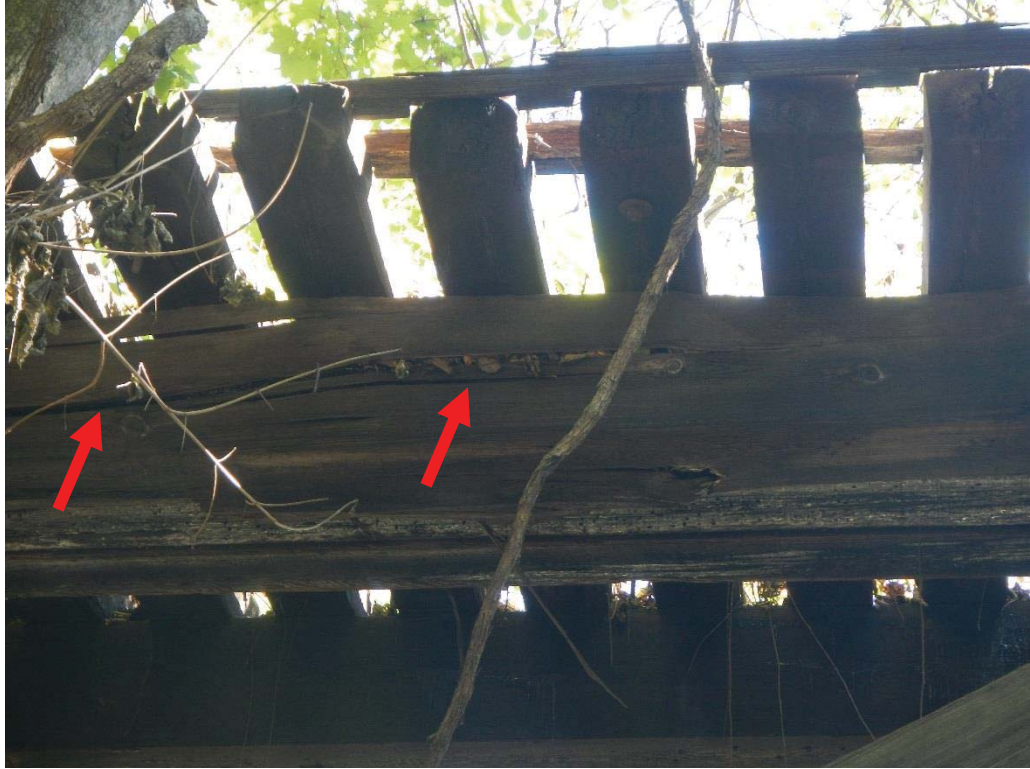
25. Span 16 Stringer 1 Decay to Top Portion of Stringer

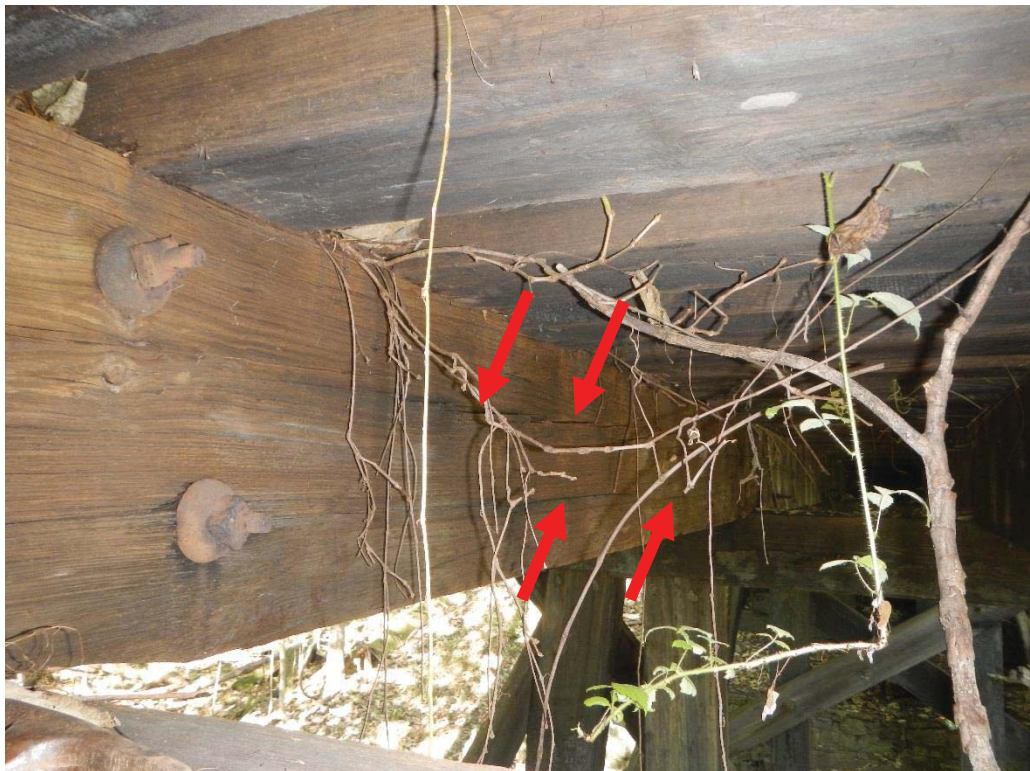
26. Span 17 Stringer 3 Horizontal Splits in Stringer

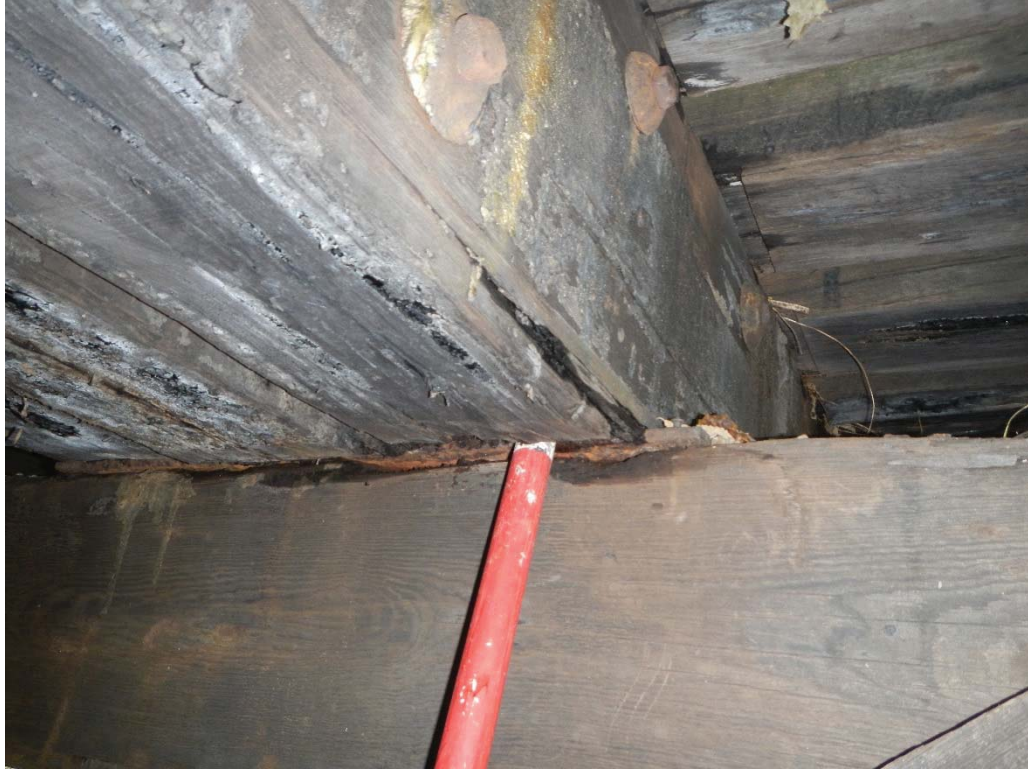
27. Span 19 Stringer 1 Decay to Bottom of Stringer Adj to Pier 18 (1' of Penetration with Rod) (Decay Extends Full Height)

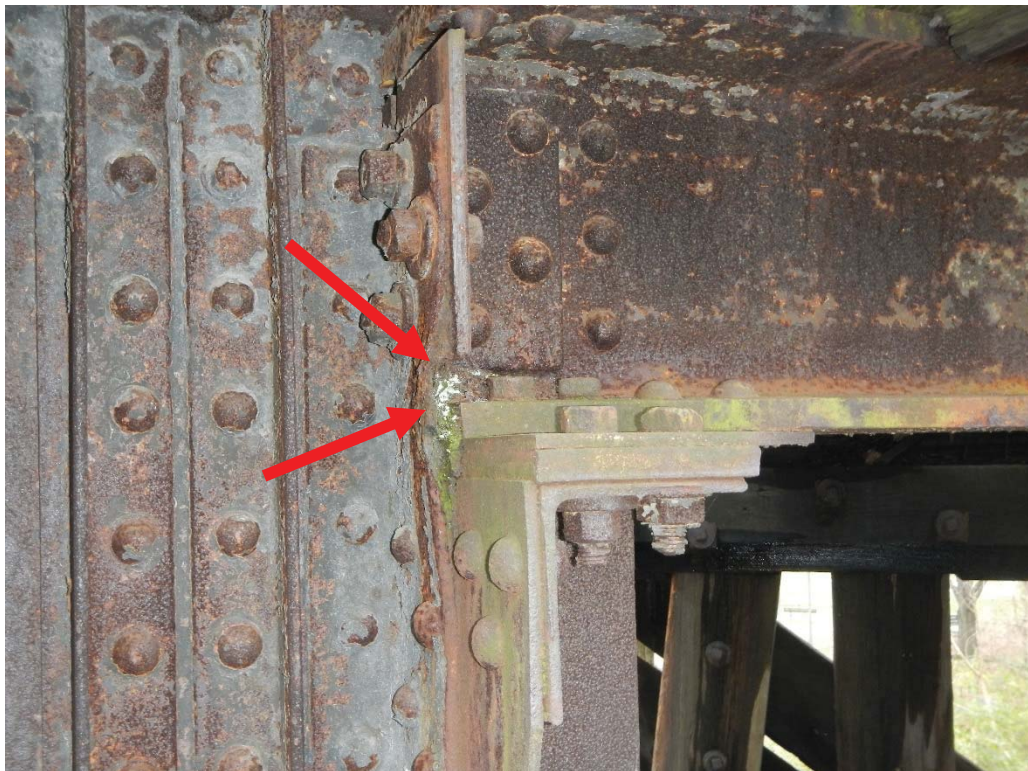
28. Span 7 Stringer 1 100% Section Loss to Connection Angle Adjacent to Pier 7

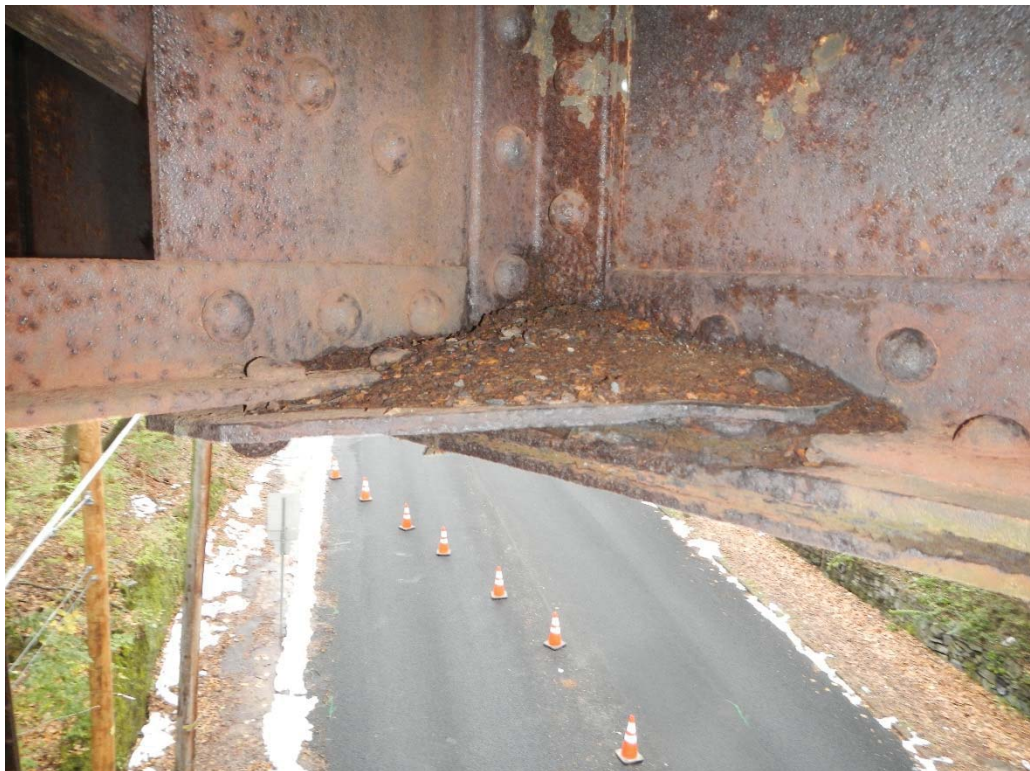
30. Span 8 Girder 1 Bottom Flange Steel Rust Residue on Horizontal Gusset Plate (Typical)

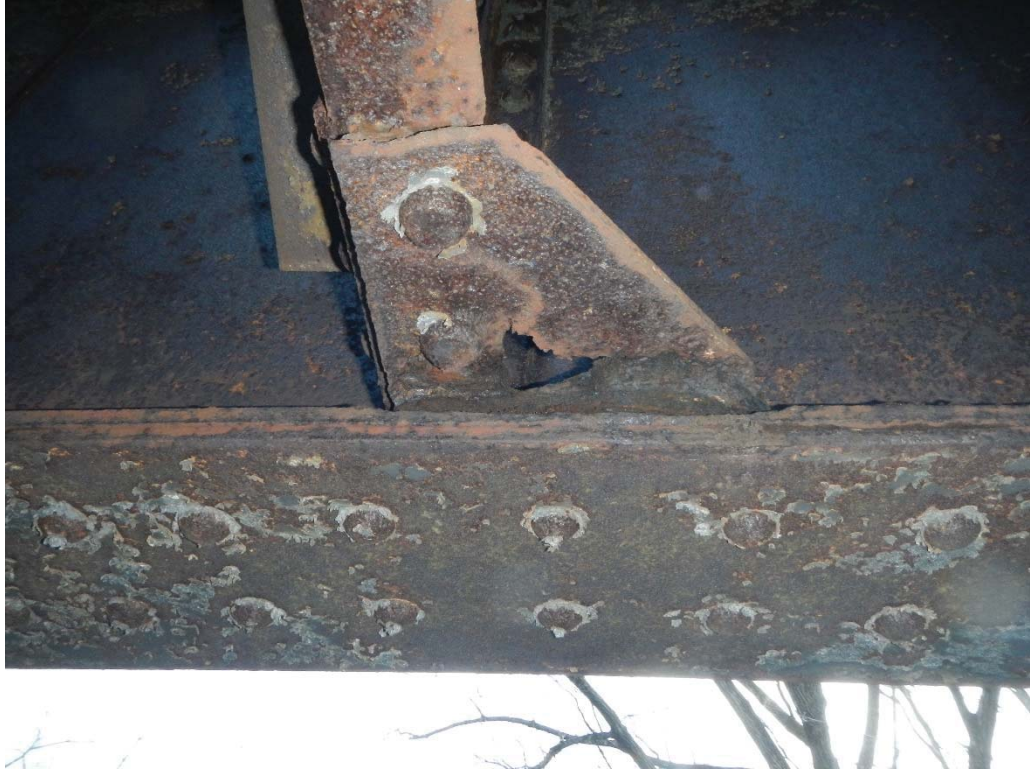
31. Span 8 Girder 2 Bottom Flange 100% Section Loss to Horizontal Gusset Plate at Diaphragm 3

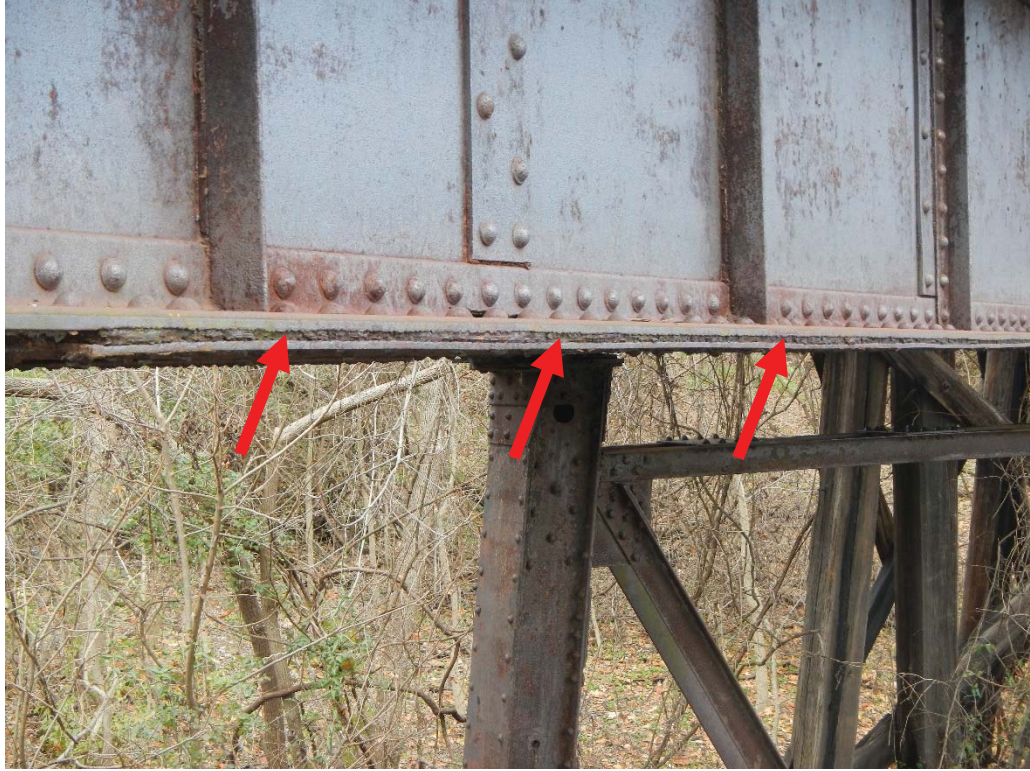
35. Span 9 Girder 2 Pack Rust Between Bottom Flange and Cover Plate (Typical)

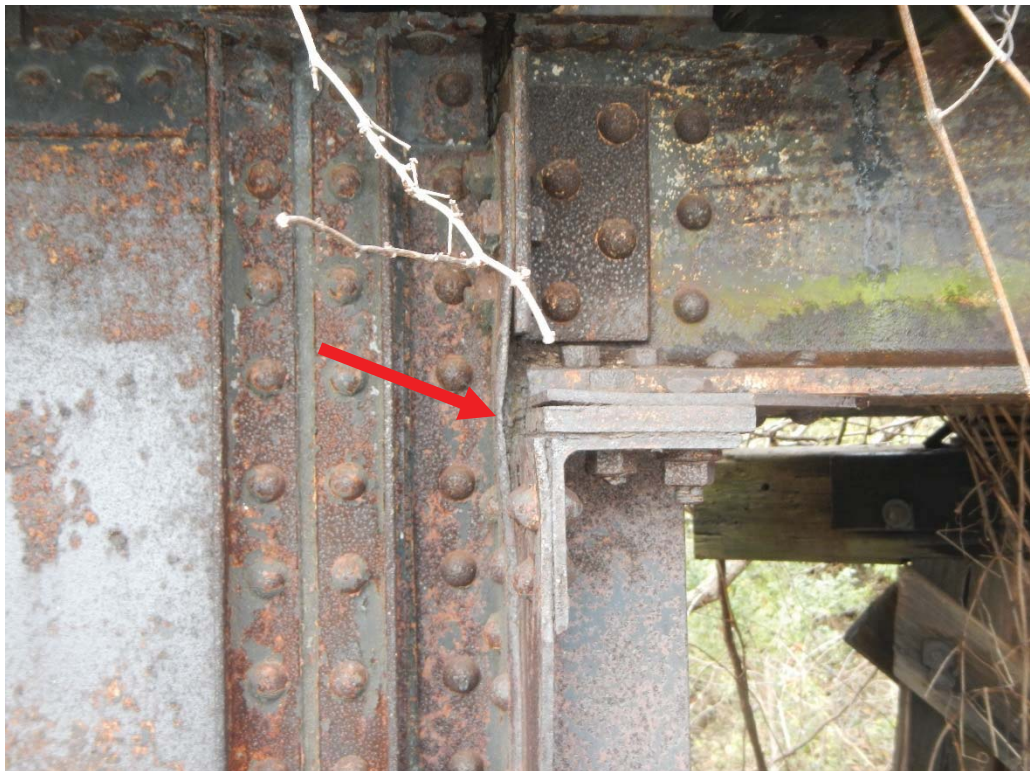
36. Span 10 Stringer 2 Bent Connection Angle with Section Loss Adjacent to Pier 9

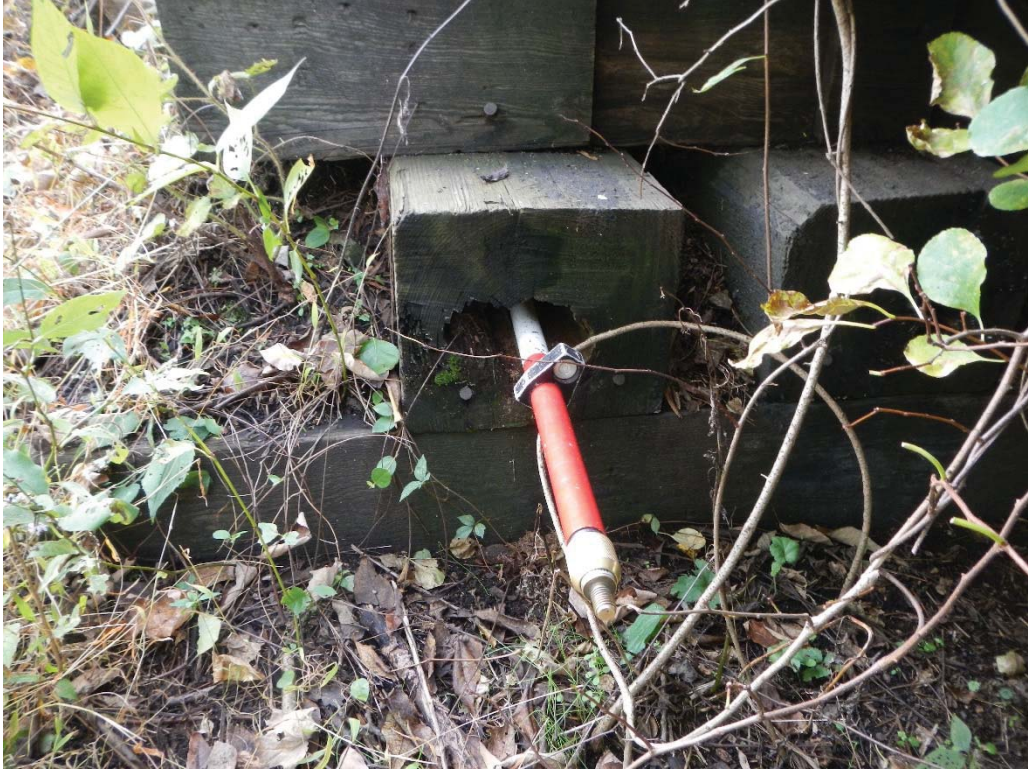
37. Near (West) Abutment Stem Longitudinal Member Decay (3' of Penetration with 4' Rod)

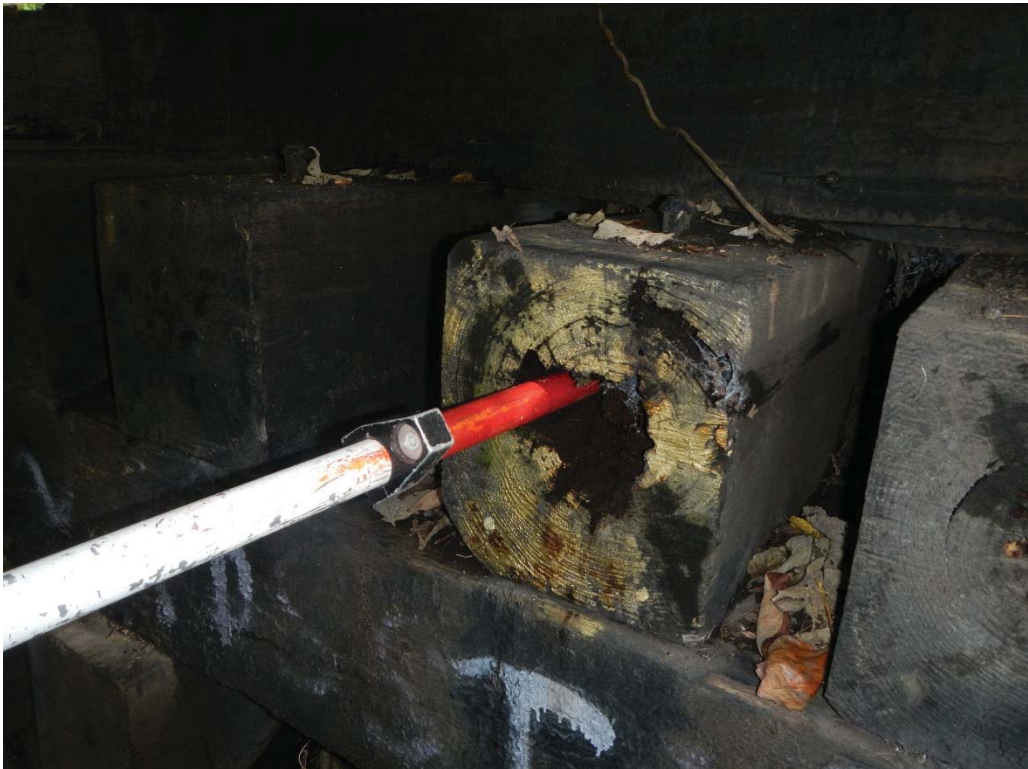
38. Far (East) Abutment Stem Longitudinal Member Decay (2'-6" of Penetration with 4' Rod)

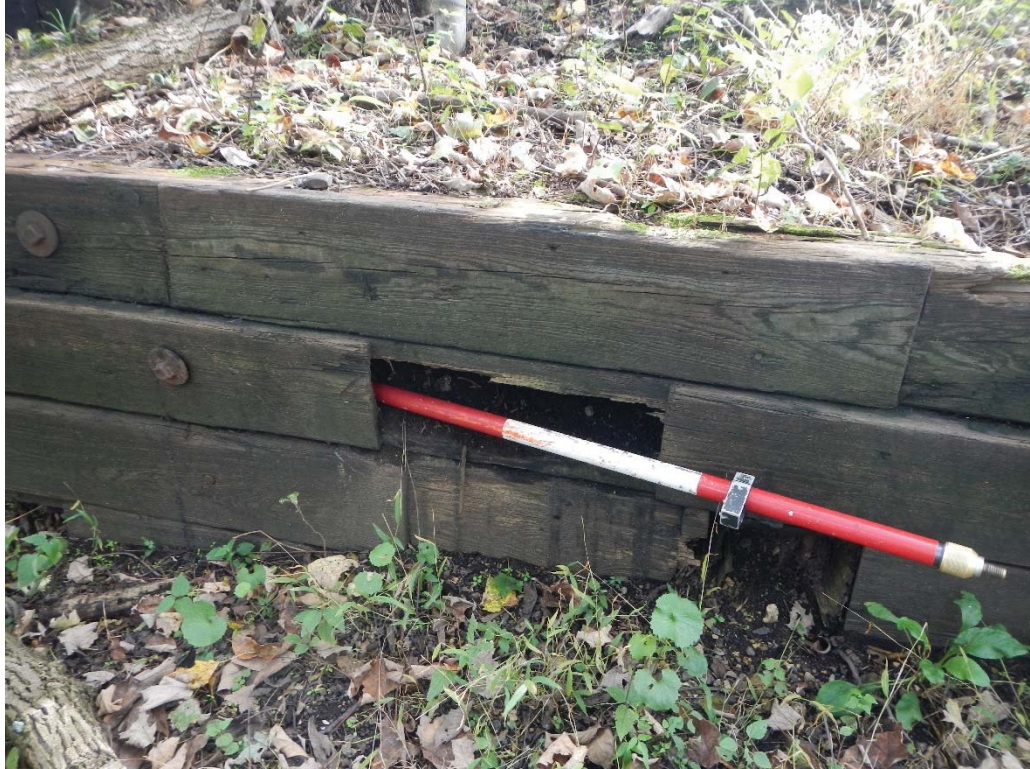
39. Near (West) Abutment Left (North) Wing Decay

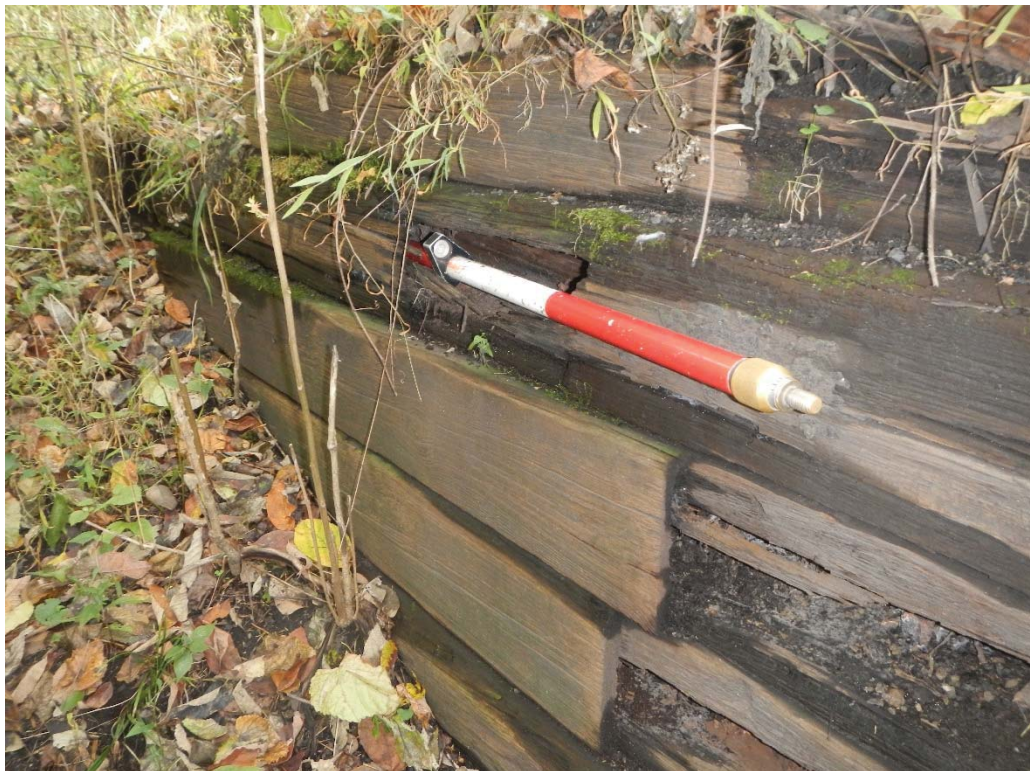
40. Far (East) Abutment Left (North) Wing Decay

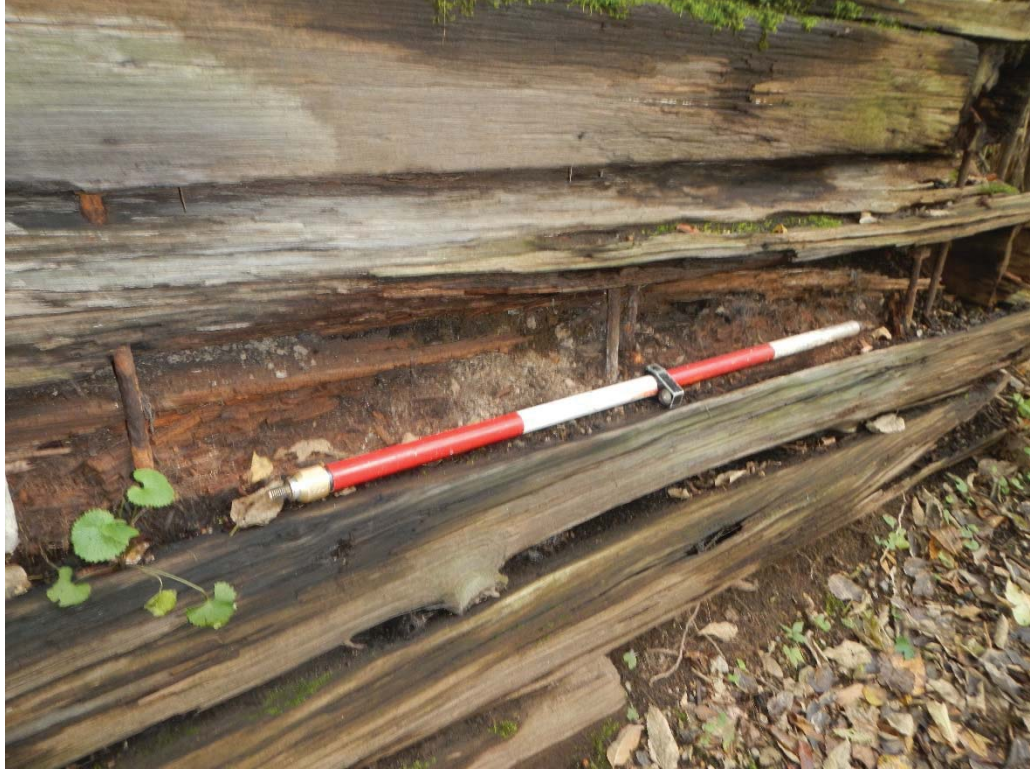
41. Far (East) Abutment Right (South) Wing Decay

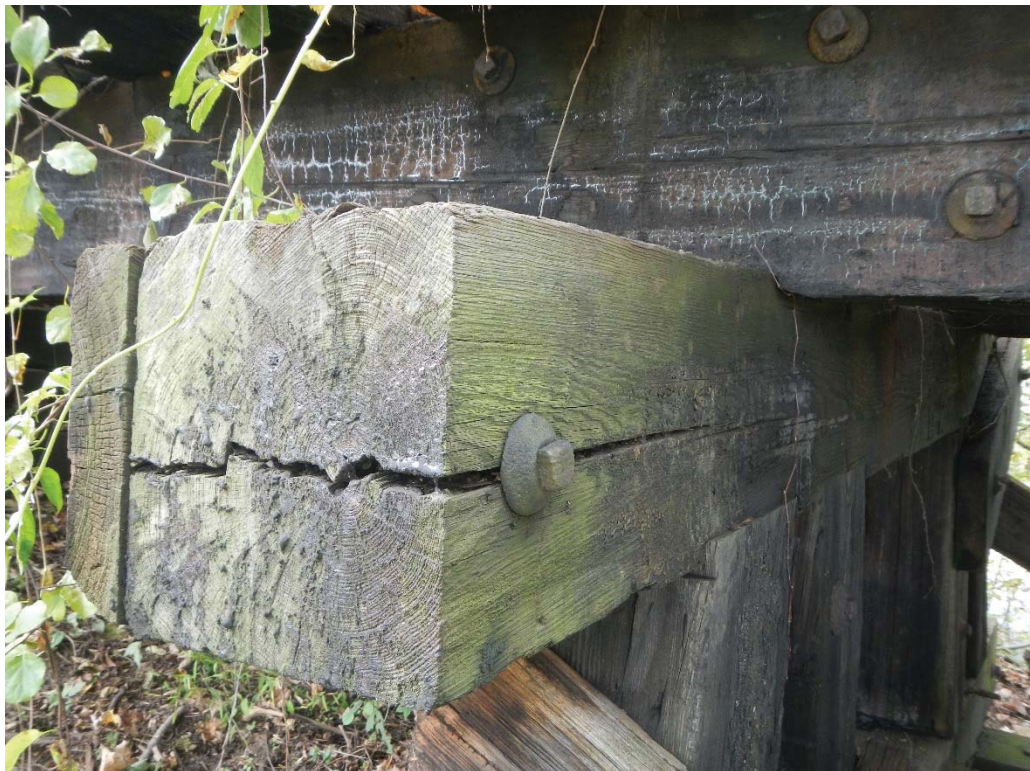
42. Pier 1 Right (South) End Top Strut Split (Split is Full Length)

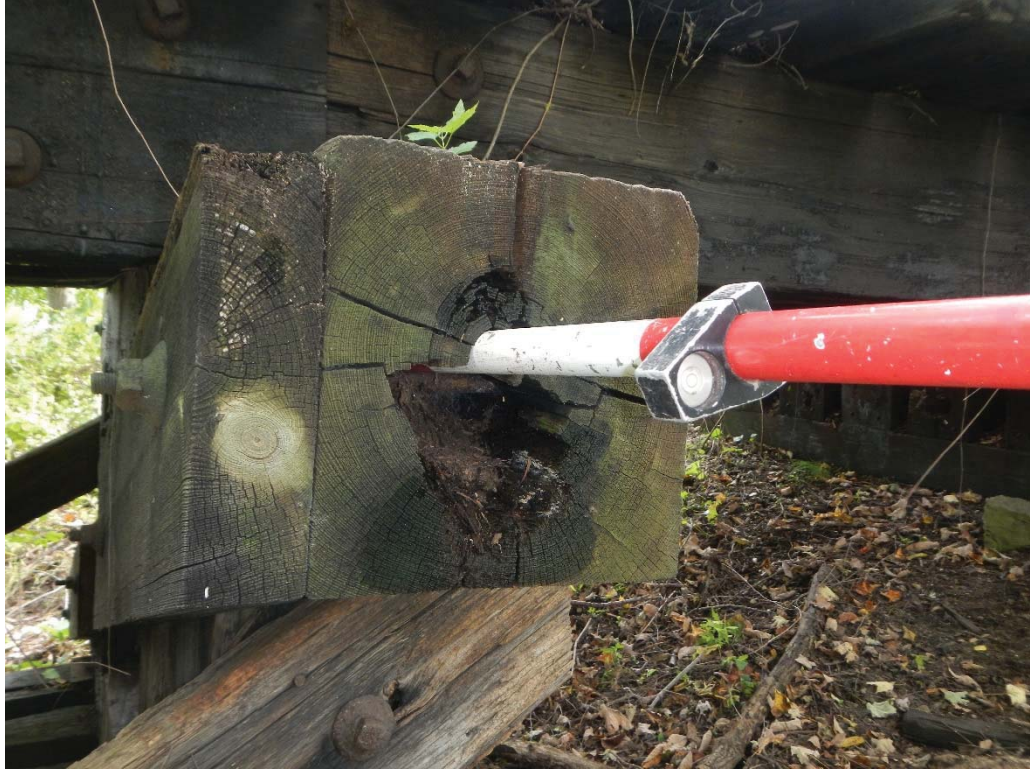
43. Pier 1 Left (North) End Top Strut Decay (2'-4" Penetration with 4' Rod)

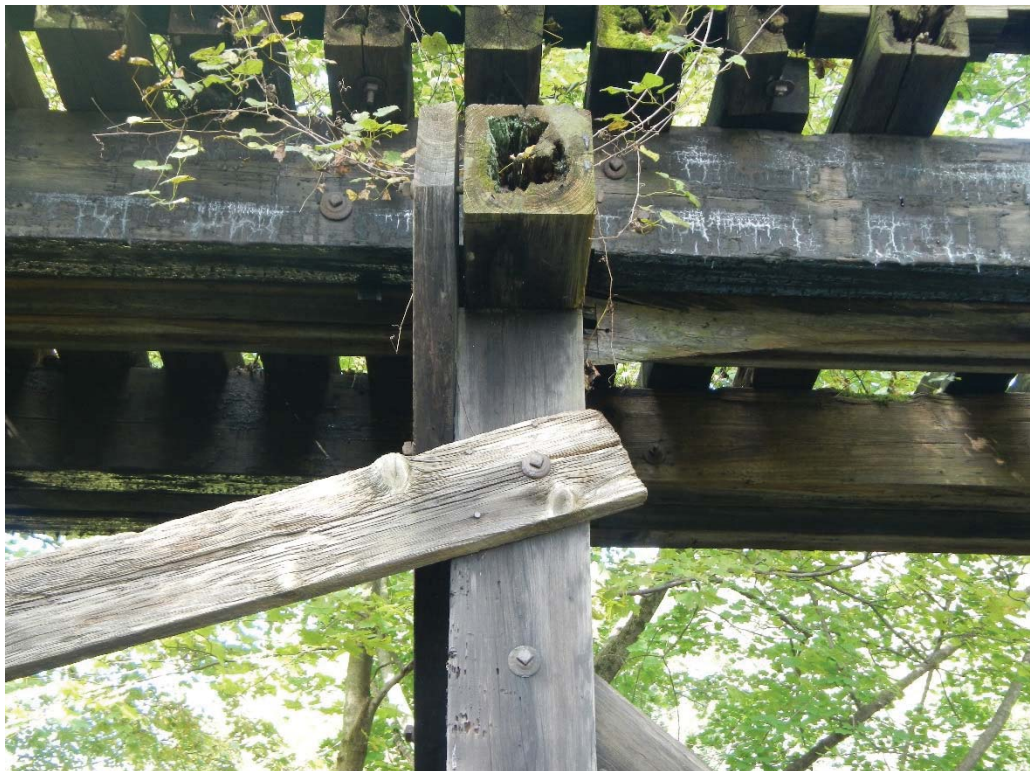
44. Pier 3 Right (South) End Top Strut Decay

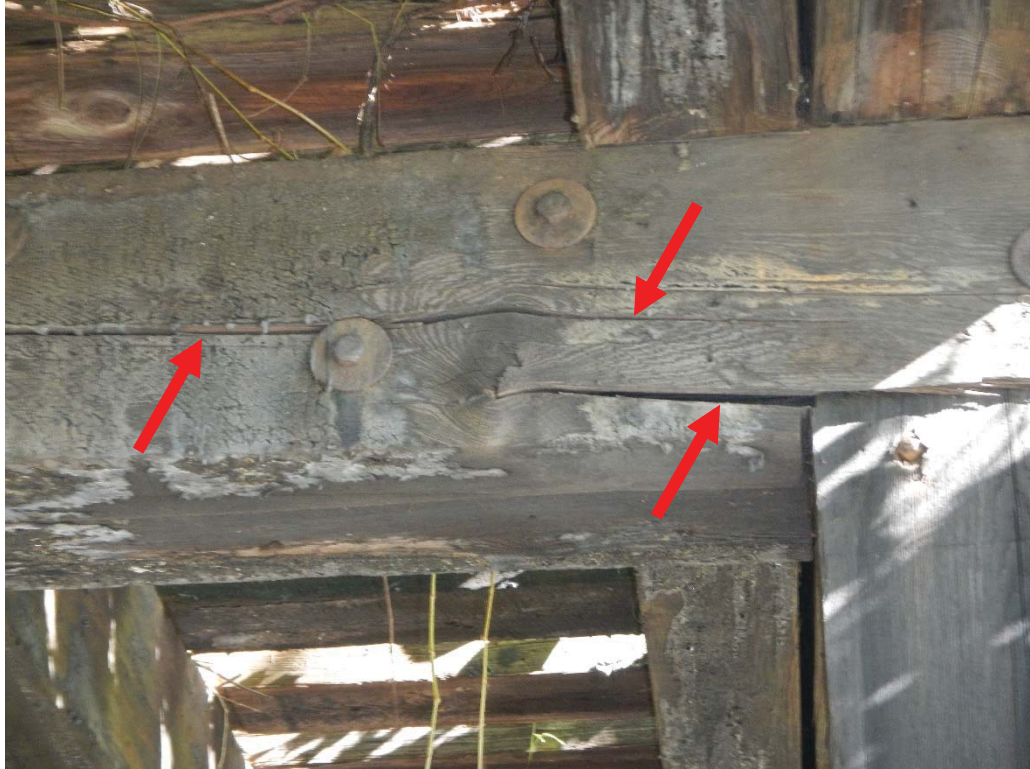
45. Pier 13 Near (West) Face Top Strut Splits

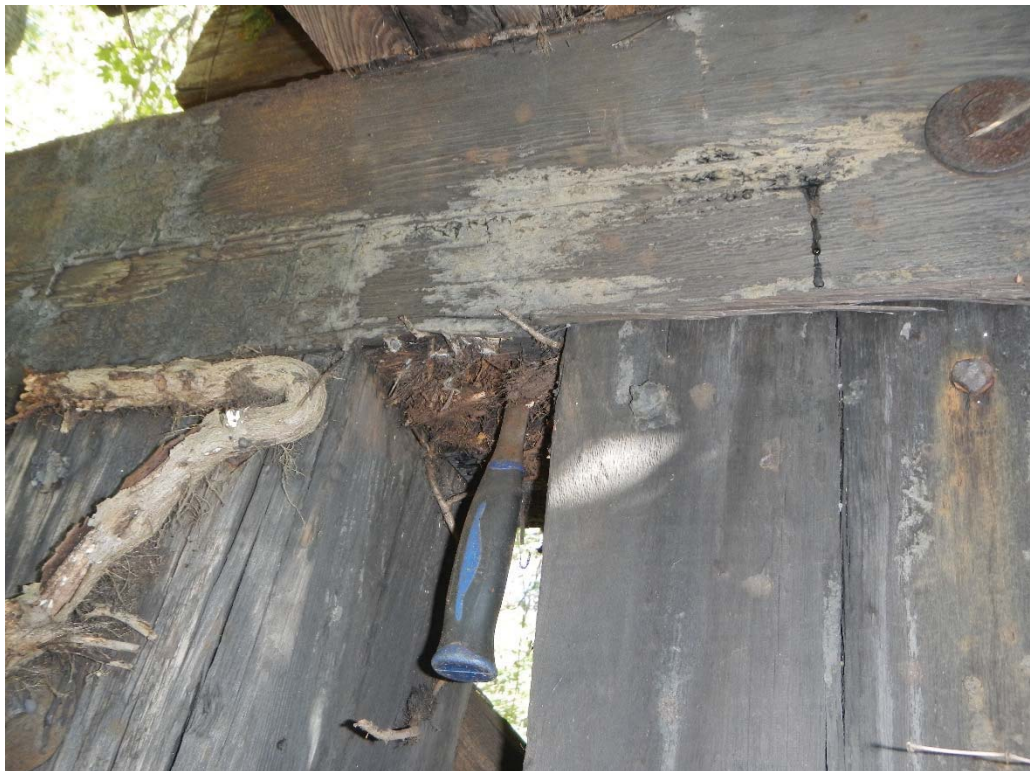
46. Pier 13 Near (West) Side Top Strut Decay Btw Cols 1 and 2 (Hammer Penetration up to 6") (Decay Extends Full Height)

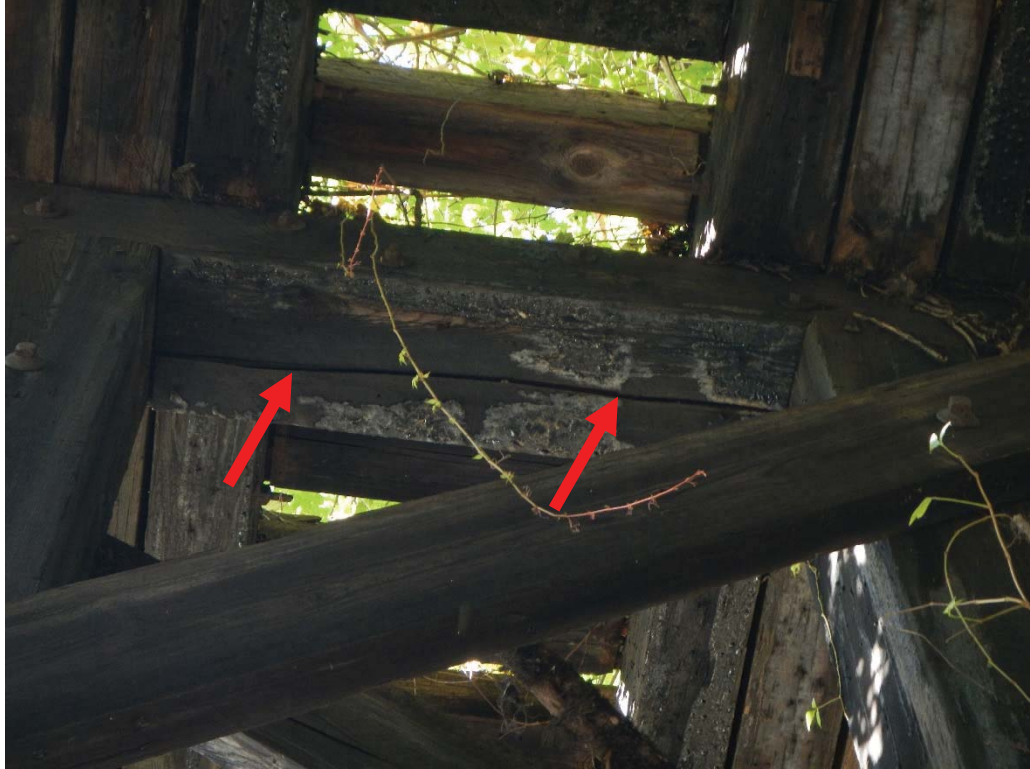
47. Pier 13 Top Strut Split at Underside Between Columns 2 and 3

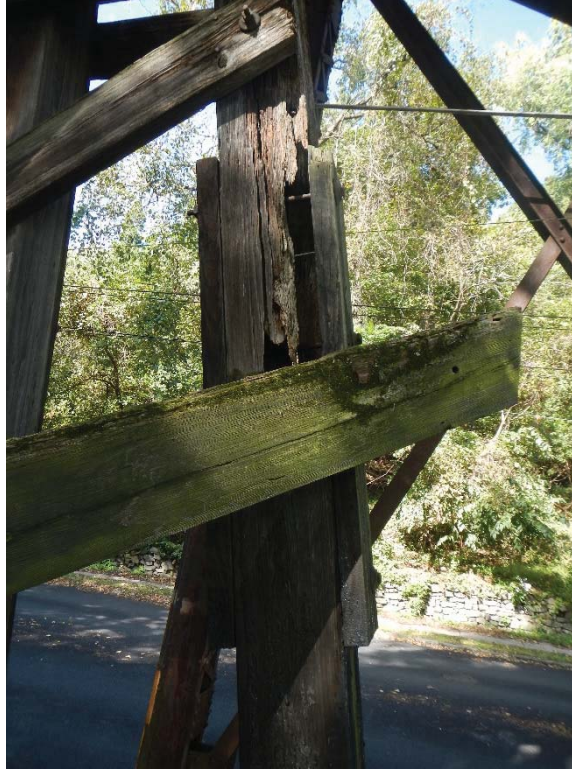
49. Pier 6 Column 5 Decay Around Column Splice (Decay Extends Full Height)

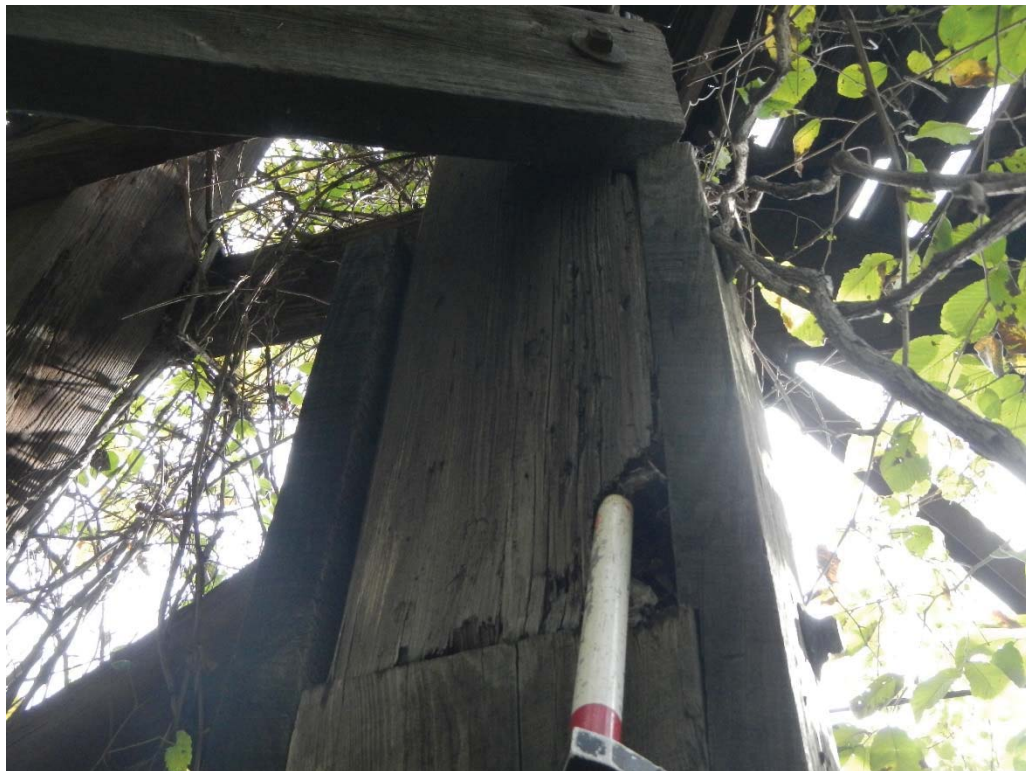
50. Pier 10 Column 1 Decay Around Column Splice

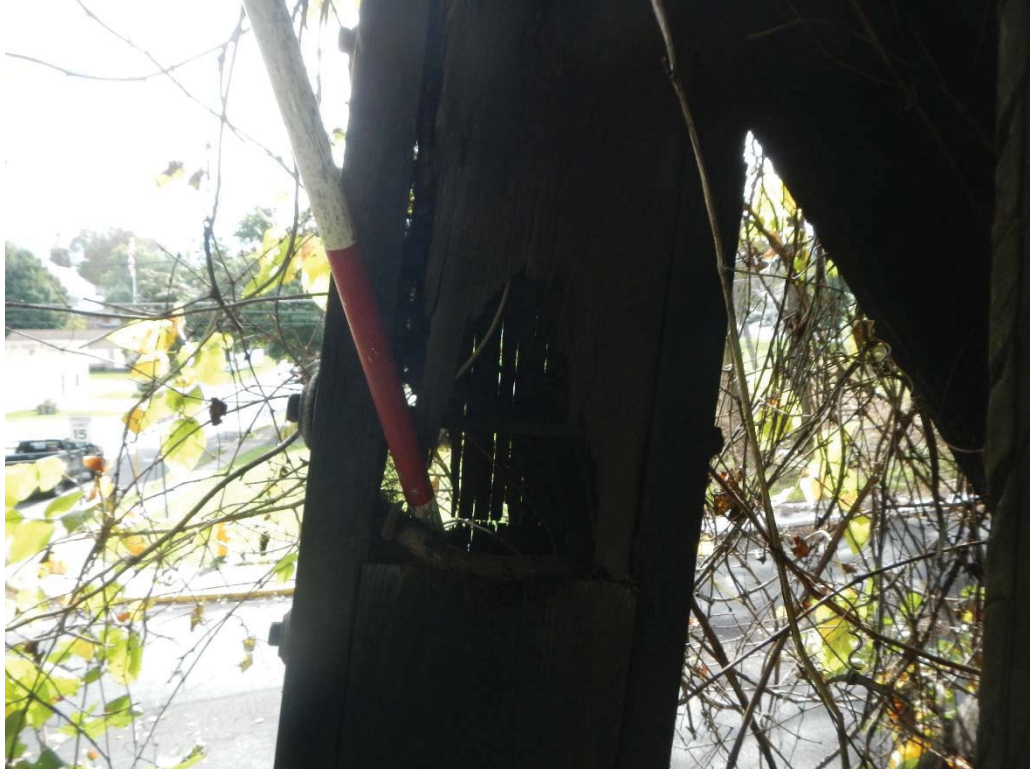
51. Pier 10 Column 5 Decay Around Column Splice

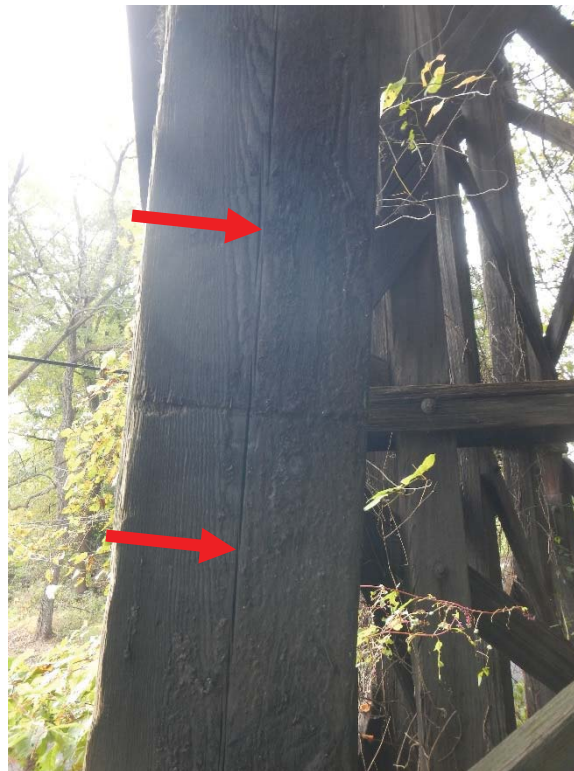
52. Pier 12 Column 4 Split Far (East) Face

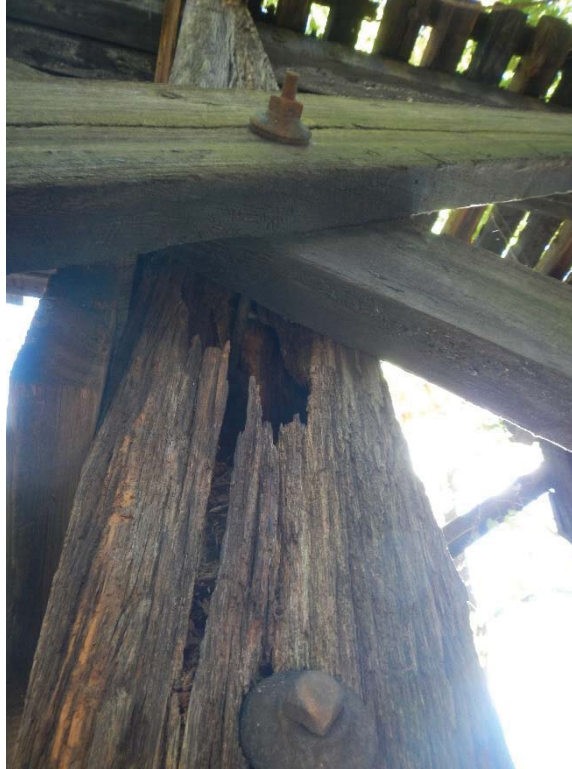
53. Pier 14 Column 1 Decay Adjacent to Longitudinal Bracing at Left (North) Face

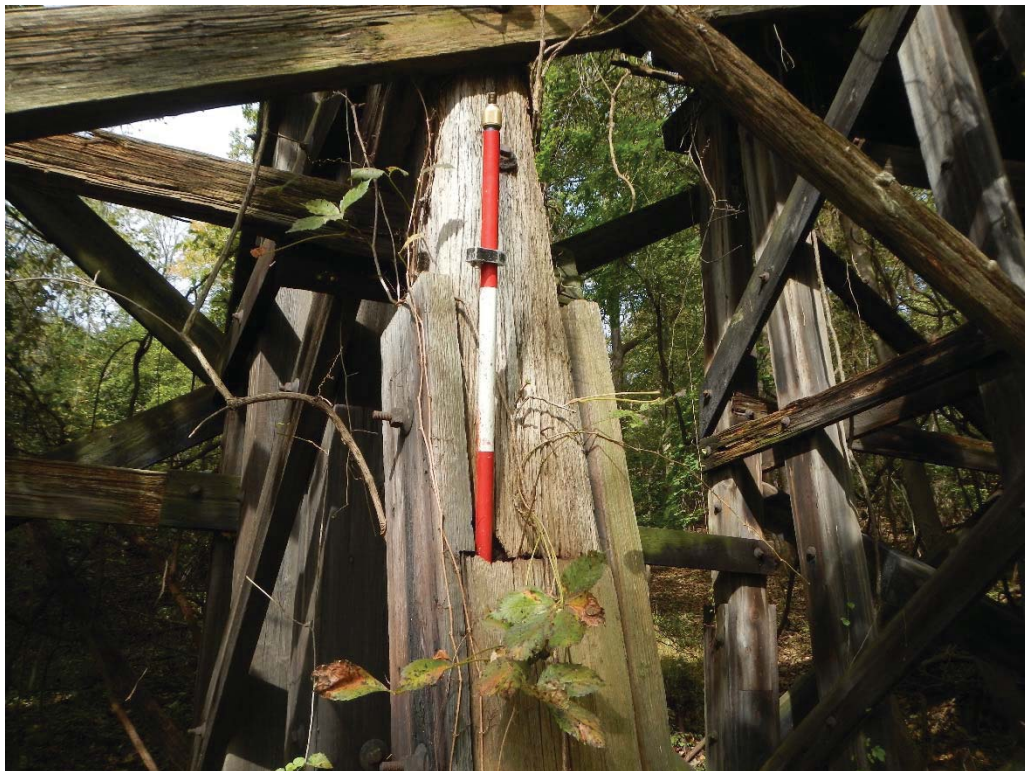
54. Pier 14 Column 4 Decay Around Column Splice (1'-4" of Penetration with 4' Rod)

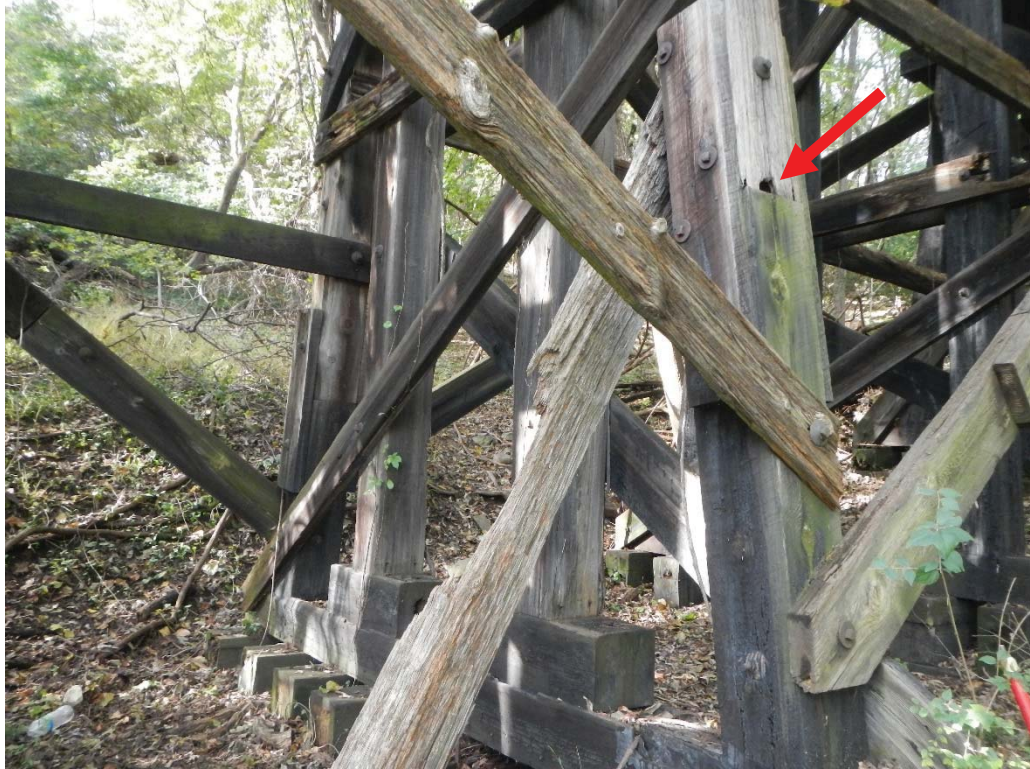
55. Pier 15 Column 4 Decay Around Column Splice
