**WEST EASTON BOROUGH
NORTHAMPTON COUNTY**

**IN-DEPTH BRIDGE INSPECTION AND
ALTERNATIVES DISCUSSION REPORT**

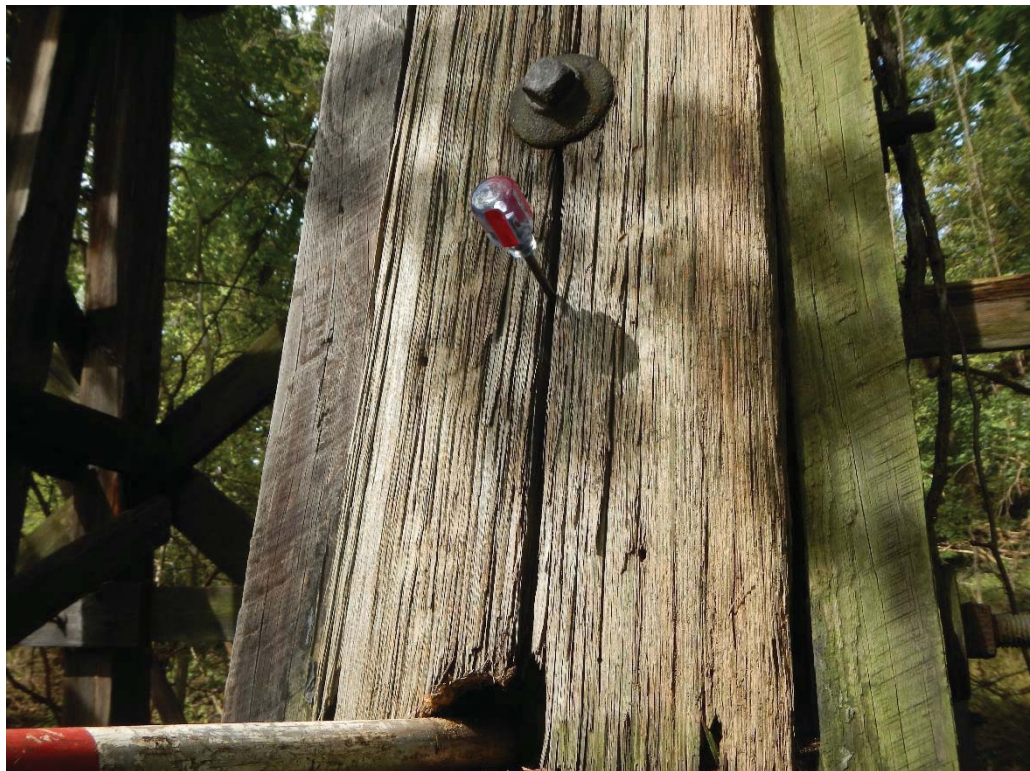
56. Pier 15 Column 4 Decay Around Column Splice Close Up

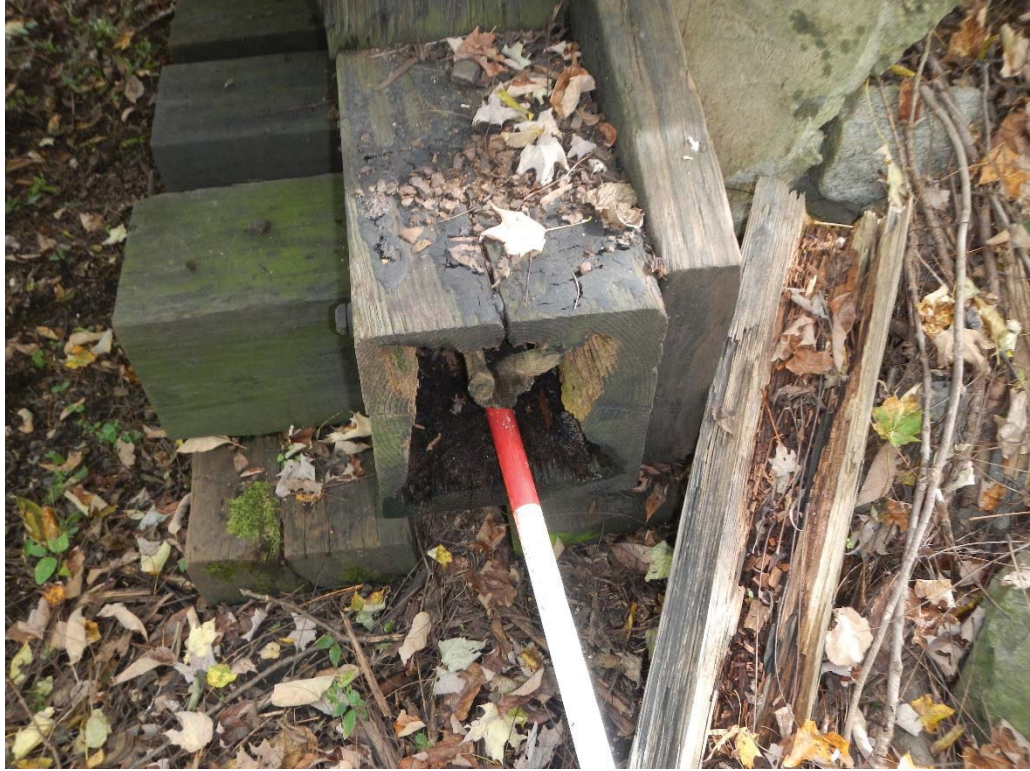
57. Pier 1 Left (North) End Bottom Strut Decay (2' of Penetration with 4' Rod)

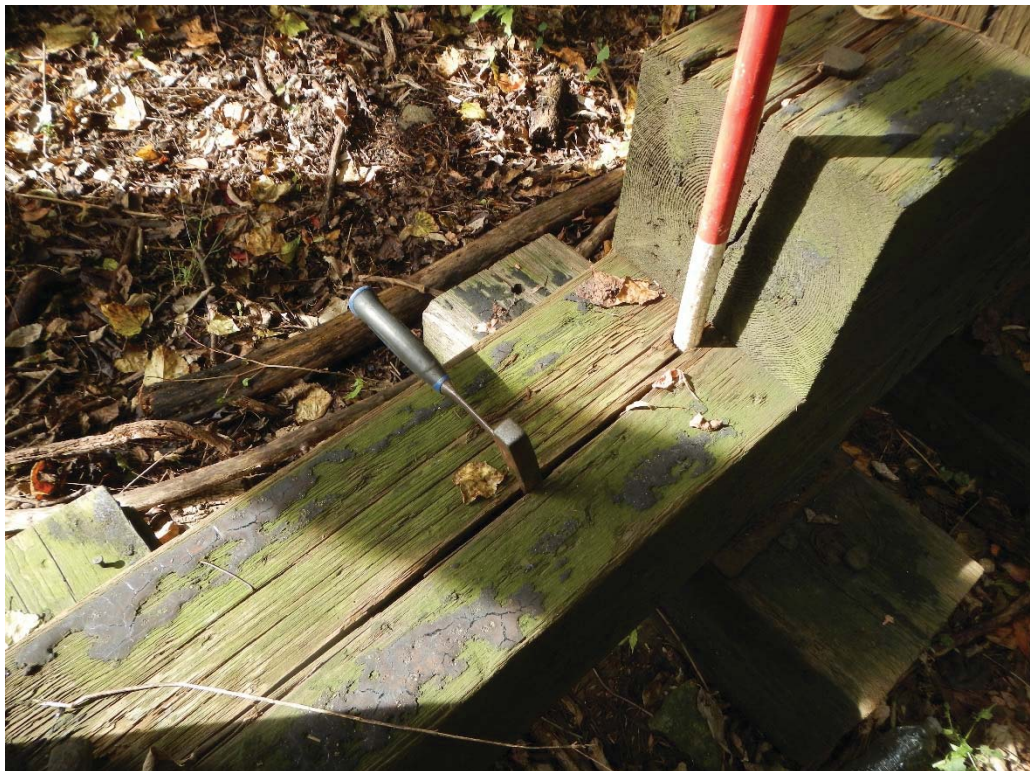
58. Pier 14 Bottom Strut Split/Decay

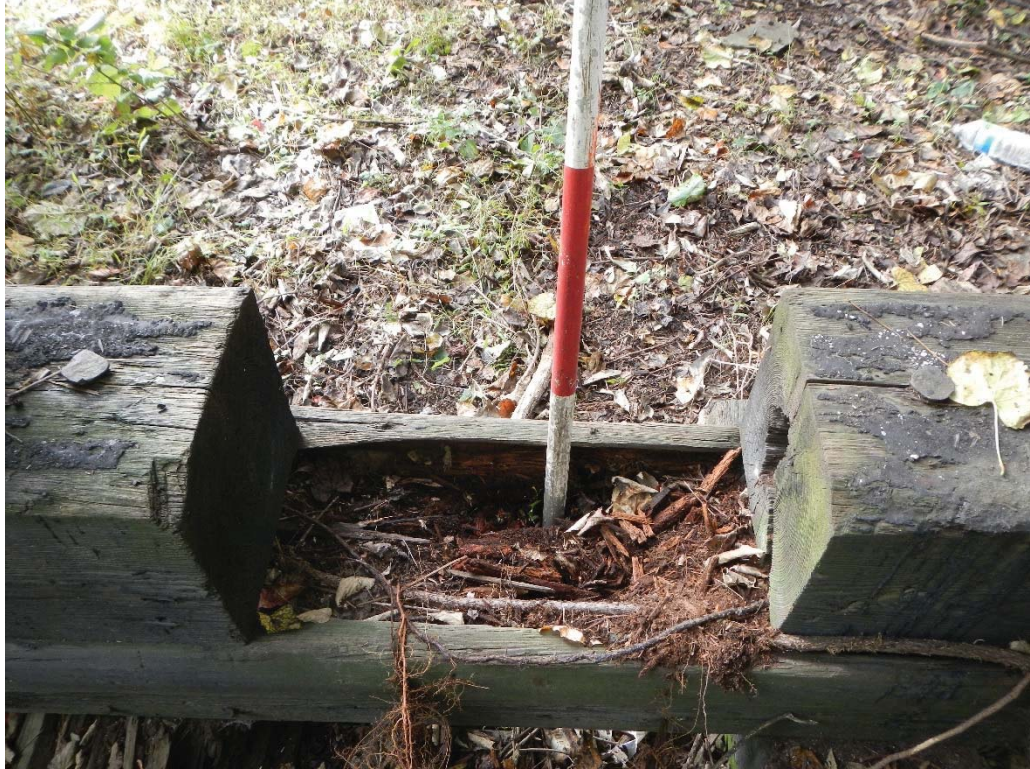
59. Pier 15 Bottom Strut Decay Between Columns 2 and 3 (Decay Extends Full Length)

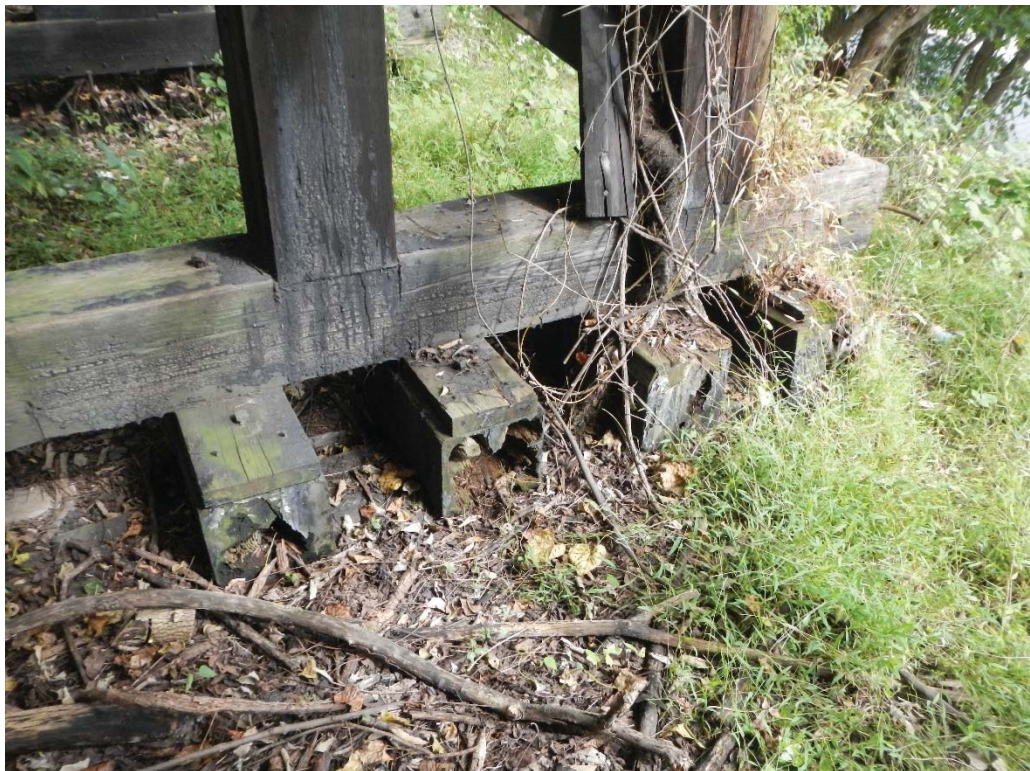
60. Pier 14 Mudsills 5 thru 8 Decay (Typical Condition)

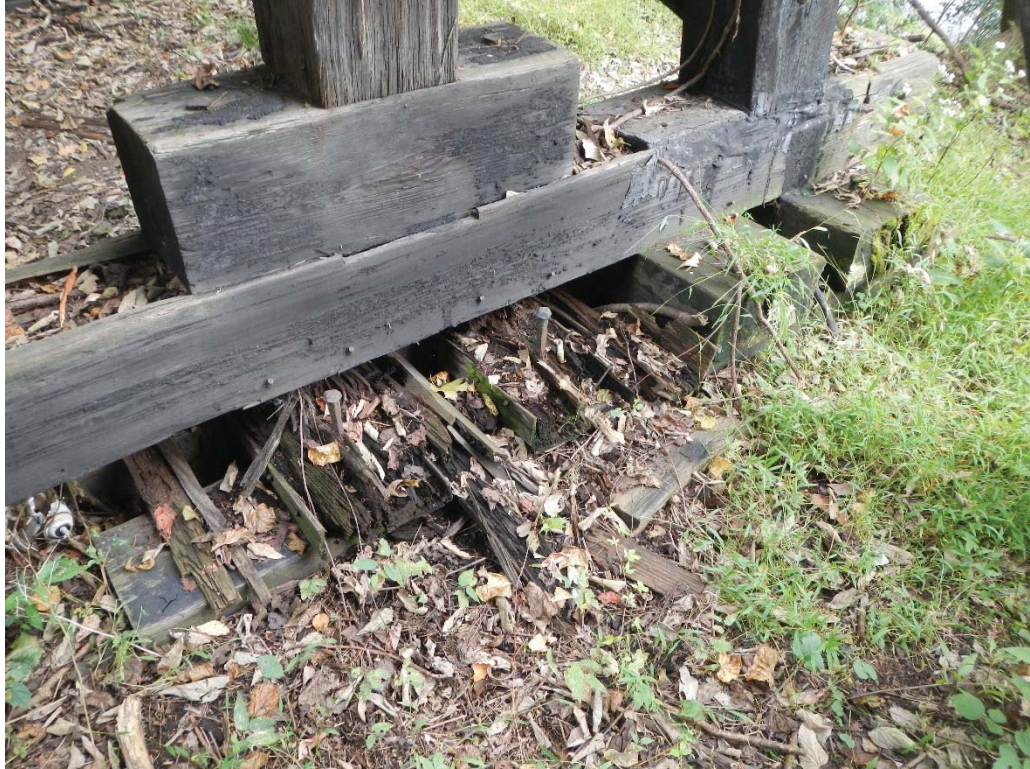
61. Pier 15 Mudsills 5 thru 8 Decay (Typical Condition)

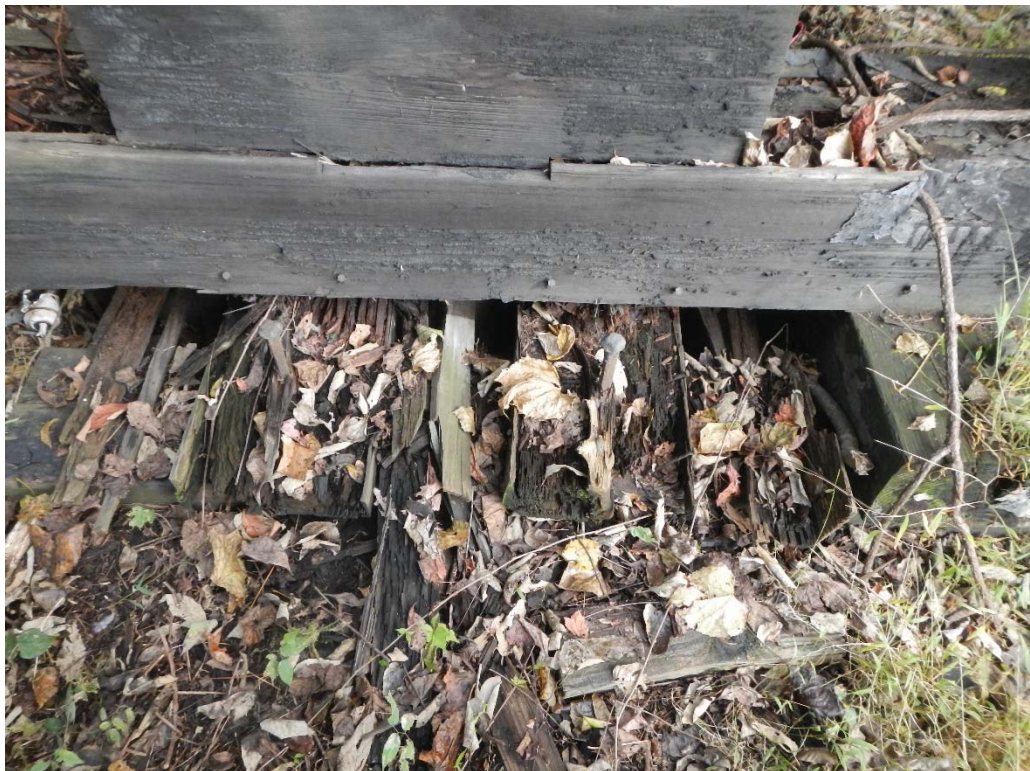
62. Pier 15 Mudsills 5 and 6 Decay Close Up

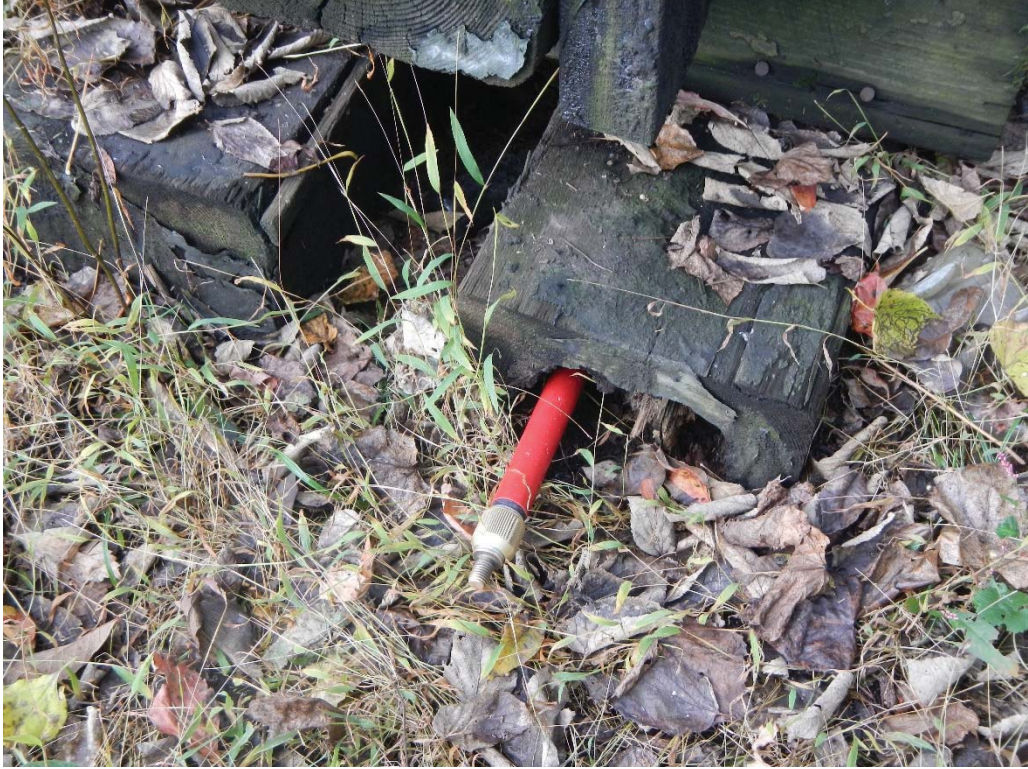
63. Pier 15 Far (East) Right (South) End Footing Decay (3'-6" Penetration with 4' Rod)

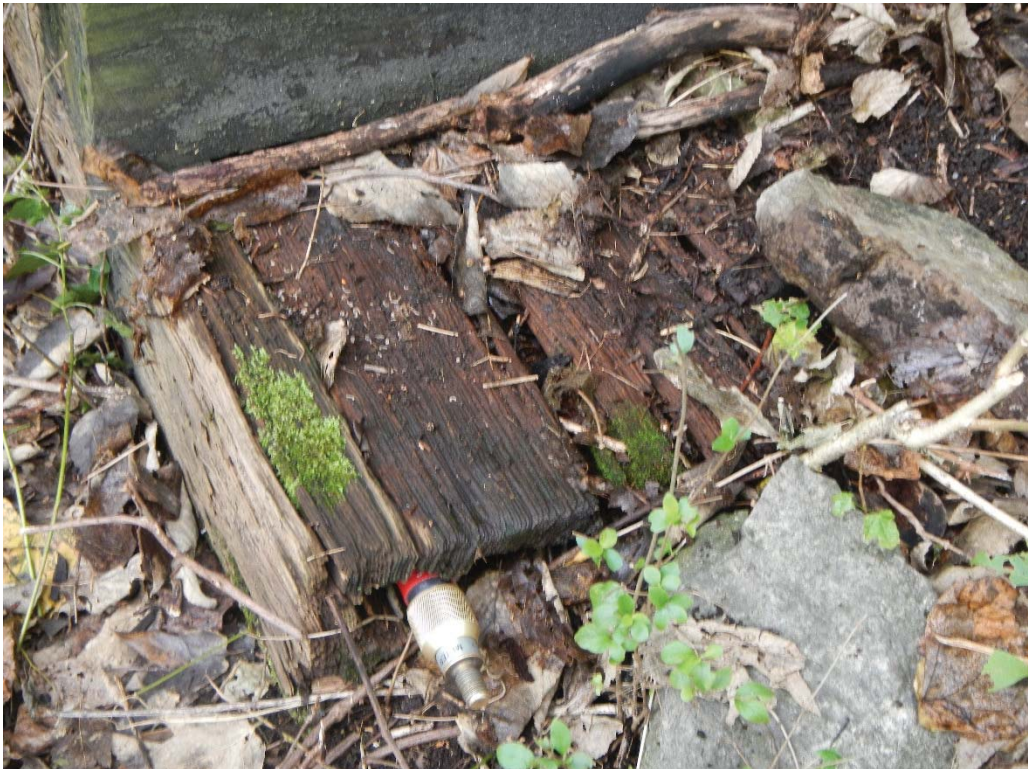
64. Pier 17 Right (South) End Footing Decay (4' of Penetration with 4' Rod)

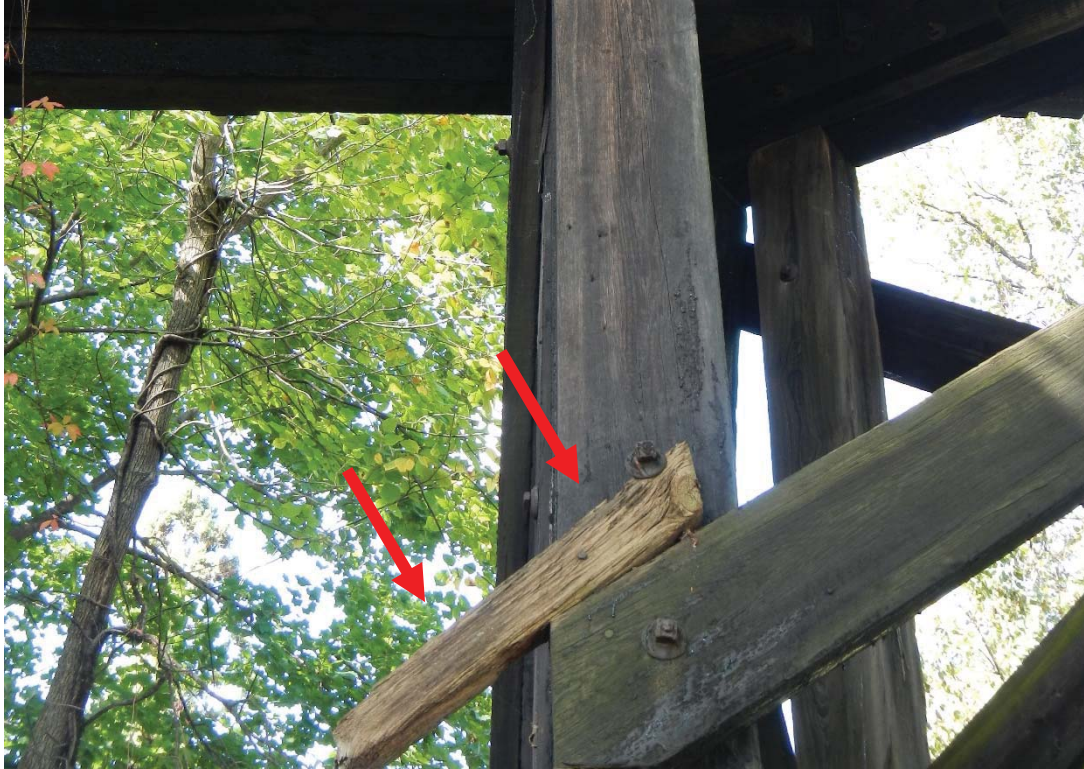
65. Span 5 Right (South) Longitudinal Bracing Missing at Pier 5

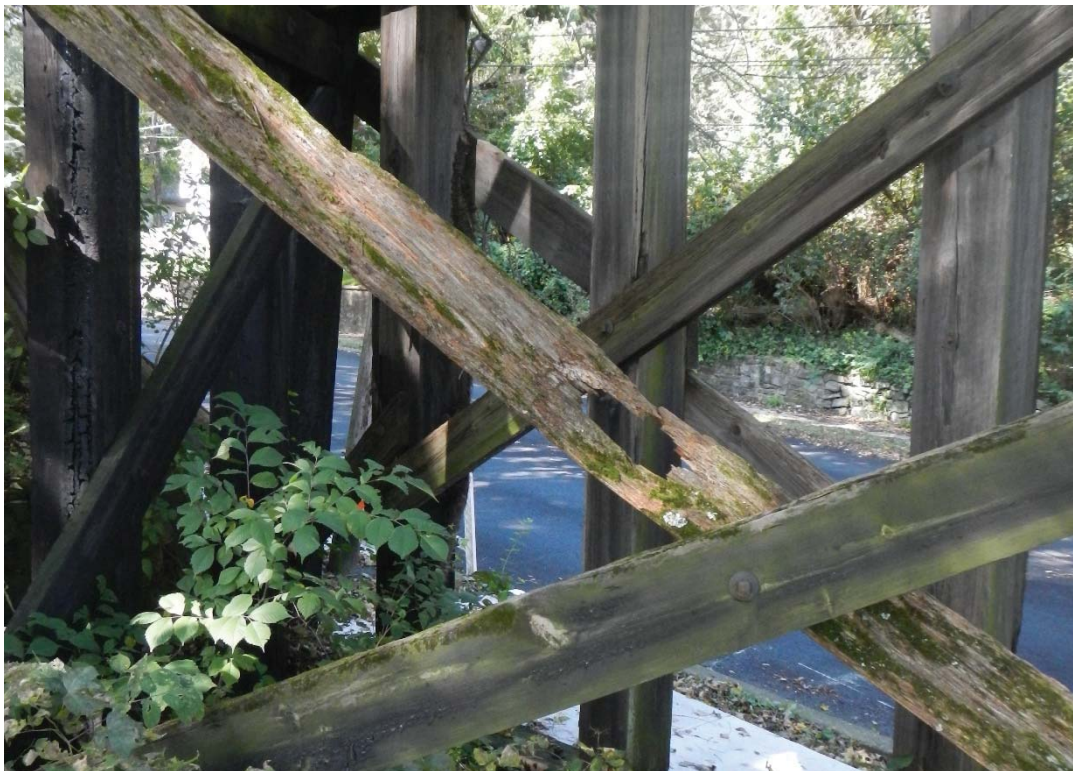
66. Span 6 Right (South) Longitudinal Bracing Decay

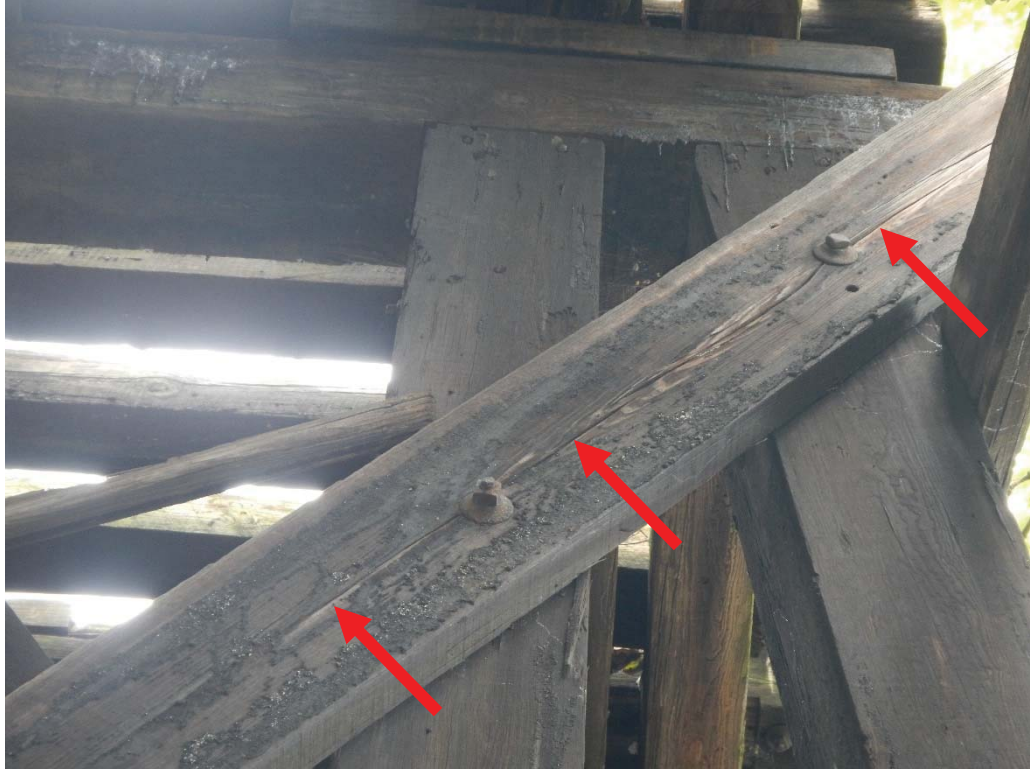
67. Pier 5 Near (West) Top Diagonal Transverse Brace Split

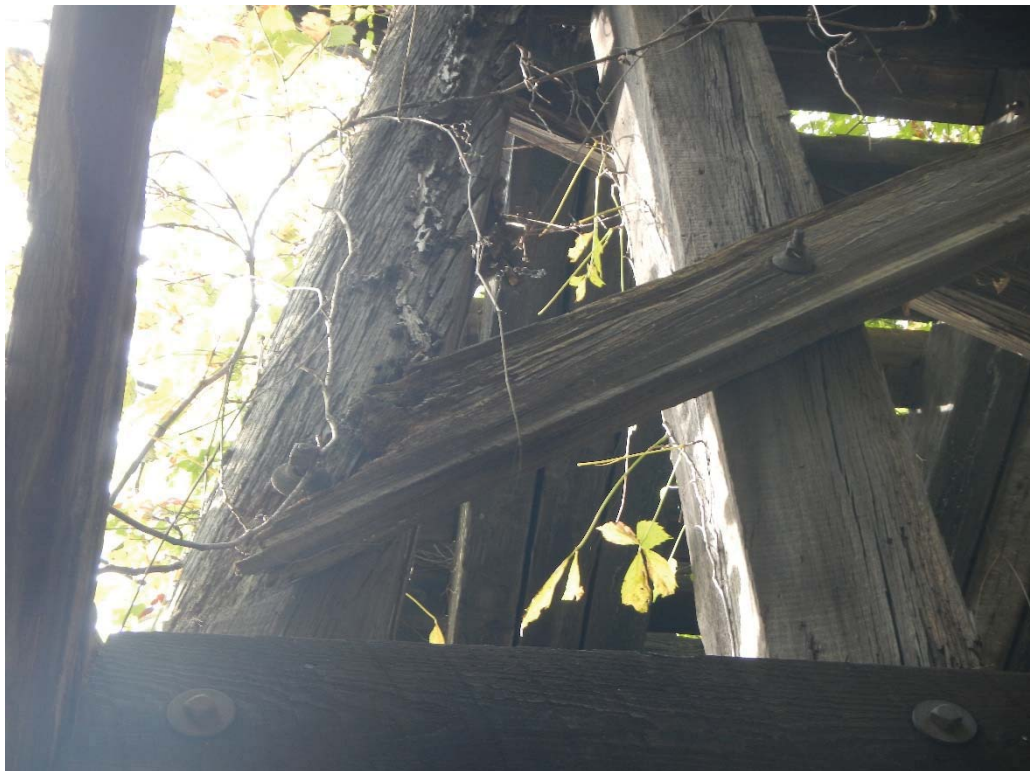
68. Pier 14 Far (East) Top Diagonal Transverse Brace Decay

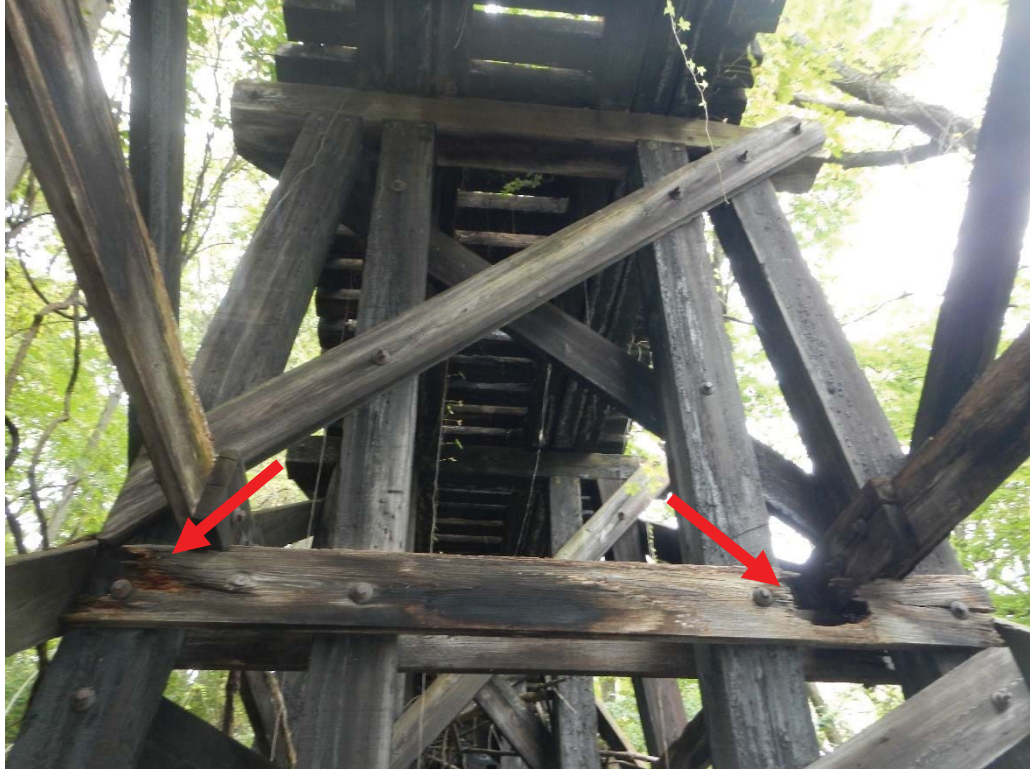
69. Pier 16 Near (West) Horizontal Transverse Brace Decay

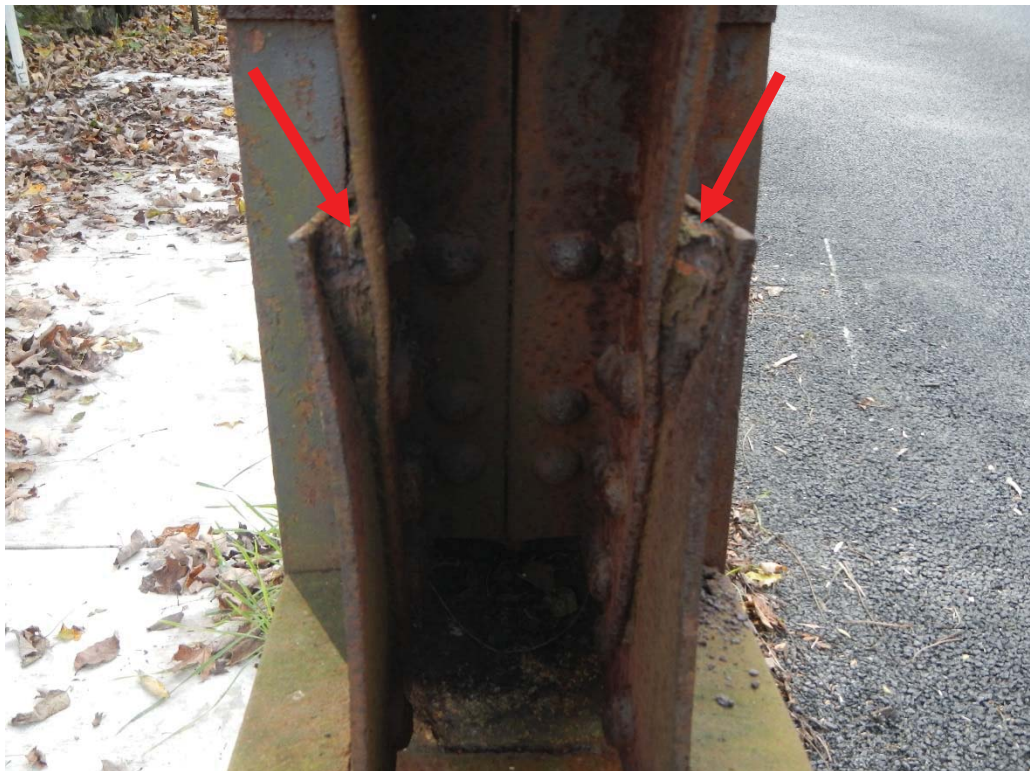
70. Pier 7 Column 1 Bracing Vertical Gusset Plates Bent with Pack Rust

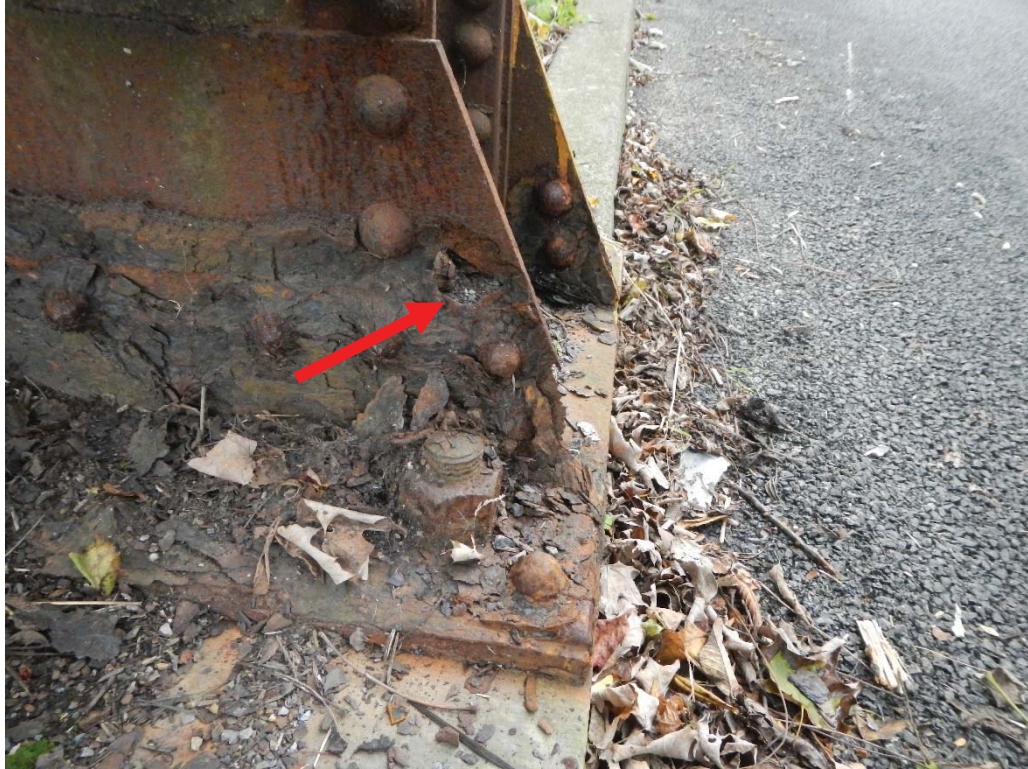
71. Pier 7 Column 1 Connection Angle 100% Section Loss

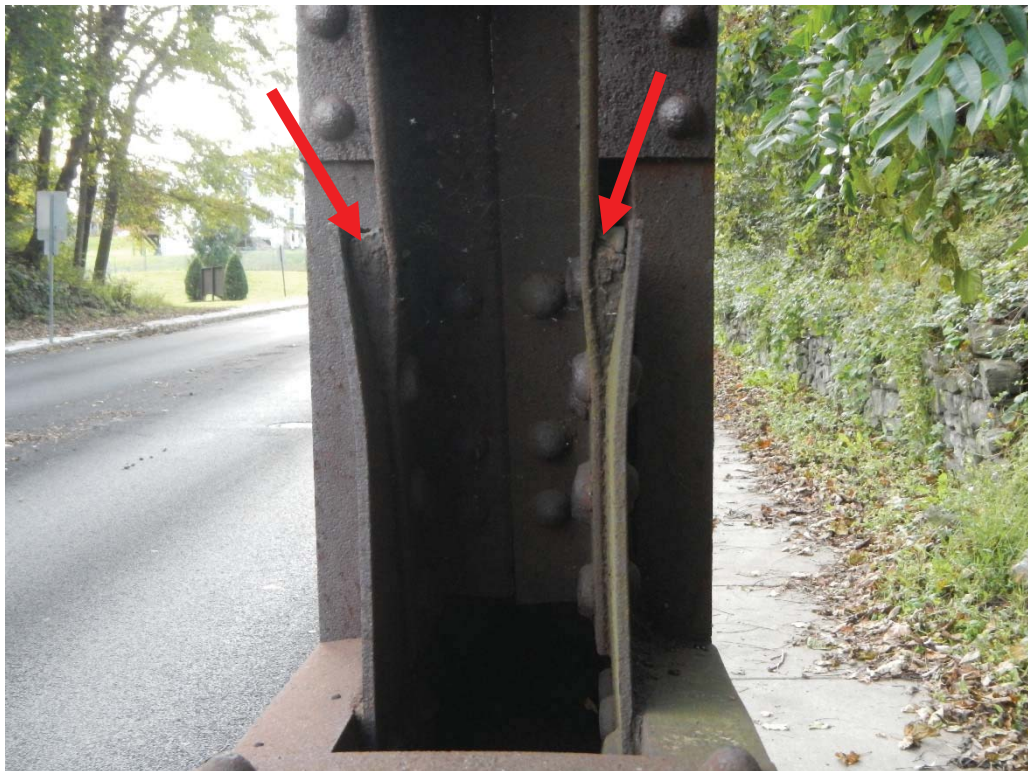
74. Pier 9 Column 1 Bracing Vertical Gusset Plates Bent with Pack Rust
